MASTER PLAN STUDY
ON
BRIDGE DEVELOPMENT
IN
THE DEMOCRATIC SOCIALIST REPUBLIC OF SRI LANKA

FINAL REPORT

BRIDGE
INSPECTION, MAINTENANCE AND REHABILITATION
GUIDELINE

JULY 1996

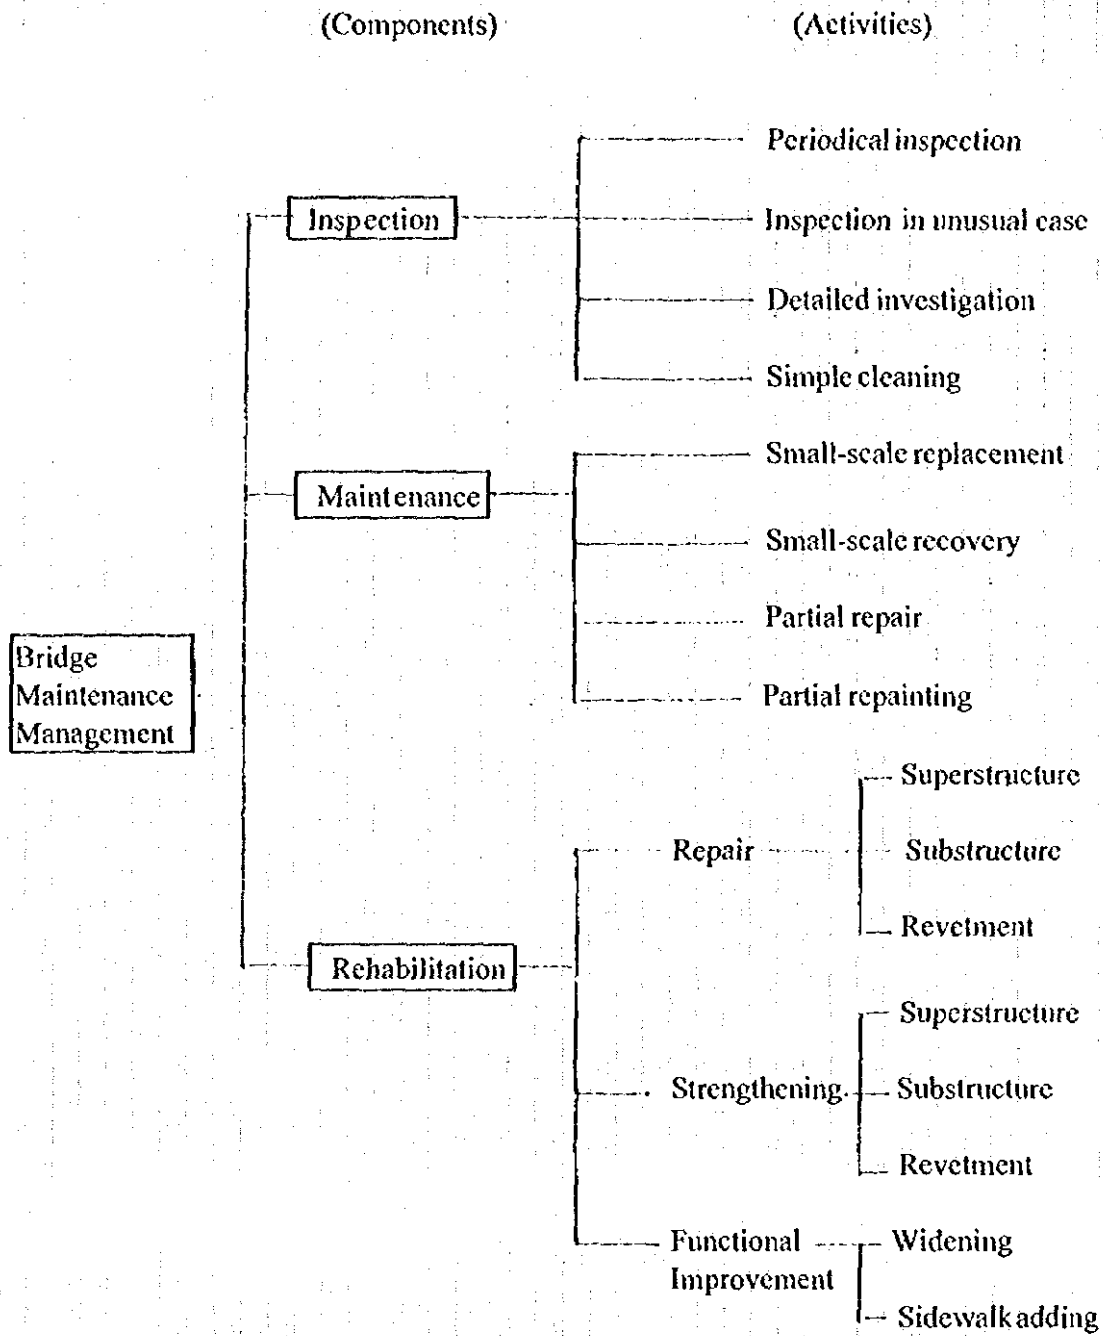
Figure 1.1 Definition and Functions of Maintenance Management

The bridge maintenance and rehabilitation consists of inspection, maintenance and rehabilitation as shown in Figure 1.1.

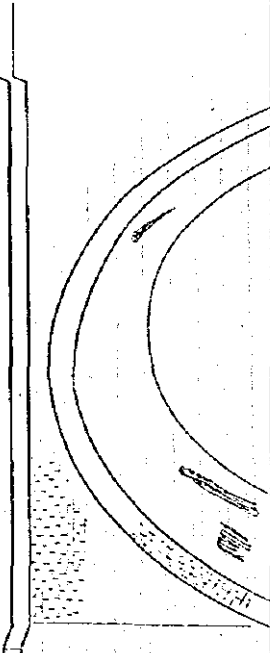
NAME OF BRIDGE: MAWANELLA BRIDGE		SER No. 85 - A001 - 9 1/2 km	Date of Inspection 24.05.1995
LOCATION A-1-Pr ARCH	CONDITION Water Leaks	Sketch

<p>Photo album No. 35 - 6</p>		<p>Comment 1. Water leaking through the deck.</p>	
<p>LOCATION Drain pipe (tree)</p> <p>Photo album No. -</p>		<p>Sketch</p>

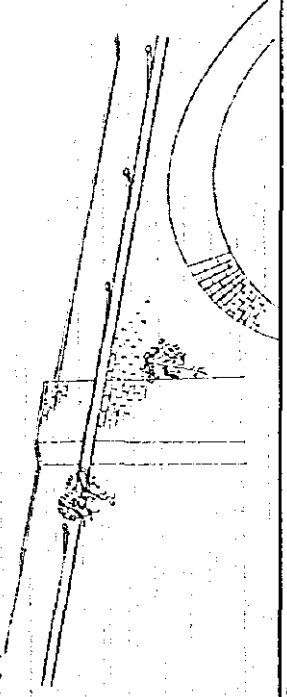
<p>Comment 1. Some trees grown on the brick surface. Treating the brick surface with a chemical (epoxy coat) can be done as a remedial measure.</p>

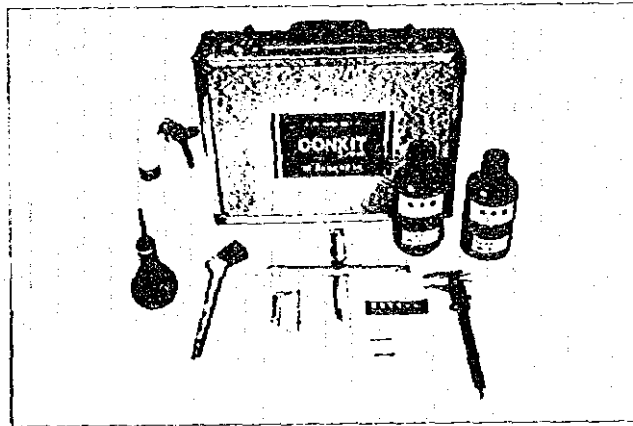
(4) Concrete Neutralization Tester (CONKIT)

Concrete during casting contains strong alkali. However when time passes, concrete touches carbon dioxide (CO_2) in the air and alkali of concrete will decrease.

The pH of concrete is below 9, then reinforcement steel has a environment to start rust.

- 1) Spray test liquid to the point of concrete
- 2) Red color- to alkali
No change- to Neutral
- 3) In order to test the depth of neutralization, chip concrete with electric hammer drill then spray test liquid.

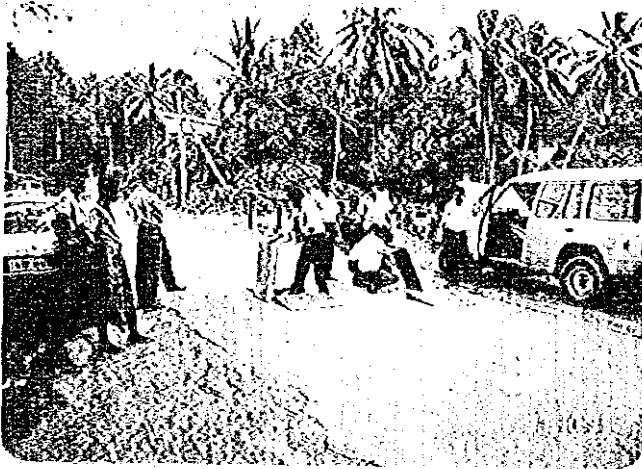
Loading Test

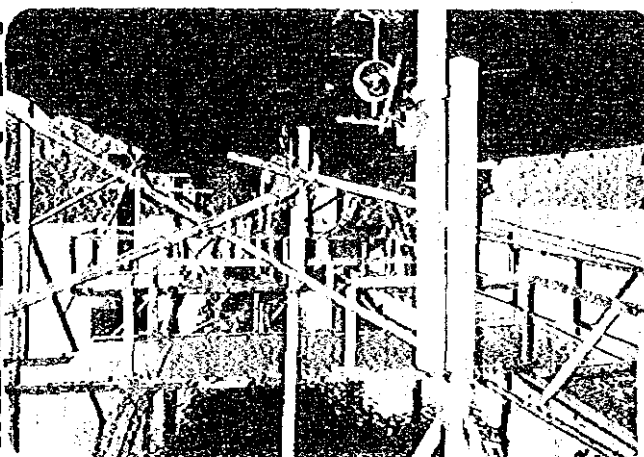
Scaffolding for loading test
Ser No. 59
