## シンズリ道路建設計画 (第二-3工区)

### 基本設計調査報告書

#### 資 料 編

**CONDITION SURVEY  
BENCHMARKS AND CONTROL POINTS**

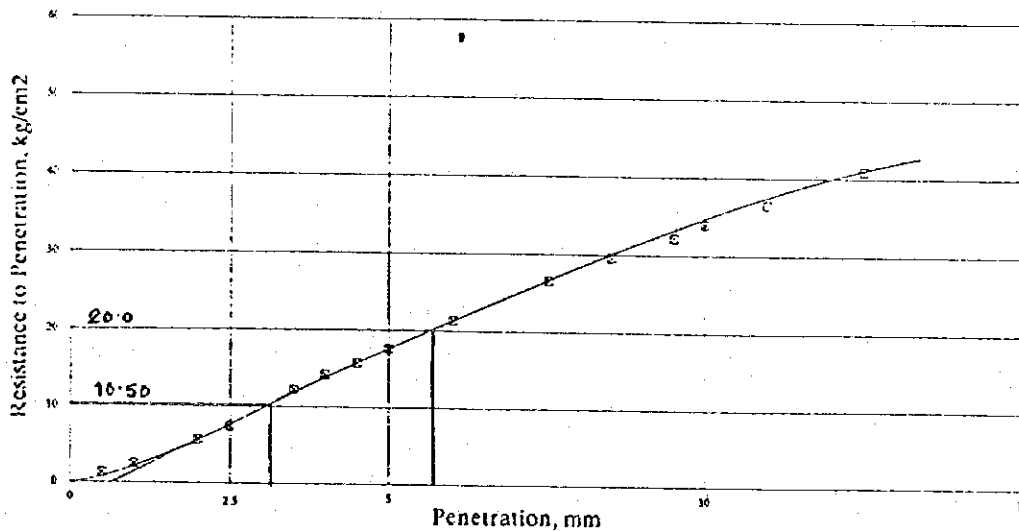
STRESS STRAIN CURVE

Initial Dial Reading	Div.
(0hrs.) 15-01-1996	6.21
Dial Reading (24hrs.)	
Dial Reading (48hrs.)	
Dial Reading (72hrs.)	
Final Dial Reading	
(96hrs.) 19-01-1996	6.55
Swell, %	0.26
CBR of 5mm Penetration	19.05

Note: CBR =  $\frac{\text{Corrected Load Value} \times 100}{\text{Standard Load}}$

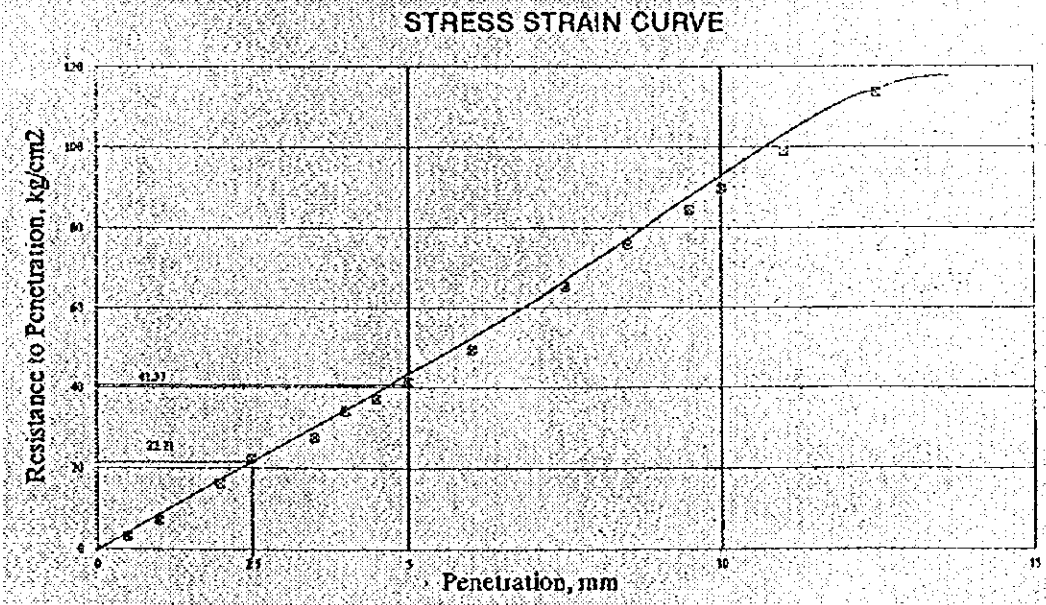
Mould No.	16
Wt. of Mould+Soil, gm	9800.00
Wt. of Soil, mg	5380.00
Wet Density, gm/cc	2.28
Dry Density, gm/cc	2.22
Wt. of Soil after Soaked, gm	9950.00
Water Absorbed, %	2.78
CBR Value of, %	
CBR of 2.5mm Penetration	31.73

Initial Dial Reading	Div.
(0hrs.) 15-01-1996	5.92
Dial Reading (24hrs.)	
Dial Reading (48hrs.)	
Dial Reading (72hrs.)	
Final Dial Reading (96hrs.) 19-01-1996	5.95
Swell, %	0.02
CBR of 5mm Penetration	39.40

Note:  $CBR = \frac{\text{Corrected Load Value} \times 100}{\text{Standard Load}}$

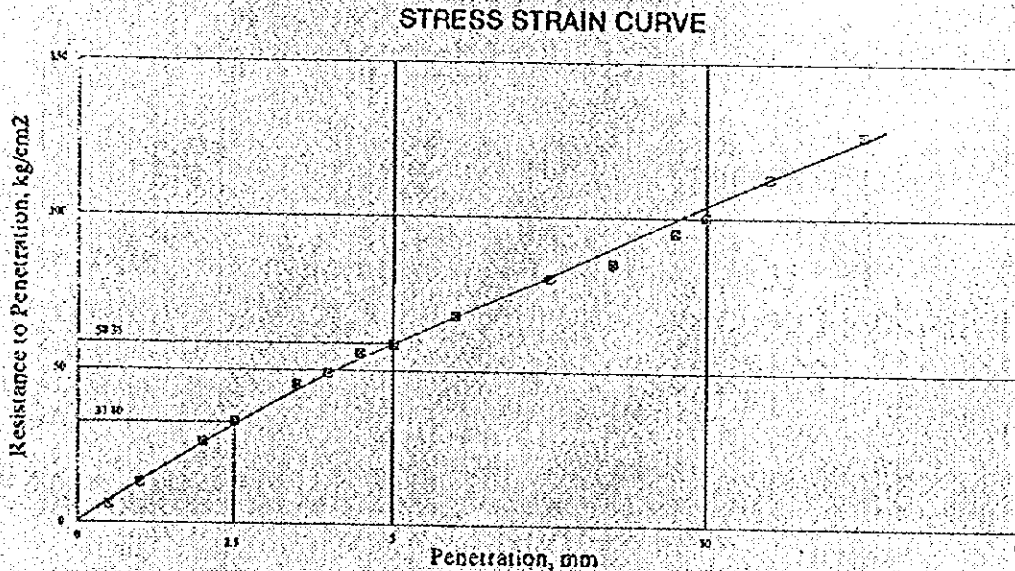
Mould No.	C3
Wt. of Mould + Soil, gm	9050.0
Wt. of Soil, mg	5150.00
Wet Density, gm/cc	2.29
Dry Density, gm/cc	2.22
Wt. of Soil after Soaked, gm	5295.00
Water Absorbed, %	2.81
CBR Value of, %	
CBR of 2.5mm Penetration	47.29

Initial Dial Reading	Div.
(0hrs.) 15-01-1996	6.80
Dial Reading (24hrs.)	
Dial Reading (48hrs.)	
Dial Reading (72hrs.)	
Final Dial Reading (96hrs.) 19-01-1996	6.84
Swell, %	0.03
CBR of 5mm Penetration	55.57

Note:  $CBR = \frac{\text{Corrected Load Value} \times 100}{\text{Standard Load}}$

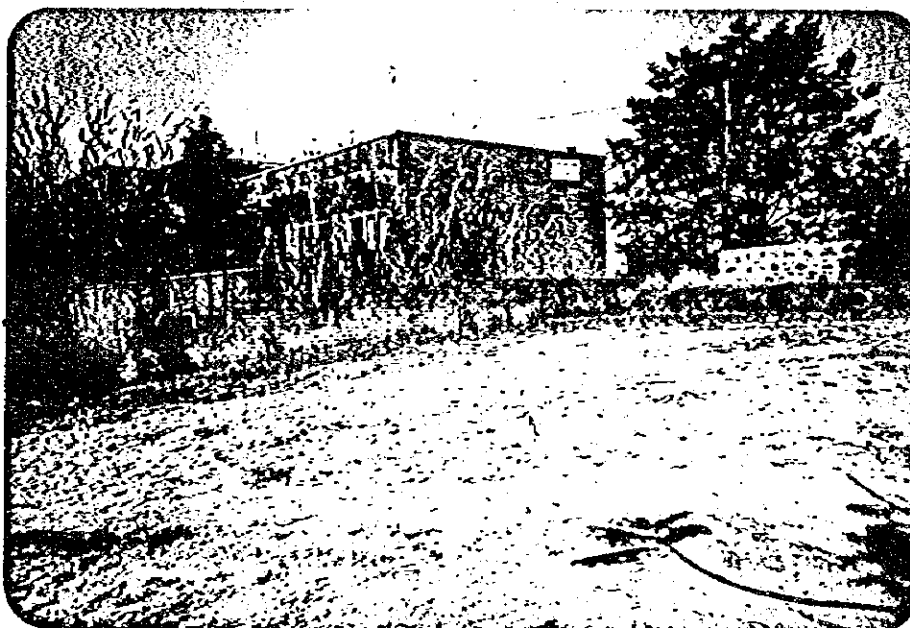
The point was disturbed during the construction of the forestry office building above.

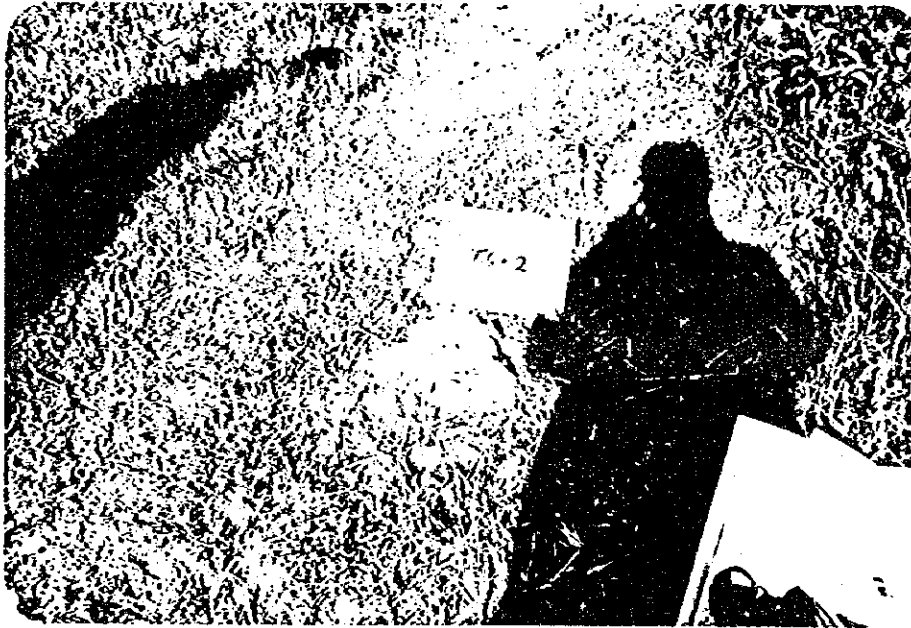
- Near the house of Surya Bahadur Thapa
- Could be used
- Even centre peg existed

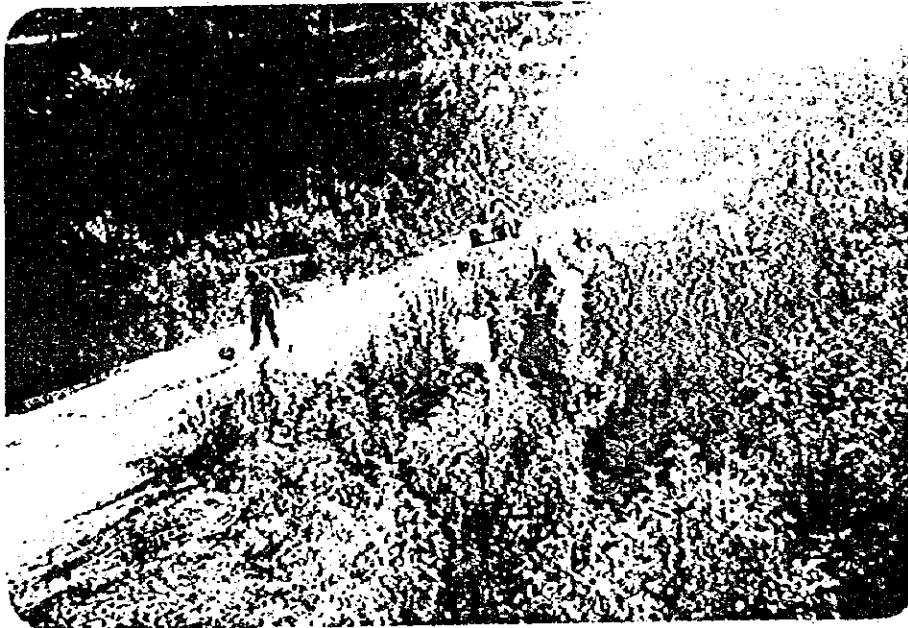
Reported to be around the above area

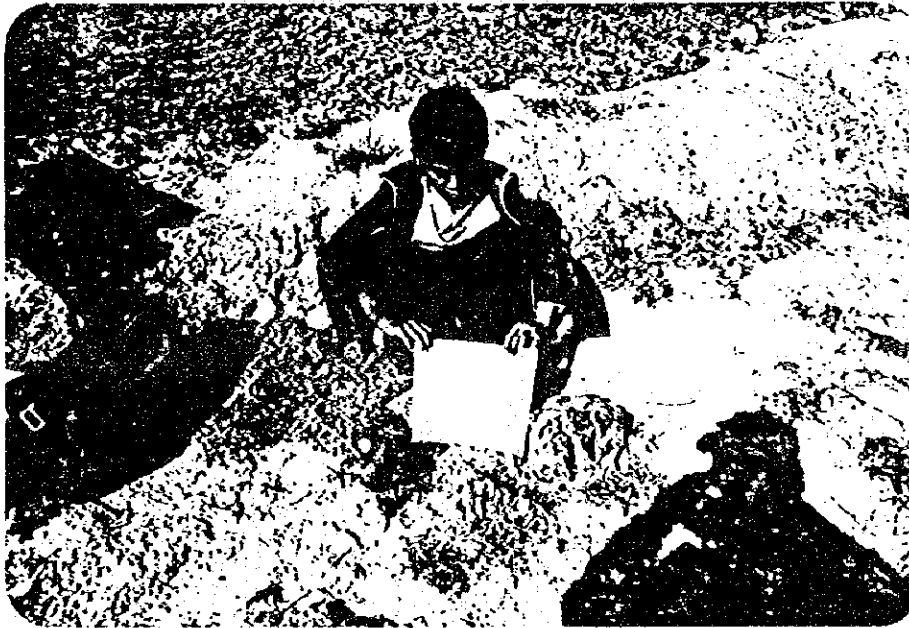
- Near the land of Naw Raj Mahat
- Could be used
- Even centre peg existed

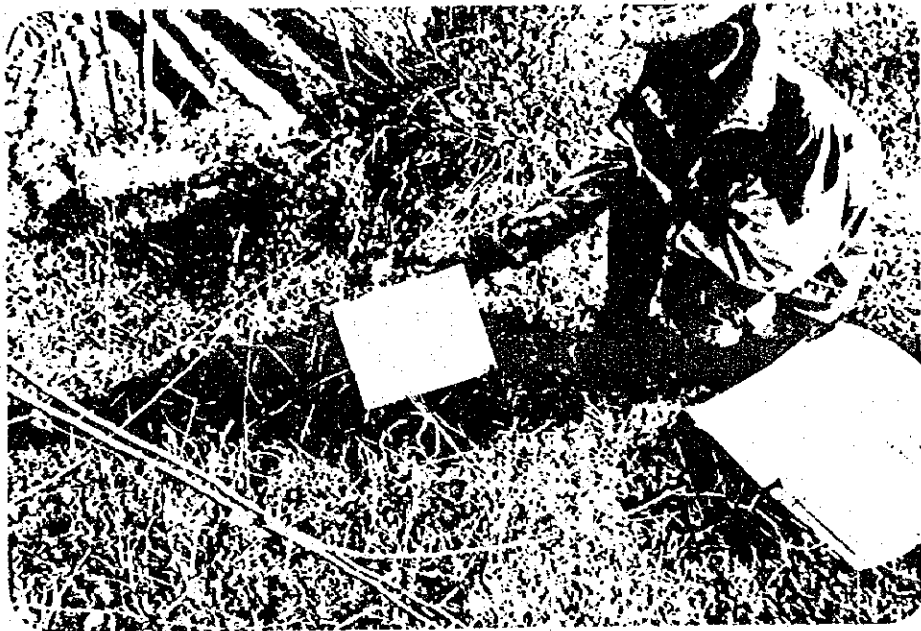
- The point is known to Mr. Hari Bahadur K. C.
- Could be used
- Even centre peg existed

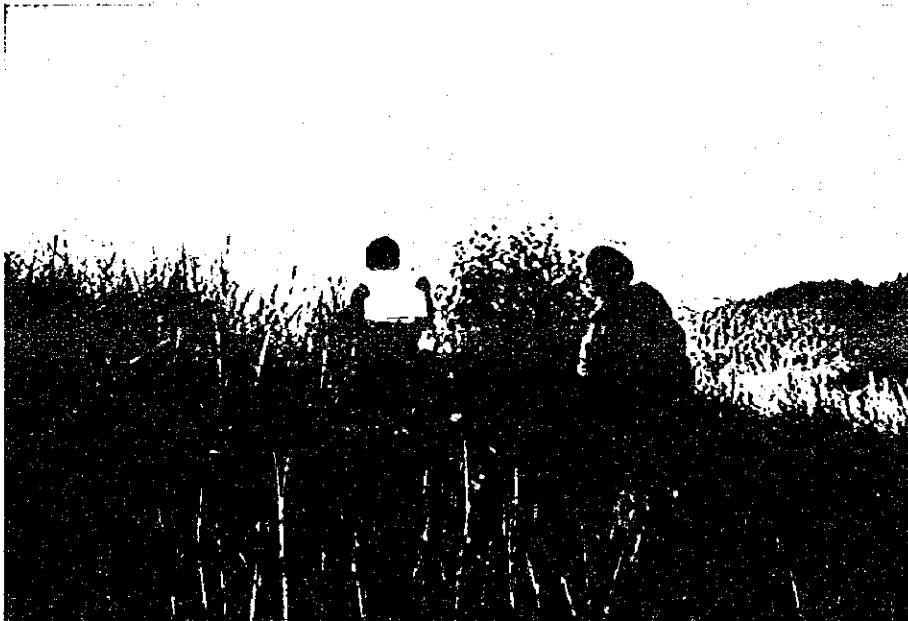
- Totally damaged condition located at Sanu Babu's Land

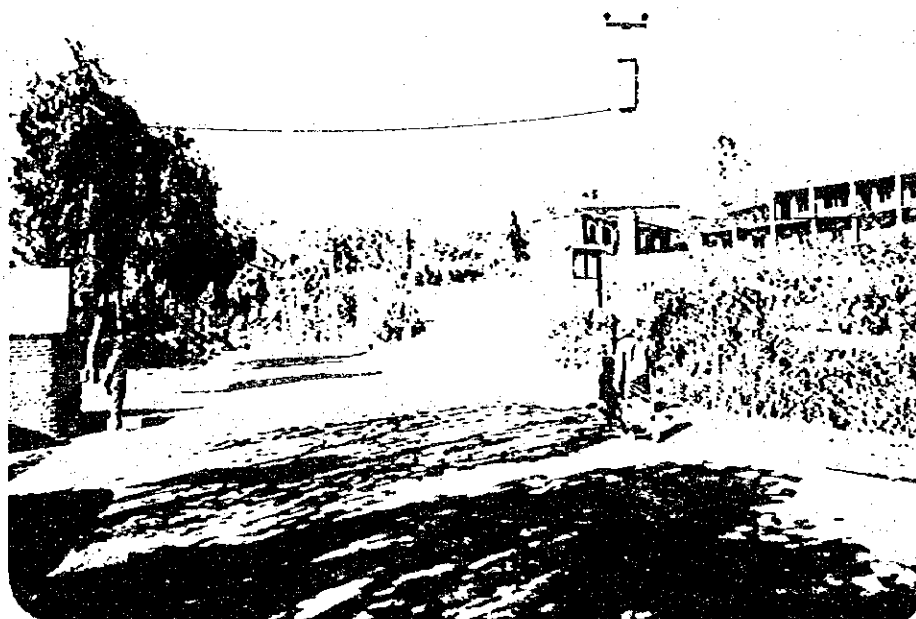
- B. M. is damaged during the extension of road to Hotel Himalayan Horizon

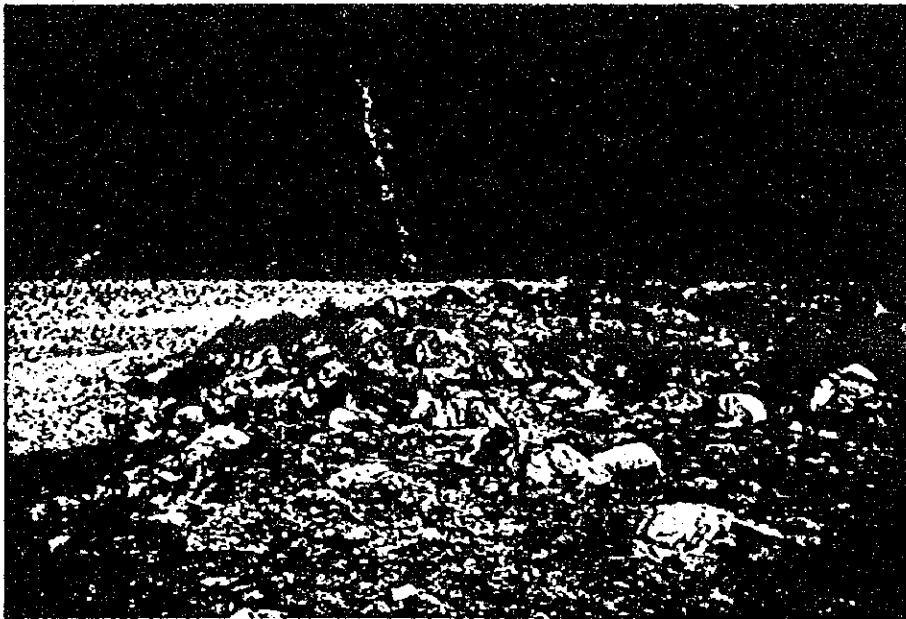
Washed out by the river

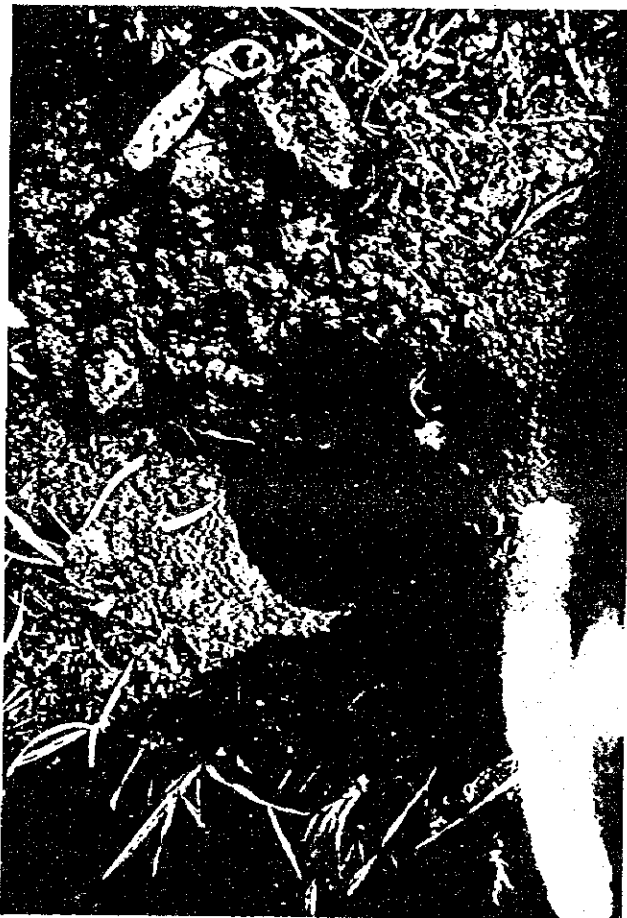
- B. M. is 1 feet down from ground level
- Land owner is Man Bahadur Tamang Wrad No. 2

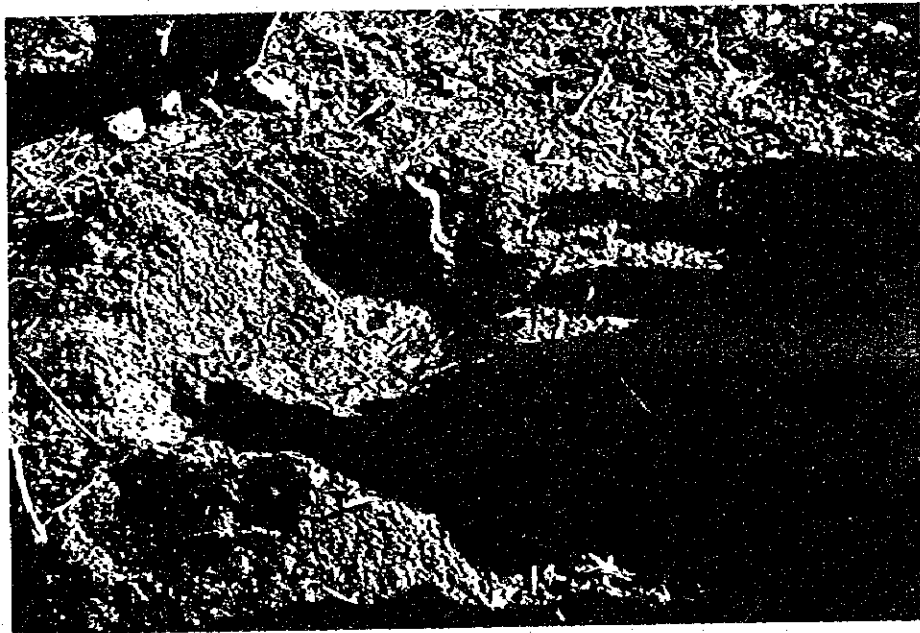
- B. M. is 1/2 feet down from ground level
- Land owner is Gajabir Lama

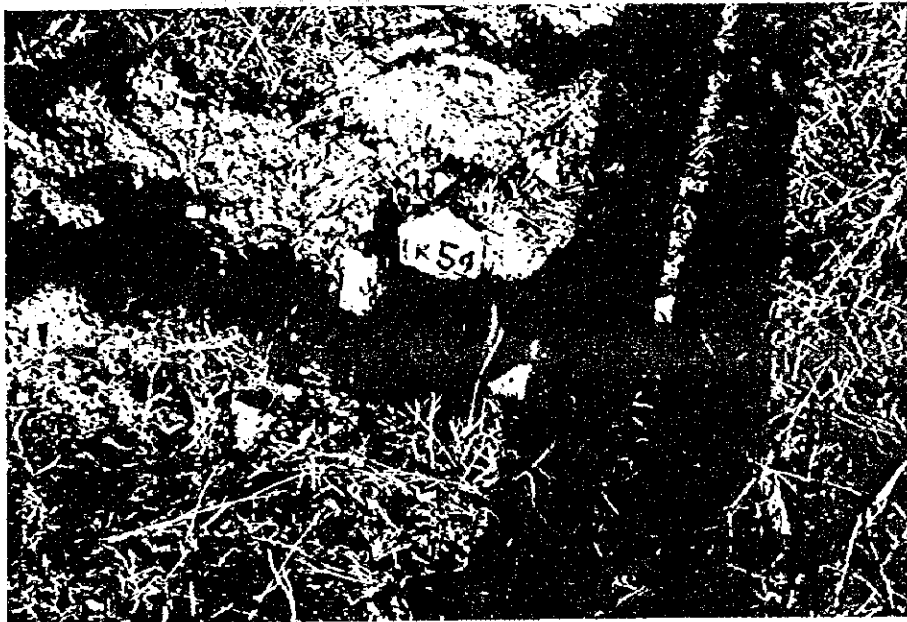
Totally damaged
