Longitudinal Profiles of the Manhari Khola

His Majesty's Government of Nepal
 Ministry of Forest and Soil Conservation/Department of Soil Conservation
 THE STUDY ON THE DISASTER PREVENTION PLAN
 FOR SEVERELY AFFECTED AREAS BY 1993 DISASTER
 IN THE CENTRAL DEVELOPMENT REGION OF NEPAL
 JAPAN INTERNATIONAL COOPERATION AGENCY

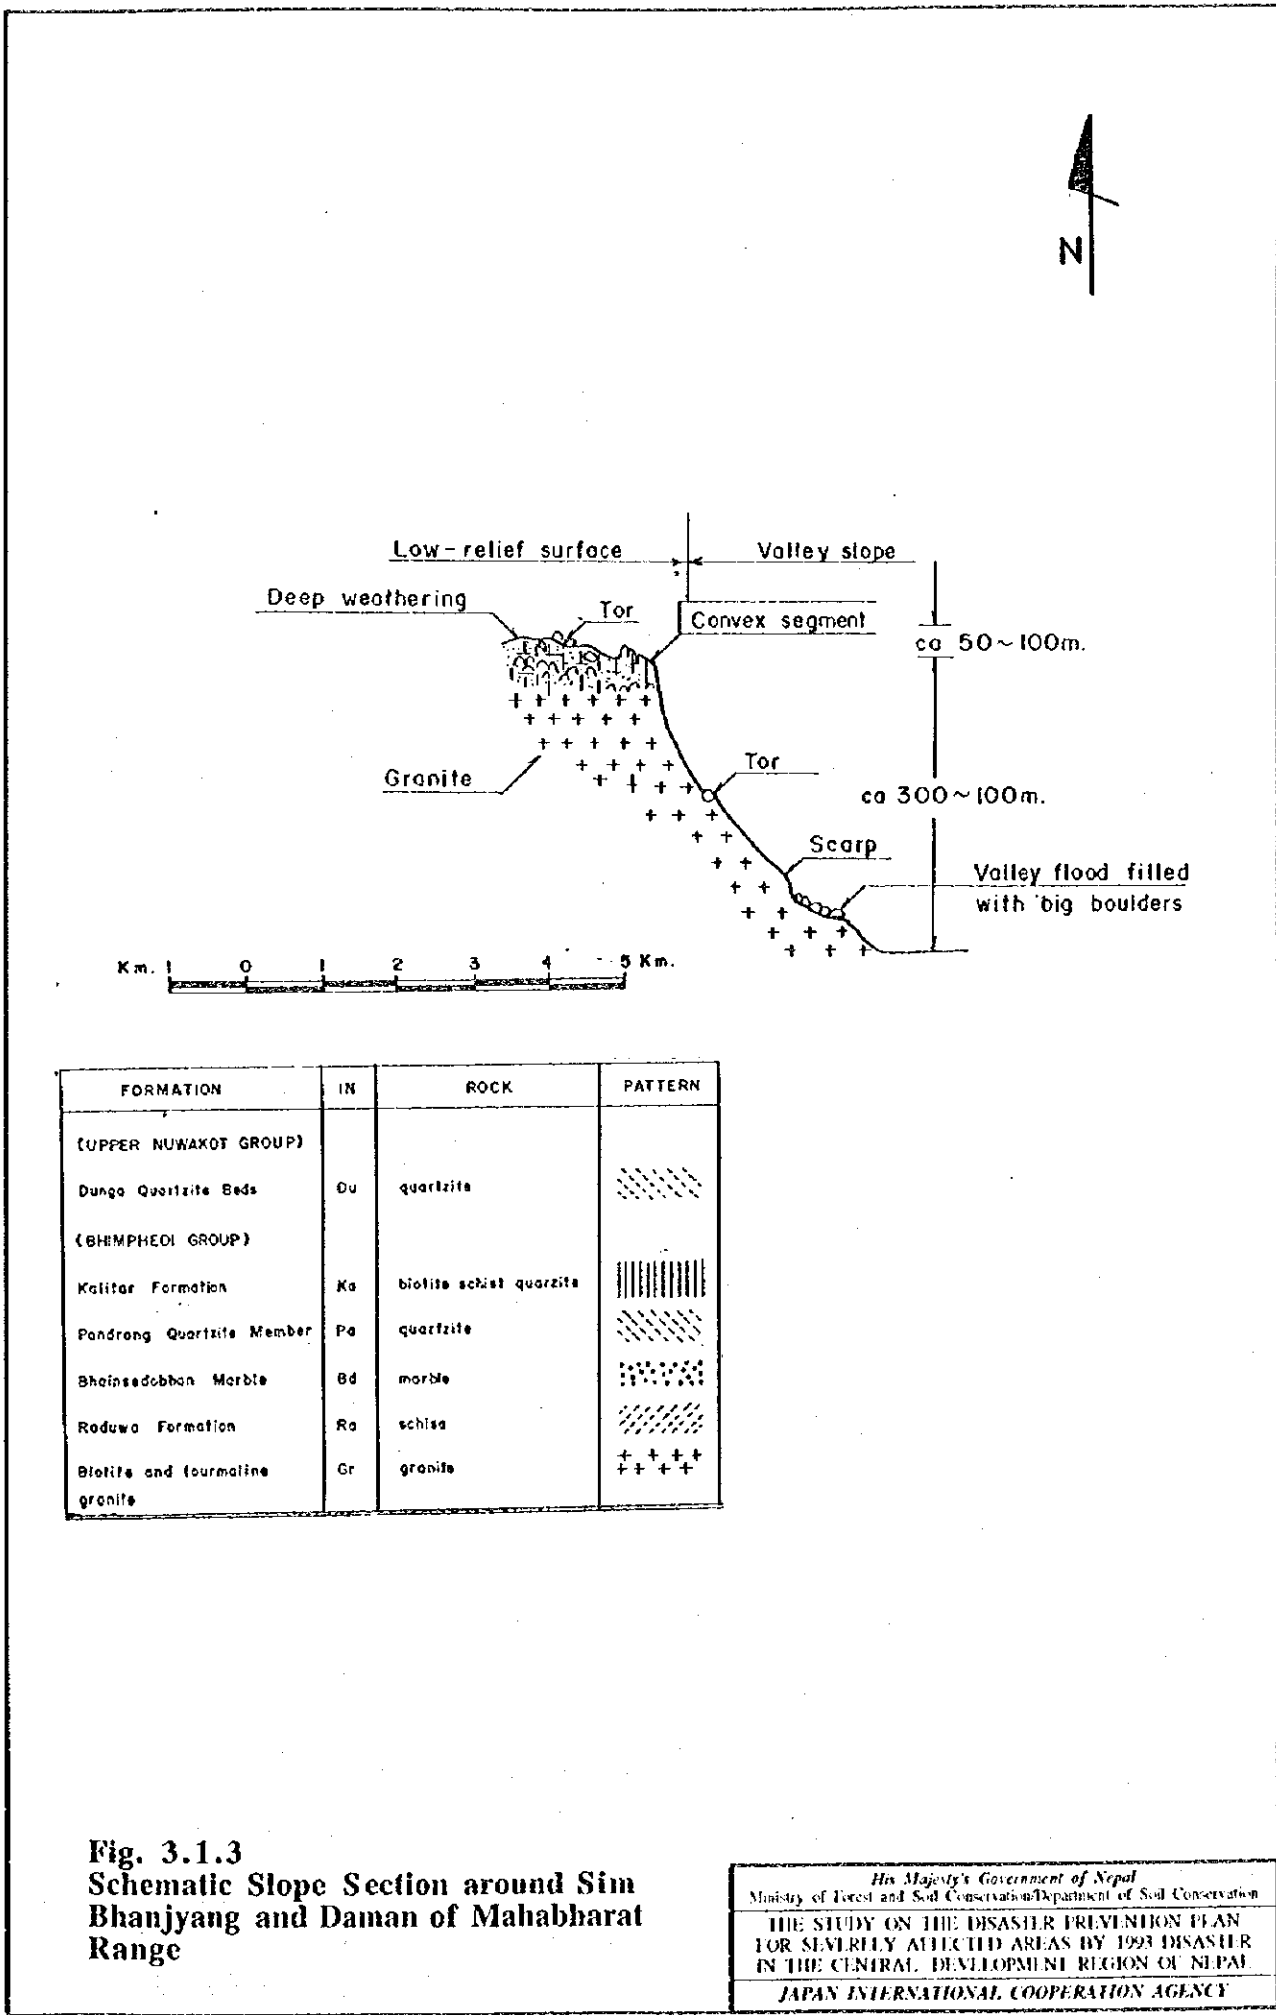
Fig. 3.1.3
Schematic Slope Section around Sim Bhanjyang and Daman of Mahabharat Range

FORMATION	IN	ROCK	PATTERN
(UPPER NUWAKOT GROUP)			
Dungra Quartzite Beds	Du	quartzite	Diagonal hatching (top-left to bottom-right)
(BHIMPHEDI GROUP)			
Kalitar Formation	Ka	biotite schist quartzite	Vertical hatching
Pandrong Quartzite Member	Pa	quartzite	Diagonal hatching (bottom-left to top-right)
Bhainsadobhan Marble	Bd	marble	Stippled pattern
Raduwa Formation	Ra	schist	Diagonal hatching (top-left to bottom-right)
Biotite and tourmaline granite	Gr	granite	Plus sign pattern (+ + + +)

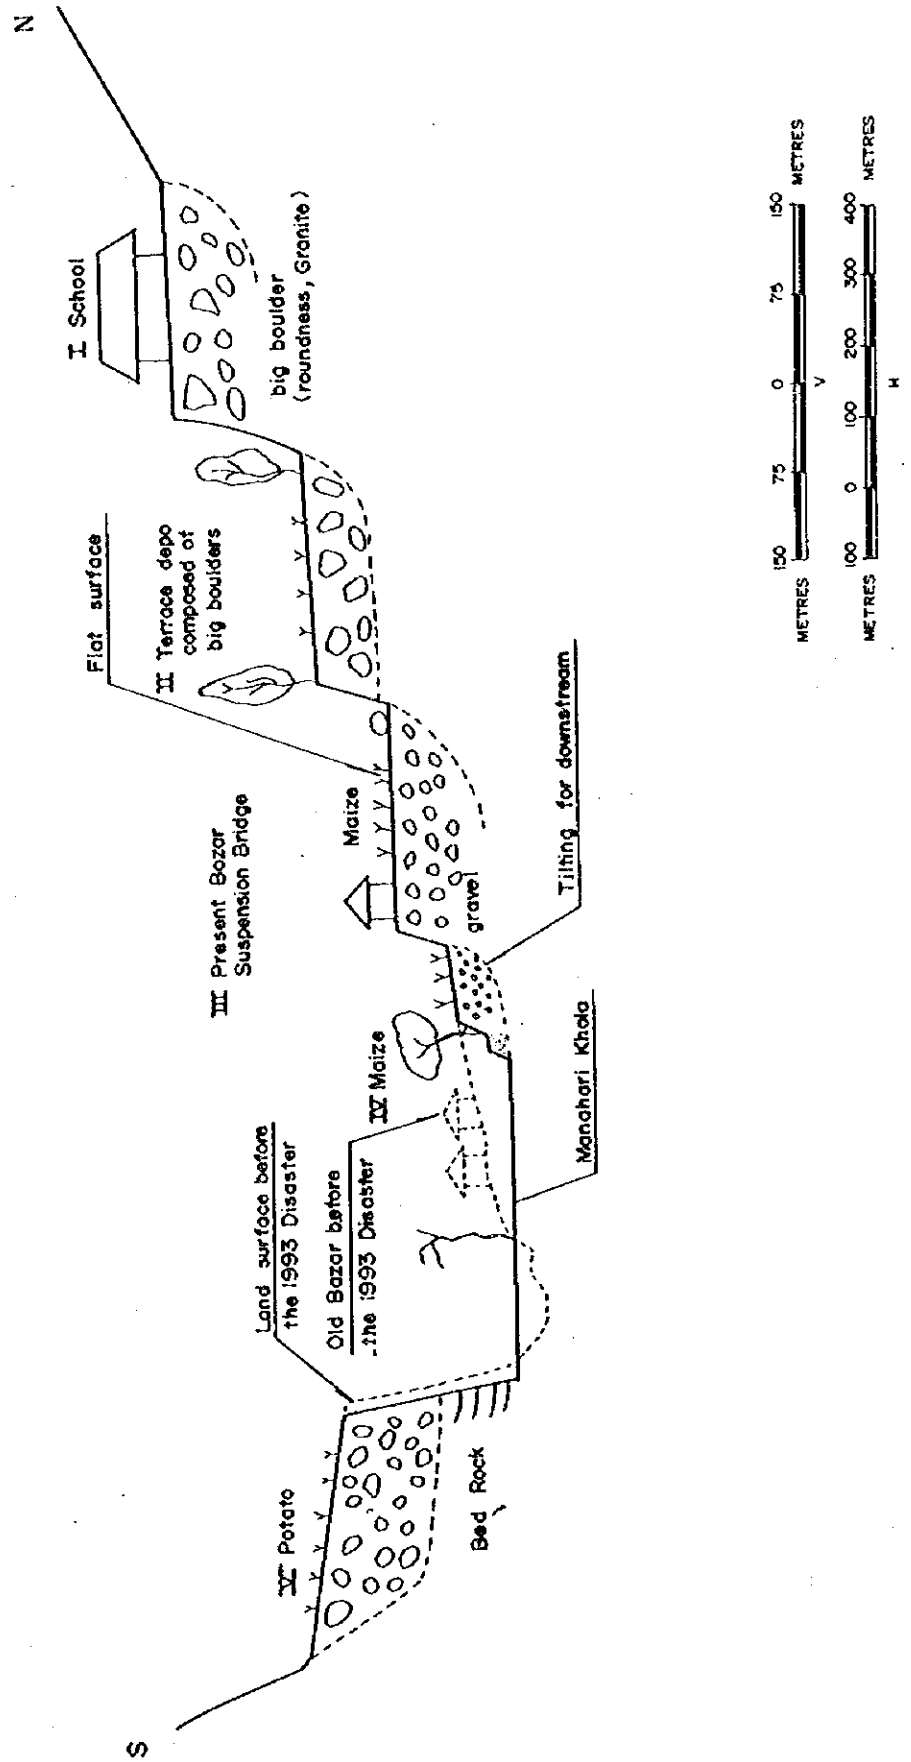
Fig. 3.2.4
Schematic Cross Section of Namtar

I-V River Terrace Surface

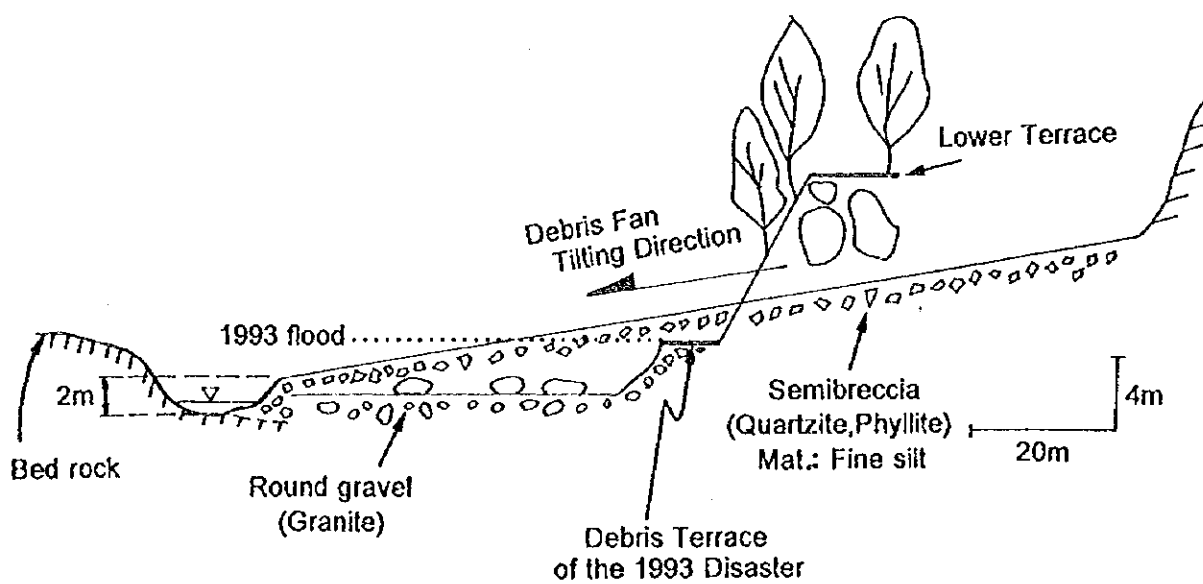
Fig. 3.2.7
Cross Section at the Large Scale Slope Failure
on the Right Bank of Upstream from Namtar

Major landslide in Tilar

* Maximum length	125m
* Maximum width	300m
* Area of landslide	25,625m ²
* Volume of displaced material	102,500m ³

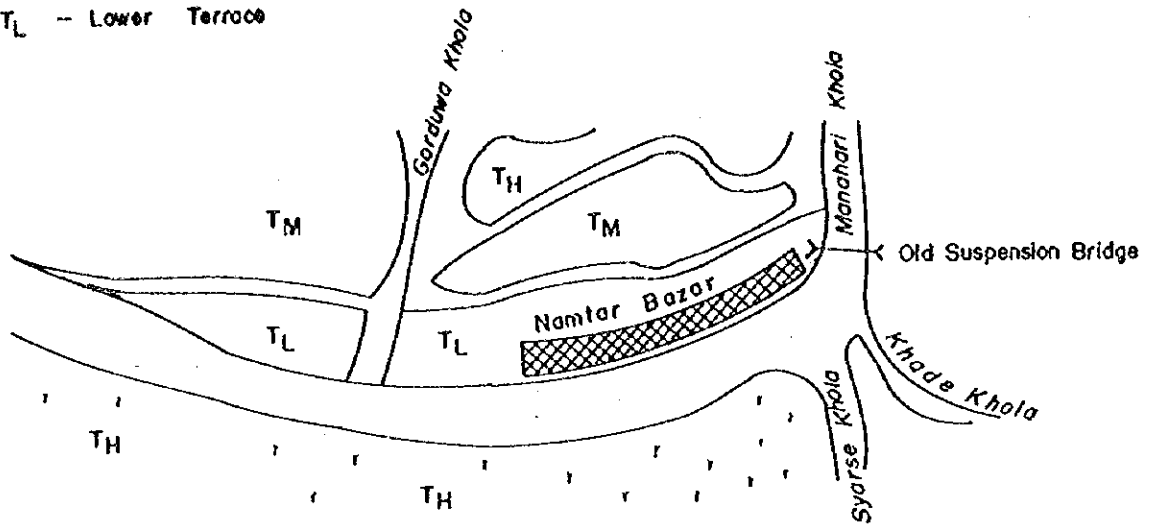
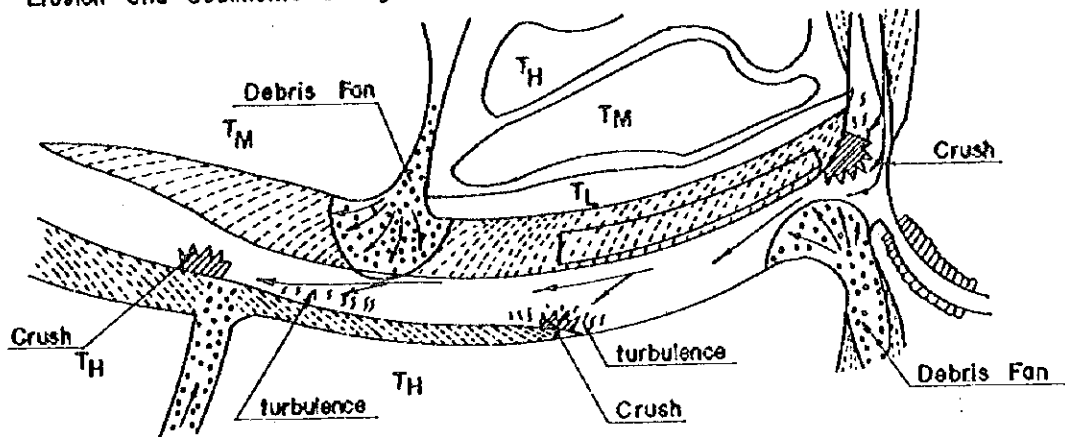
Fig. 3.3.1
Landform Changing Map before and after
1993 Disaster

(1) Before the 1993 Disaster

(2) Erosion and Sediments during the 1993 Disaster

(3) Present River Channel
