トルコ共和国
地震防災研究センター
巡回指導調査団報告書

平成7年11月

国際協力事業団
社会開発協力部

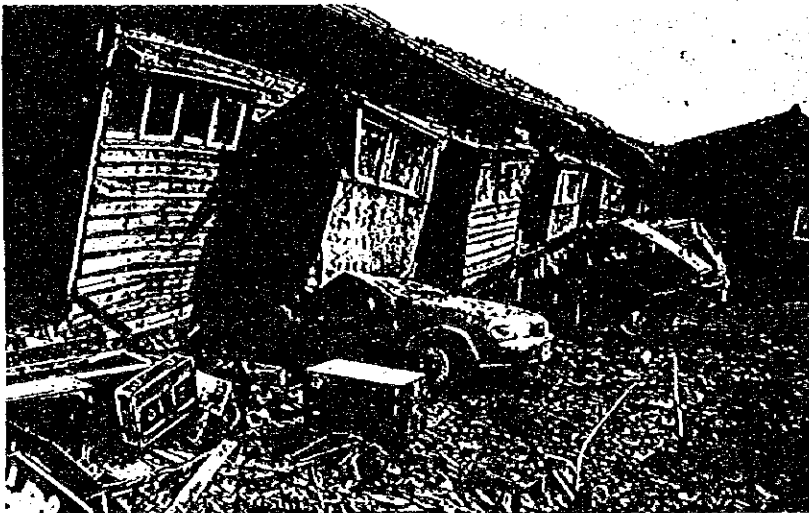
Offering little resistance, more than 50,000 wooden houses collapsed in the quake.

the destruction were the fires caused by collapsing wooden buildings and the extent of damage to reinforced concrete and steel-structure buildings built 20 to 30 years ago, before implementation of the current Seismic Design Code. Also striking were the collapse of the first floor of buildings with weak first-story structures, the collapse of the middle sto-
