DISASTER REVIEW
1995
(Series IV)

His Majesty's Government of Nepal
Ministry of Water Resources
Water Induced Disaster Prevention Technical Centre
(DPTC)
&
Japan International Cooperation Agency

DISASTER REVIEW 1995

(SERIES IV)

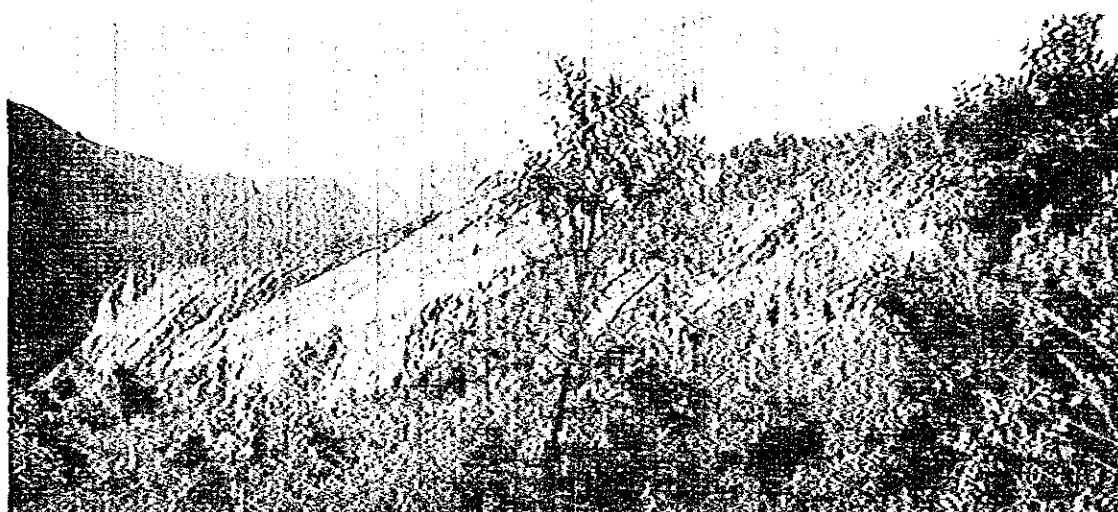
Plate 2.1

An old & big landslide at Thakani V.D.C. of Sindhupalchok district, induced due to geological & hydrological reasons

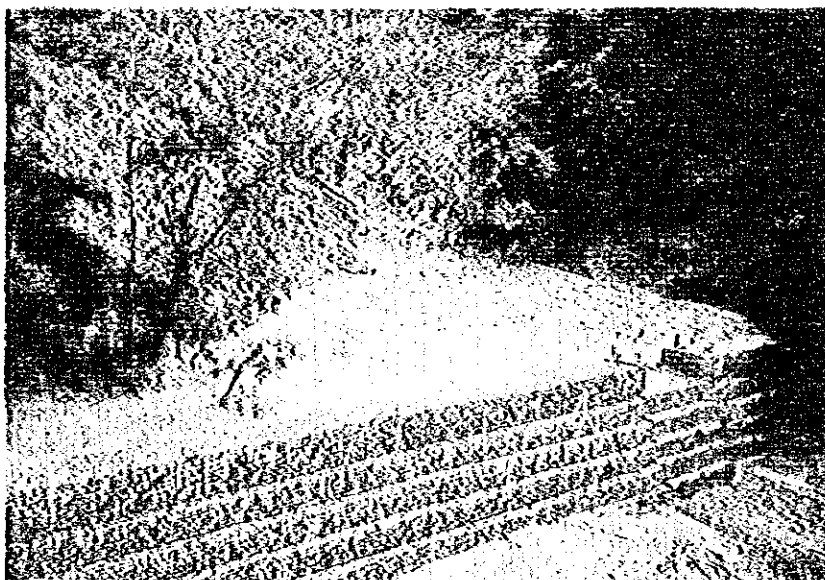
Plate 4. Photo : DPTC
Gabion Check Dam for Toe Loading at 62 km. along Charali-Ham Road.

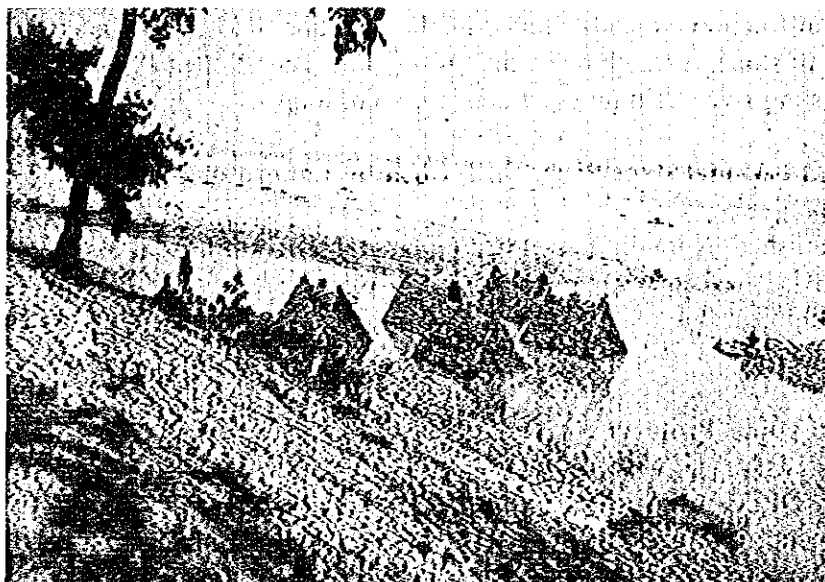
Plate 5.

This has been selected as the model construction works in order to identify suitable methods against river bank erosion in big Rivers by applying different types of spurs, revetments on the experimental basis. River bank erosion is serious along right bank of Mahakali River in Dodhara and Chandani VDC of Kanchanpur district. After completion of topographic map of 10.5 km. length of Mahakali river and design of river training structures jointly with

Mahakali Irrigation Project, the model construction work upto 6 km. length is expected to be completed this year. The river training work has protected Dodhara and Chandani VDC from flood of 1995 monsoon. Various types of peculiar structures like cylindrical gabions, geo-textile and geo-grid materials in rivetment, skeleton works etc. are tried and research on the effectiveness of these structures are going on to find out their effectiveness.

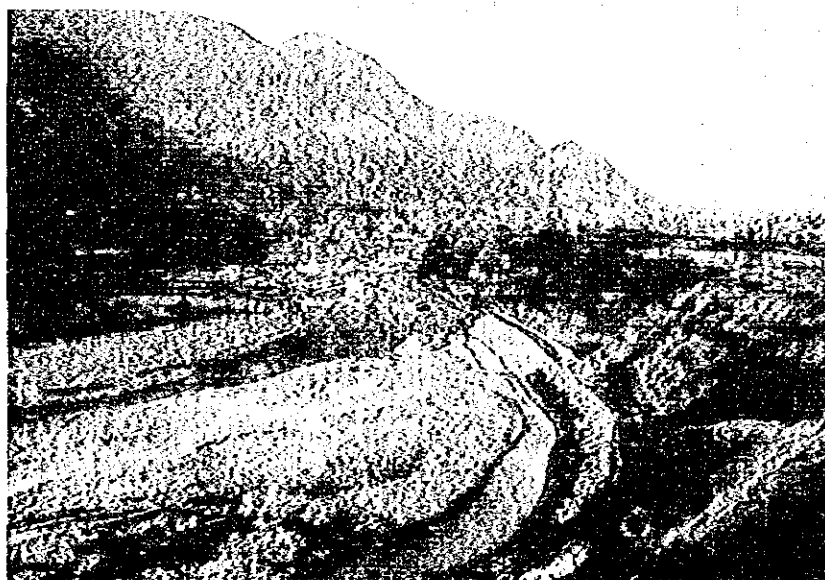
Plate 6.

b) Bagmati River at Khokana

Left bank of Bagmati river in Khokana VDC, Lalitpur district has been selected as a model site for river training works because of convenient location and suitability of site. The model construction work has been completed this year. The purpose of this study is to construct river training structure to control river toe cutting induced landslide. The construction work is

completed and no sign of further landslide is observed. The monitoring work is still going on.

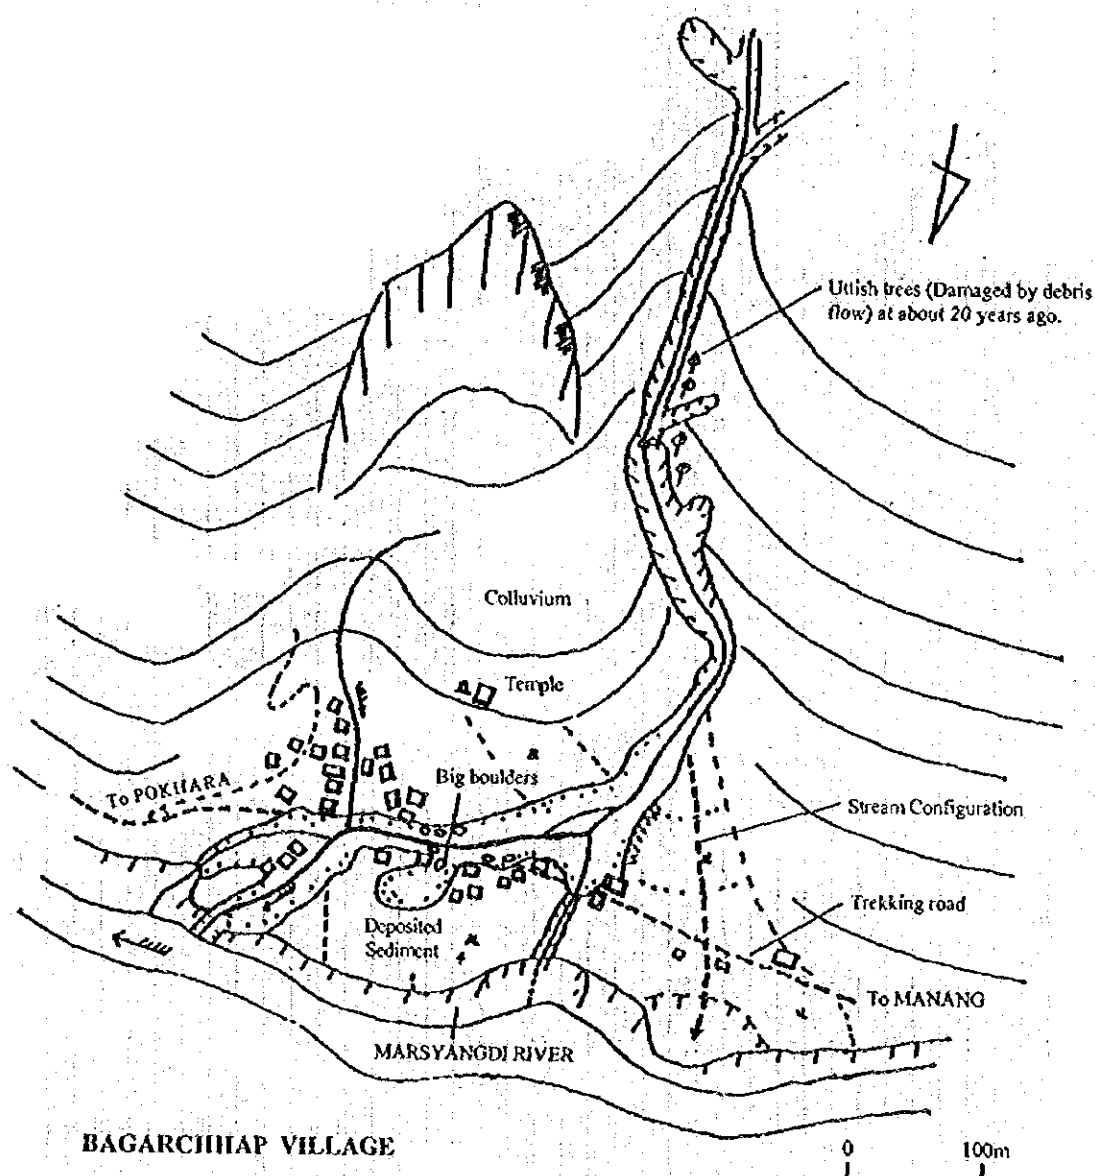
- It had clear front part with big boulders with about 8 m diameter. The front part stopped in the village
- The rare part, followed front part and spread over wider area than the front part.
- Deposited materials had shown random structures. (Mixture of mud up to big boulders).
- Deposition clearly observed in a limited area.
- The speed of flow was very fast, so that victims were found out in run-away position..
- The rare part washed away the early deposition. So that stream is flowing between 5 to 6 m down from both banks from top to middle of the new debris fan.

The gully on the existing fan was formed once on higher position by the front part then the rare part immediately washed away the centre of debris deposition. It was considered that debris flow occurred at least three times in a series by judging from the form of the deposition. The first debris flow stopped just near by the gully mouth. Next debris flow flew straight into Marsyangdi River. Finally, two streams were formed, one flowing straight from the gully mouth and another almost in the original course. Upon examination, deposits were found to be composed of Phyllite, Schist, Gneiss and some Granite.

In the gully, stream is flowing down through the newly created depth of 6 to 8 m at the bottom of the eroded banks. There is still fragile materials hanging along the 1.5 kilometer length of stream. Estimated fragile materials were on an average about 20 cubic meter per meter. In some parts of the gully, big boulders were temporarily jammed together forming water falls, the height of which were 3 to more than 6 meters. Those falls may easily collapse during another flood triggering another debris flow. Again there are many slope failures/bank collapses beside the stream. One of the biggest collapse was of 100 m width and 200 m height and is located at left bank at 2,370 m (7,775 ft.). By the judgement of the diameter of the *Alnus* trees on the collapse, it can be assumed that this collapse may have occurred at least twice, one about 25 years ago and another about 7 years ago. Some parts of the debris from the gully is deposited at the foot of this collapse. Other bank collapses are 25 m wide and 15 m high or 5 m wide and 8 m high and so on. The stream is scouring the foot of these collapses. It will cause the bed-rising on the downstream.

Fig. 1. SKETCH OF DEBRIS FLOW DISASTER AT BAGARCHHIAP

Straight channel is recommended to be excavated urgently from the upper gully smoothly. There are two alternates for excavation of alignment, one is at the newly created stream and another at the old stream course that is cultivated and no stream is there now. This channel should be prevented against the debris spreading over the village. That is why both

One check-dam should be constructed at gully mouth to control the axis of stream. When another debris flow occurs it will hit the check-dam directly, so the thickness of dam crest should be thick enough to resist that. Thickness depends on the material of the dam (G.I. Box, Concrete, etc.) The construction cost will be expensive, if the check-dam, able to resist number or debris flow occurring completely is constructed. So, People's participation for construction and maintenance is very important. Still there are huge amounts of fragile materials within the gully. So a series of check-dams are required in planned positions.

It is considered that the possibility of another debris flow in the next rainy season is very high. At least the main check-dam and channel should be constructed before the next rainy season. For these, urgent works, at least one mini backhoe (bulldozer) which can be carried helicopter is required.

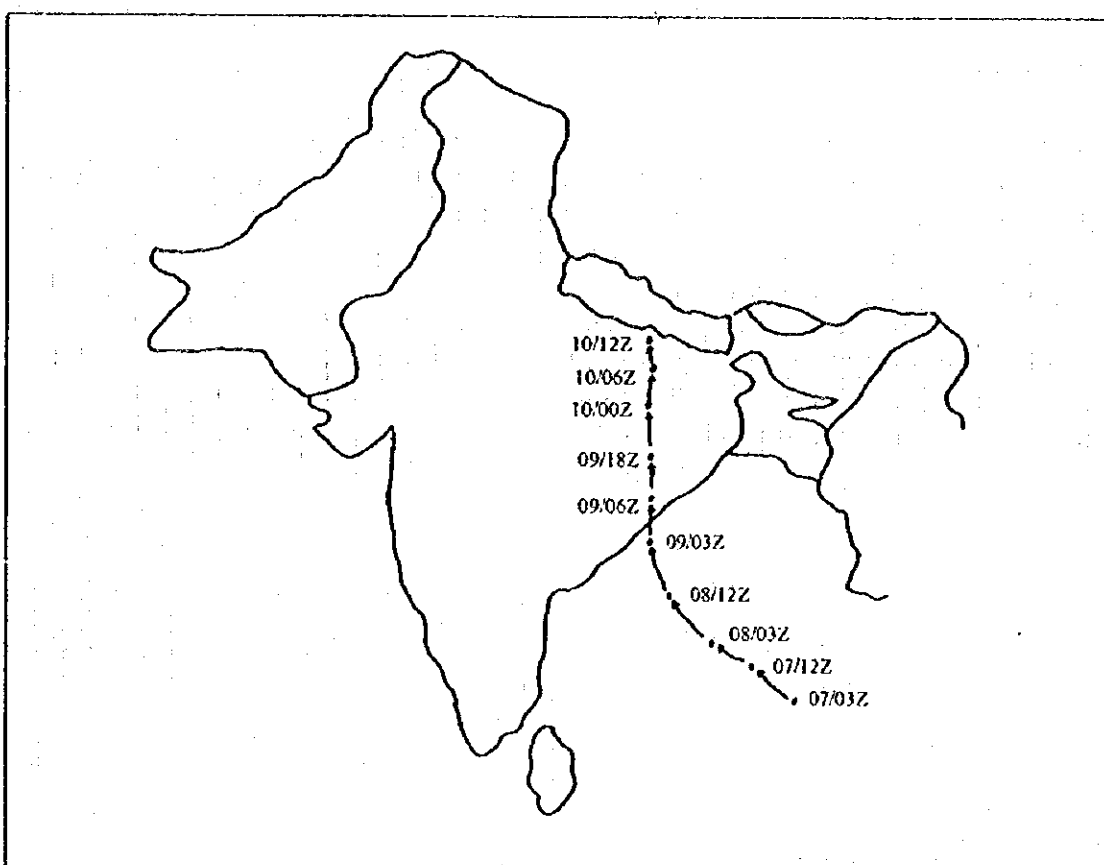
(FIGURE 2) MOVEMENT OF CYCLONIC STORM IN SURFACE
NOVEMBER 1995

Kathmandu observed 106 mm, 68 mm, 53 mm, 58 mm, 57 mm, 34 mm, 90 mm, 43 mm and 46 mm of rainfall respectively during 24 hours period. This second week rainfall has been found very high in entire parts of the country except the Terai sector of far western region. Usually, dry and fair weather prevails in November, but, the heavy rain fall in the latter half of the kingdom is extremely unusual and extraordinary. Table 3 shows the ever recorded highest amount of rainfall till 1994 during 24 hours period in November at various parts of the country. Also, the track of movement of the cyclonic storm is shown in Figure 2.

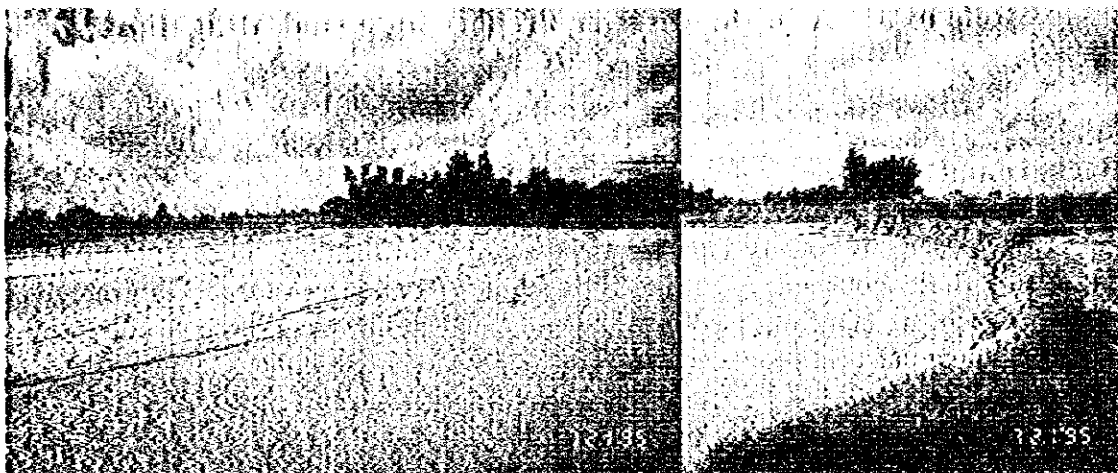
Plate 1.

**LAKHANDEHI RIVER IS CUTTING SIDE BANK AND
ENDANGERING FULPARASI VILLAGE, FULPARASI V.D.C**
