# Annex 12

## *Illegal Dumping Survey*

## 12 Illegal Dumping Survey

## **14 Assessment on the Candidate Sites for the Future Disposal Sites**

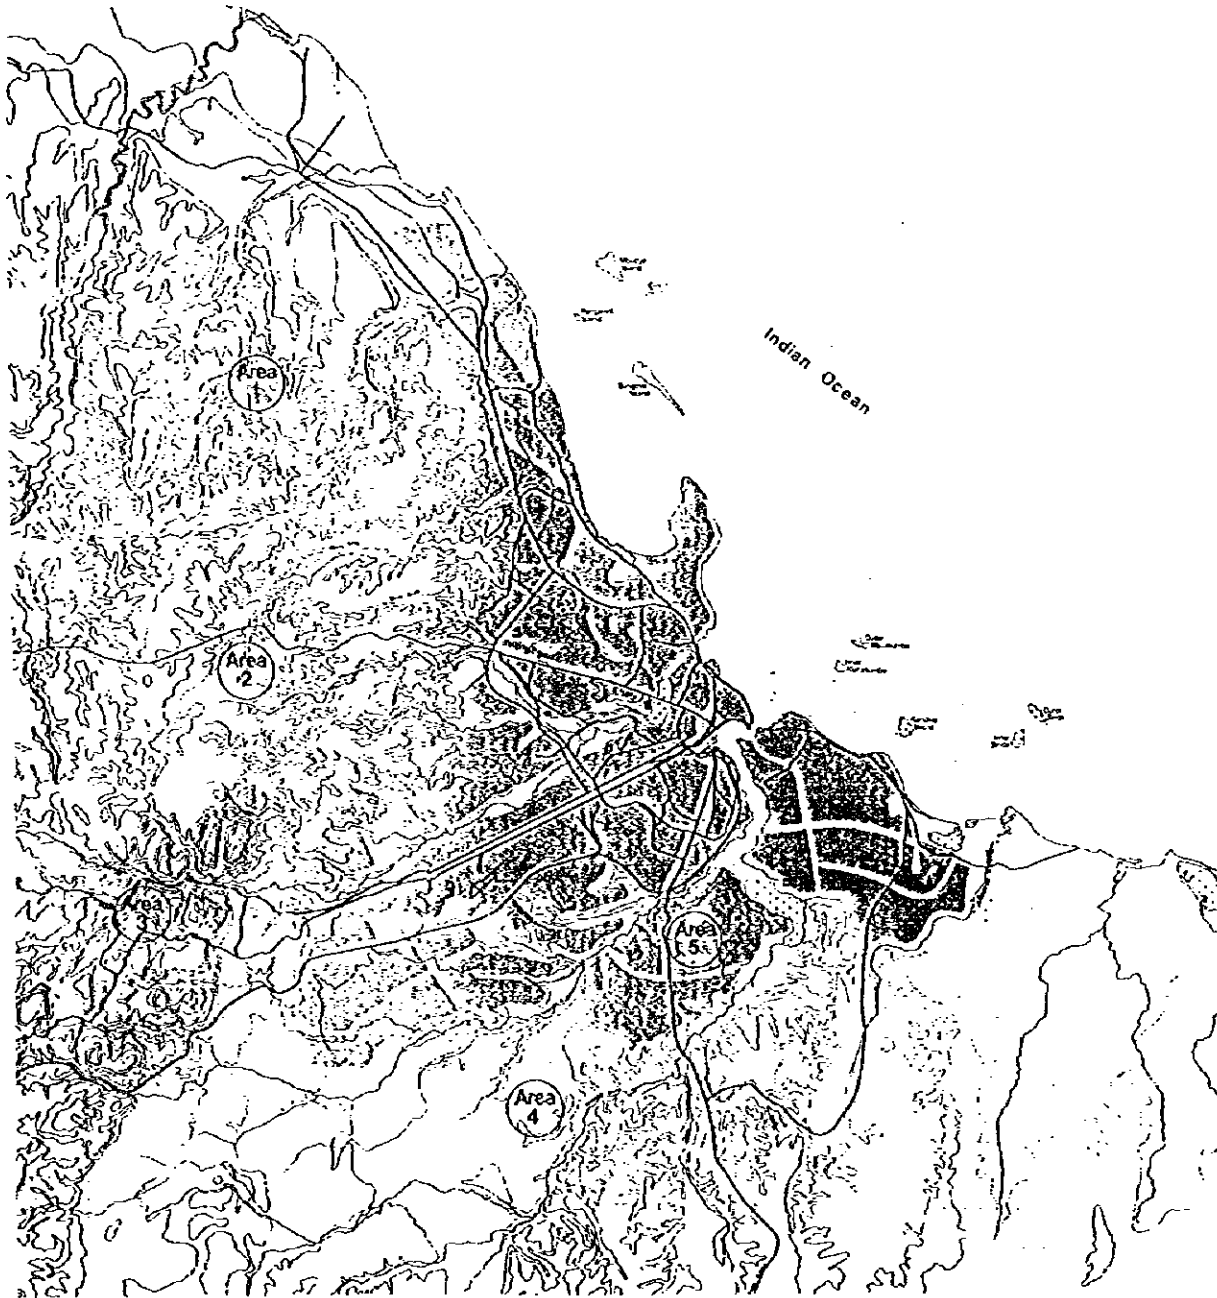
Figure 14-1: General Locations for the Disposal Sites Proposed by Master Plan in 1979

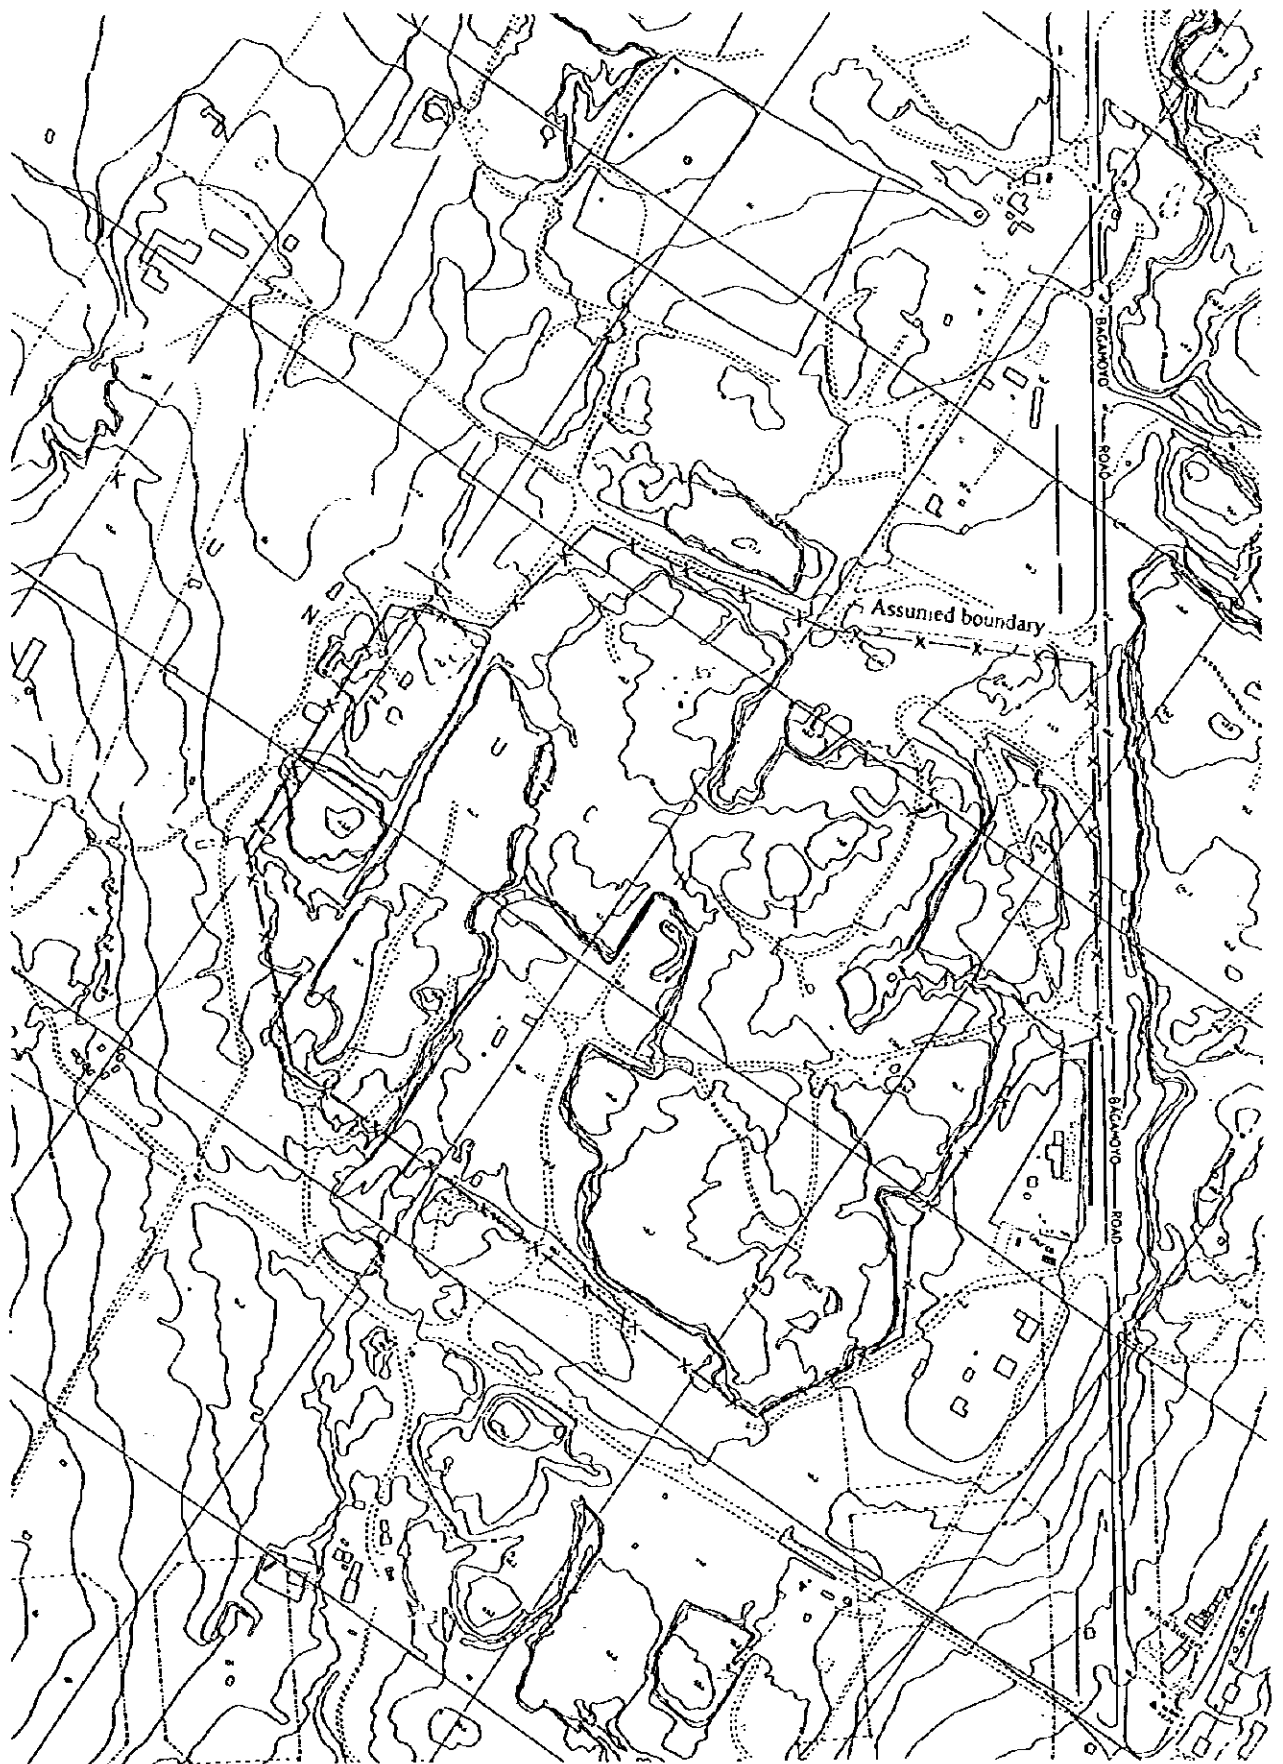
Figure 14-6: Kunduchi New MECCO Quarry Site

- Small negative environmental impacts because the natural environment in this site has been damaged by quarry operation.
- Coverage soil can be obtained within the site.
- Disposal operation can be screened by planting trees along Bagamoyo Road.
- The road from the city centre to this site is tarmaced and in good condition.
- The present value of this land is very little.
- No displacement will be involved.

It was concluded that only A-3 site, Kunduchi New MECCO quarry site, would be recommended as the new disposal site to be examined in the feasibility study to be conducted in the third phase in this study. This recommendation was officially adopted by DCC at the Interim Report meeting on 20th December 1996.
