## **9 Noise Level Survey**

## **10 Vibration Level Survey**

## **11 Air Quality Survey**

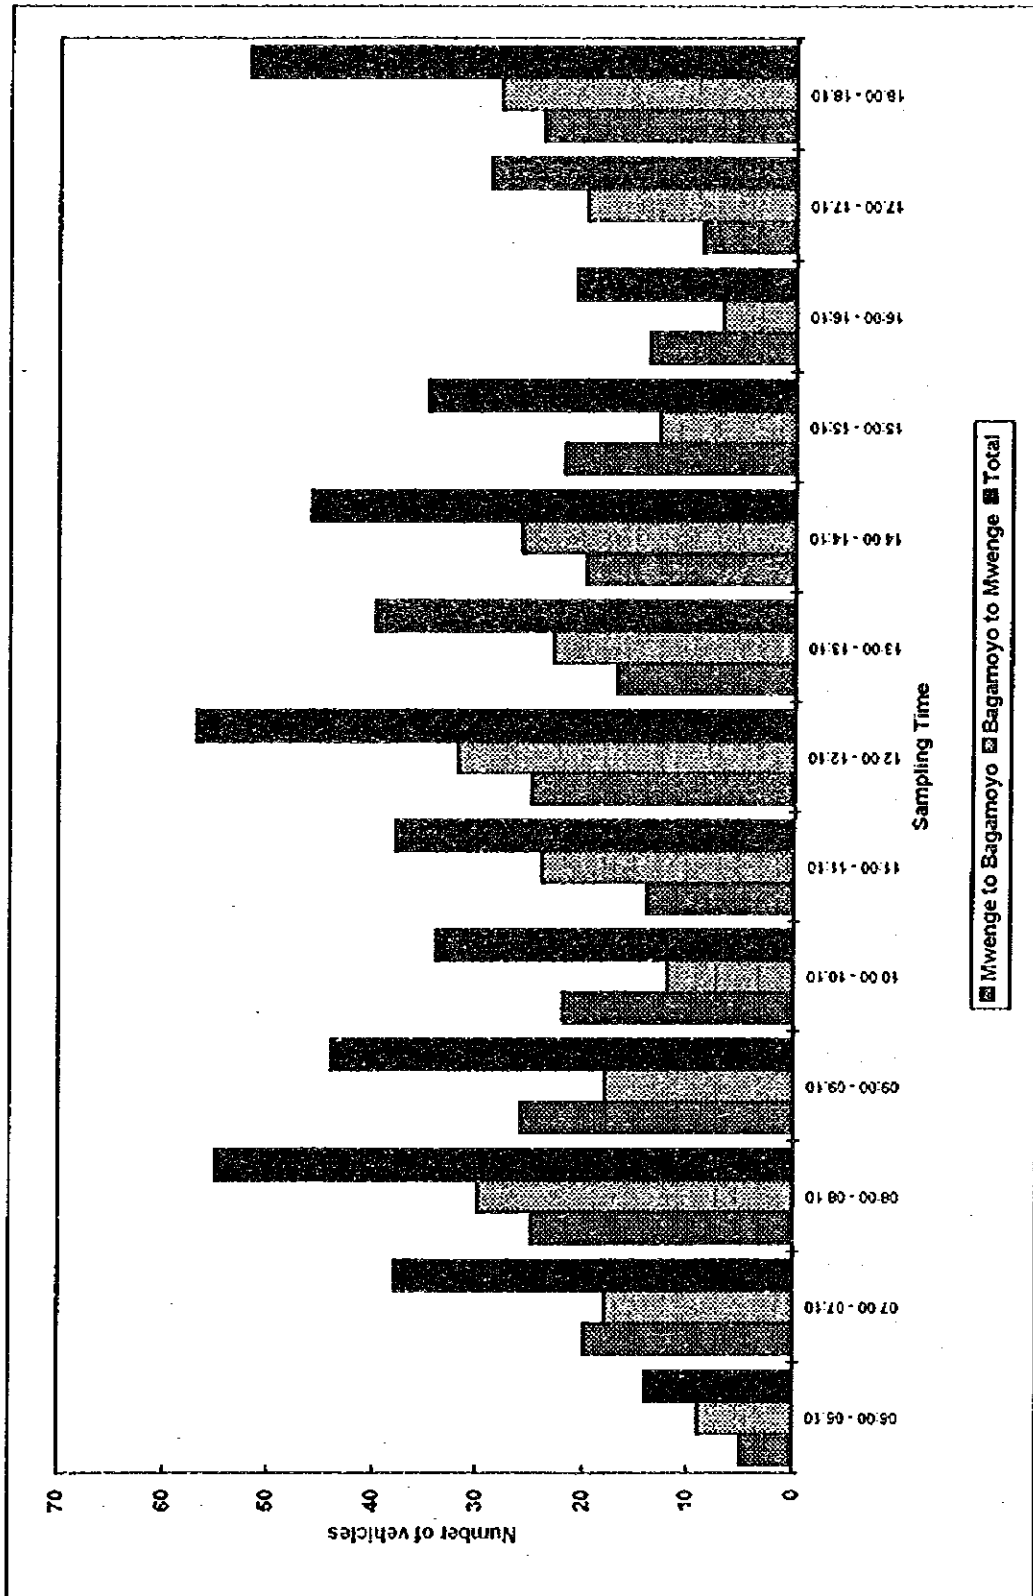
Figure 8-12: Traffic survey results for station A2: New Bagamoyo Road, near to the proposed disposal site on the south-east side: 30 January, 1997

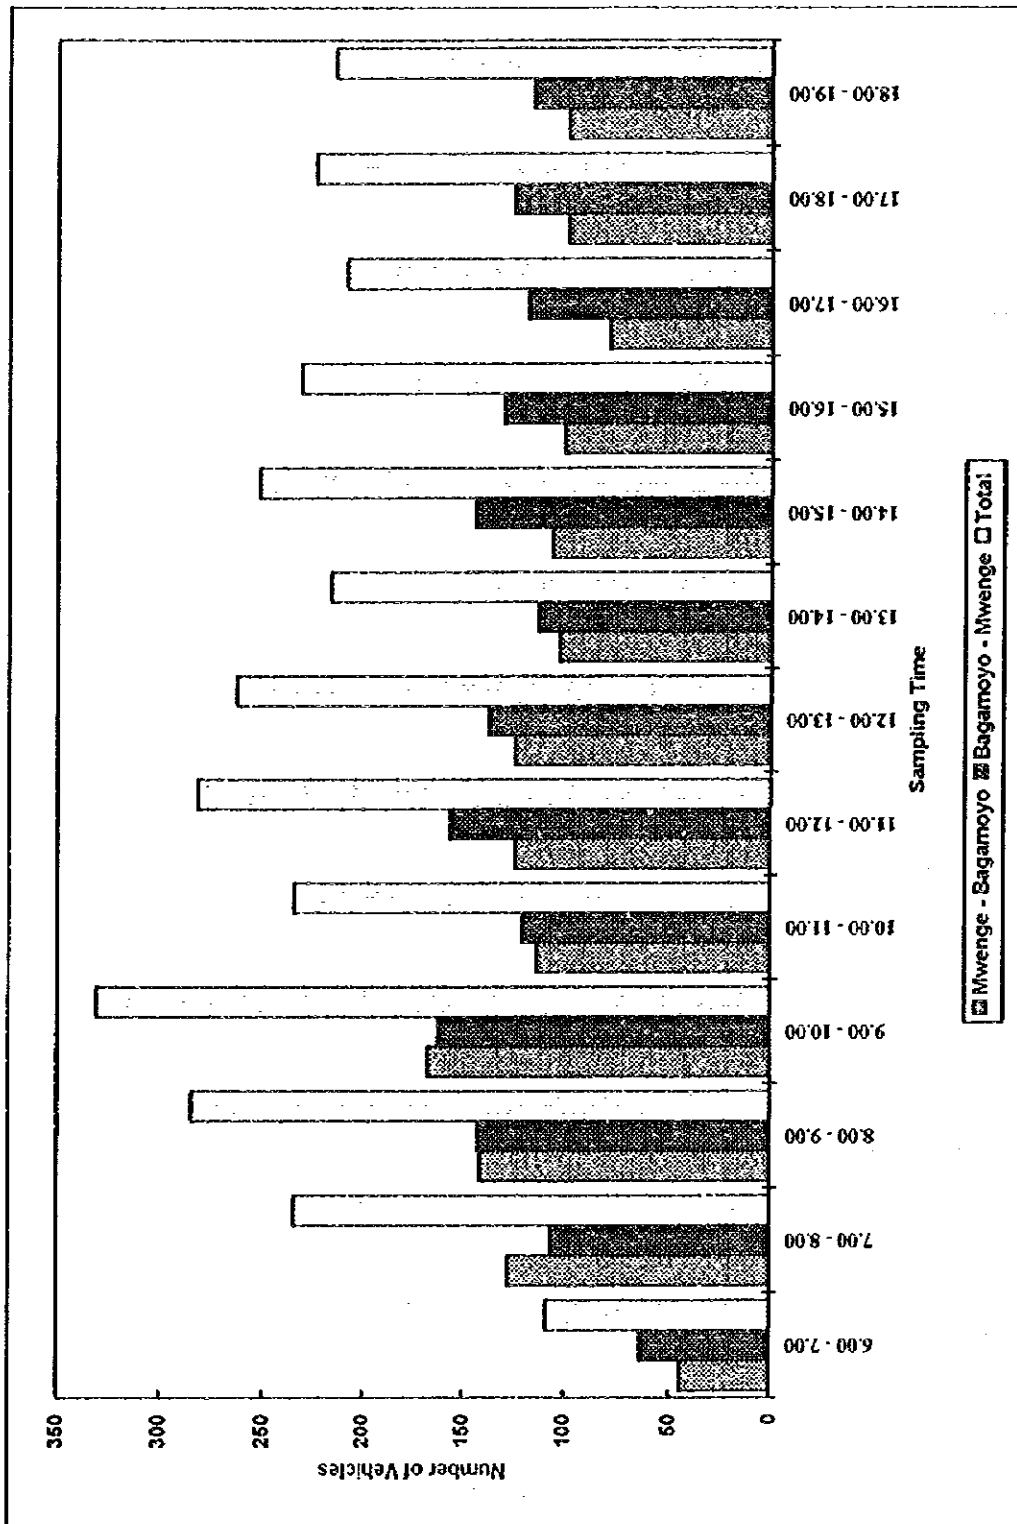
Figure 8-13: Traffic survey results for station A2: New Bagamoyo Road, near to the proposed disposal site on the south-east side: 30 January, 1997

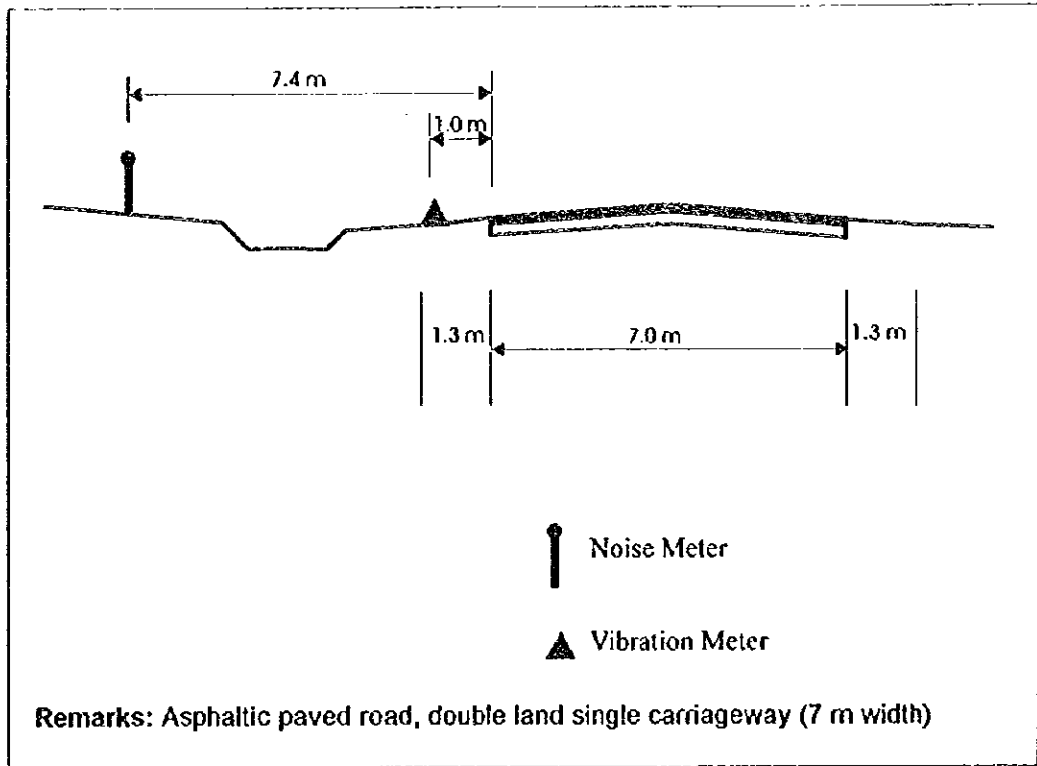
Figure 9-1: Road profile at station A1 along New Bagamoyo Road about 150 m north of the intersection with Sam Nujoma Road

At each survey station, measurements of noise levels were made 13 times during a normal working day for three consecutive days between 0600 and 1900 hours. The measurements were made using an Integrating Sound Level Meter (NL - 04 RION). This meter was placed at a height of 1.2 m above the ground on the walkway, 7.4 m from the edge of the road as shown in Figure 9-1 and Figure 9-2.

At each survey station, measurements of vibration levels were made 13 times during a normal working day for three consecutive days between 0600 and 1900 hours. The measurements were made using a vibration level meter (RION VM-52). The meter was placed at a distance of one metre from the road as shown in Figure 9-1 and Figure 9-2.

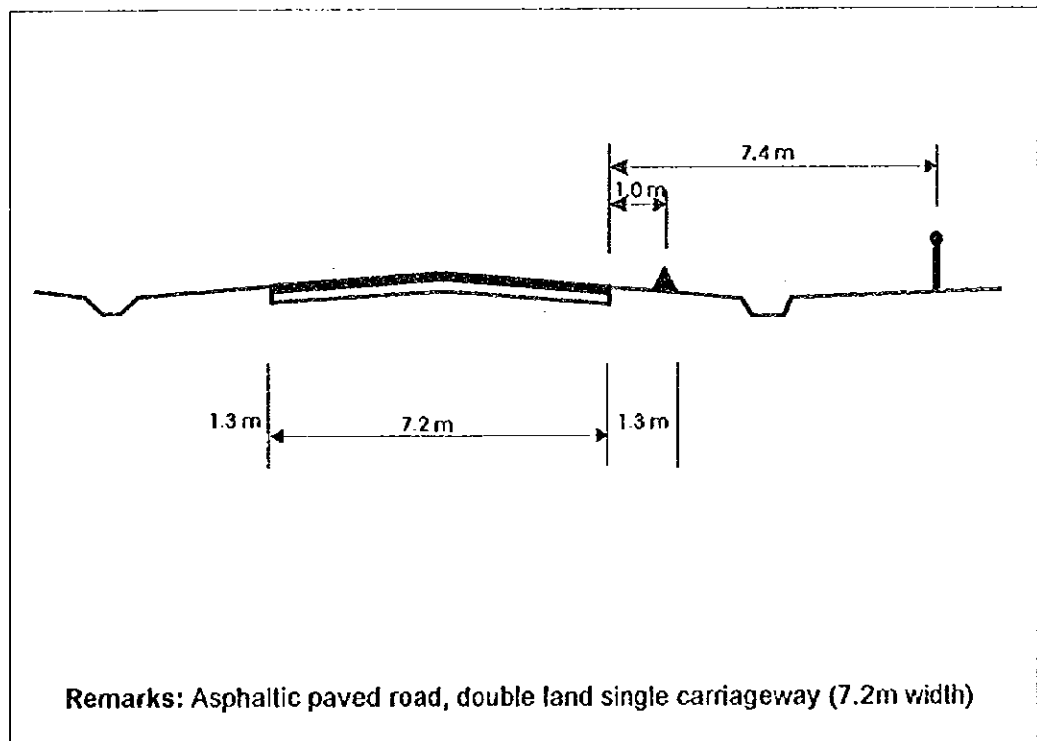
Figure 9-2: Road profile at station A2 along New Bagamoyo Road about 300 m south-east of the proposed disposal site

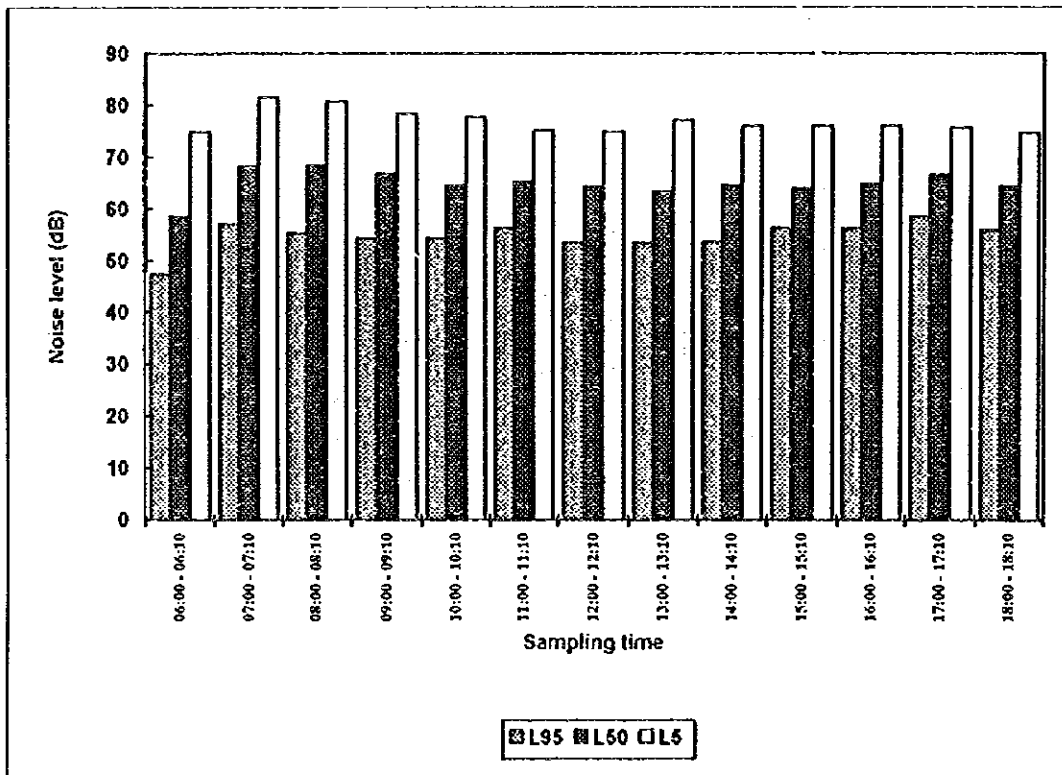
Figure 9-3: Noise level survey results at station A1: New Bagamoyo Road, 150 m north of the intersection with Sam Nujoma Road: 21 January 1997

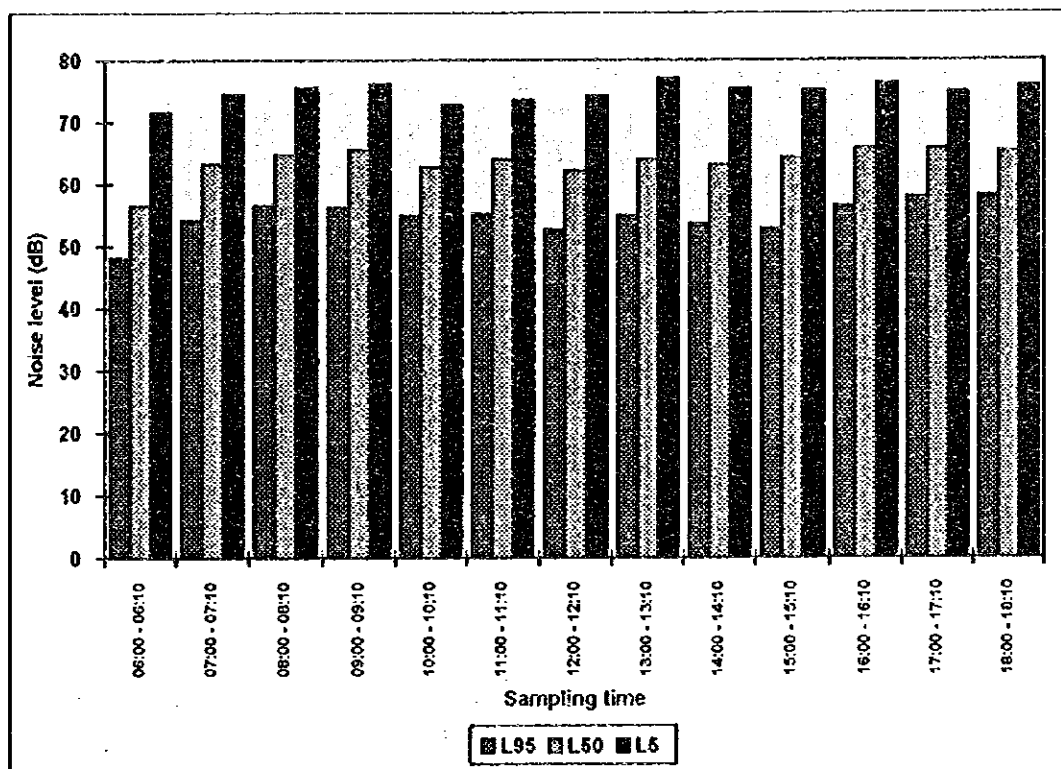
Figure 9-4: Noise level survey results at station A1: New Bagamoyo Road, 150 m north of the intersection with Sam Nujoma Road: 22 January 1997

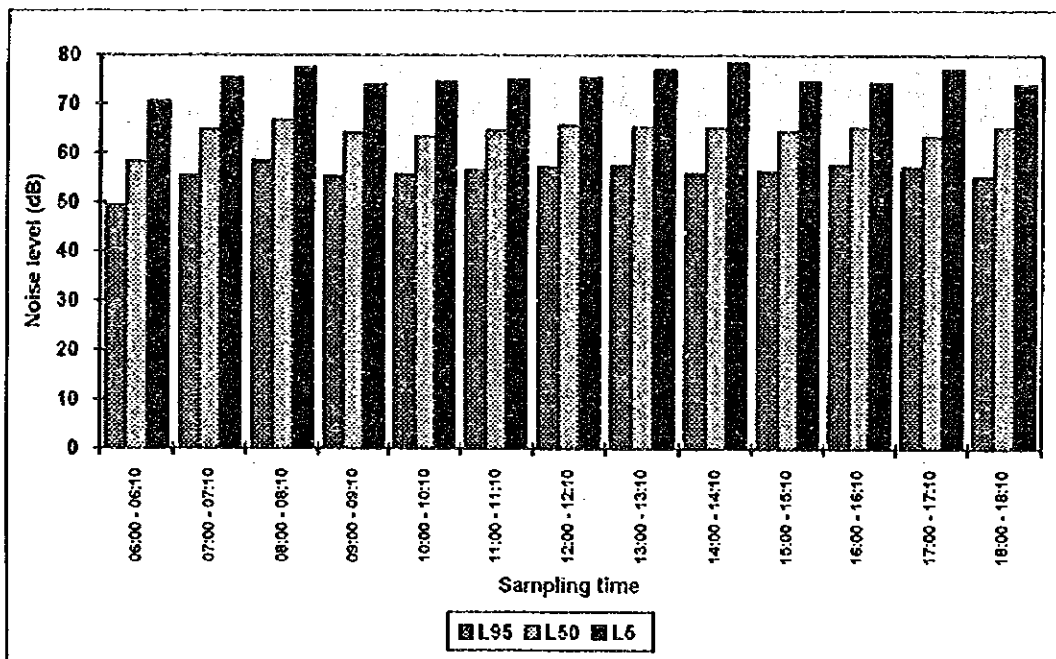
Figure 9-5: Noise level survey results at station A1: New Bagamoyo Road, 150 m north of the intersection with Sam Nujoma Road: 23 January 1997

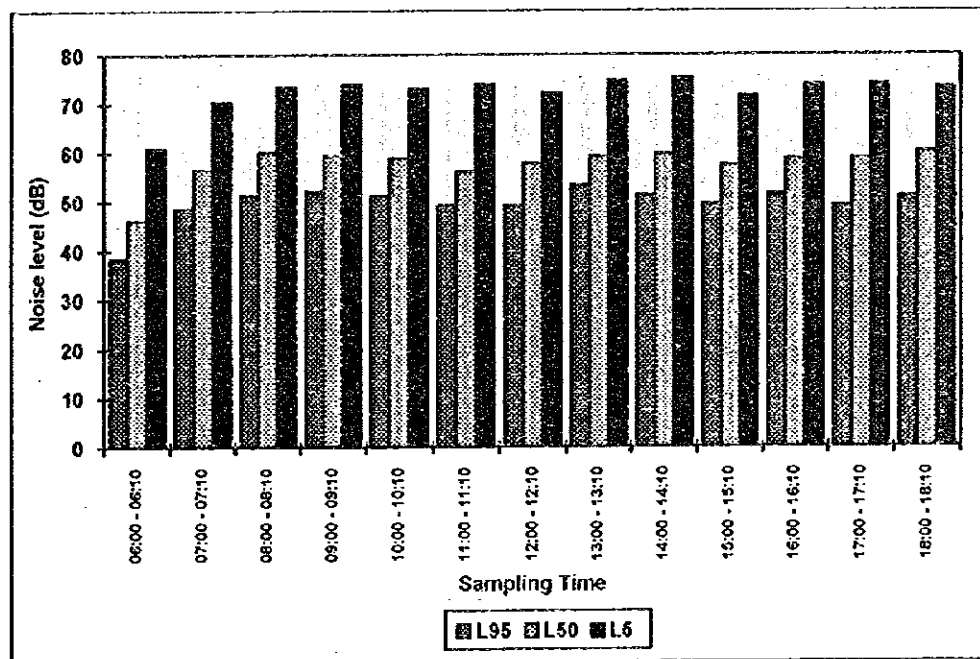
Figure 9-6: Noise level survey results at station A2: New Bagamoyo Road, near to the proposed disposal site on the south-east side: 28 January 1997

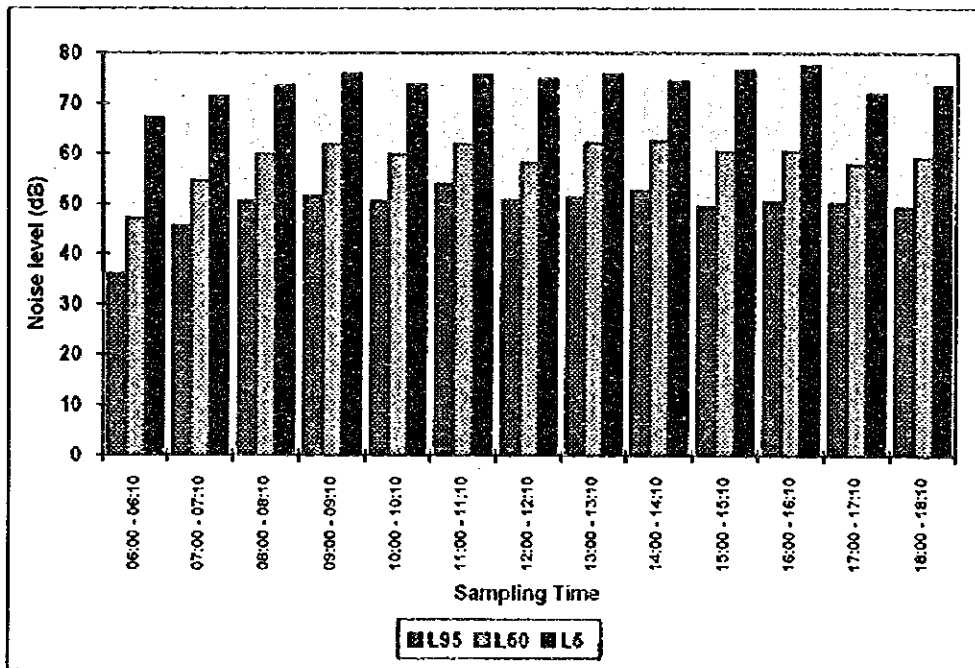
Figure 9-7: Noise level survey results at station A2: New Bagamoyo Road, near to the proposed disposal site on the south-east side: 29 January 1997

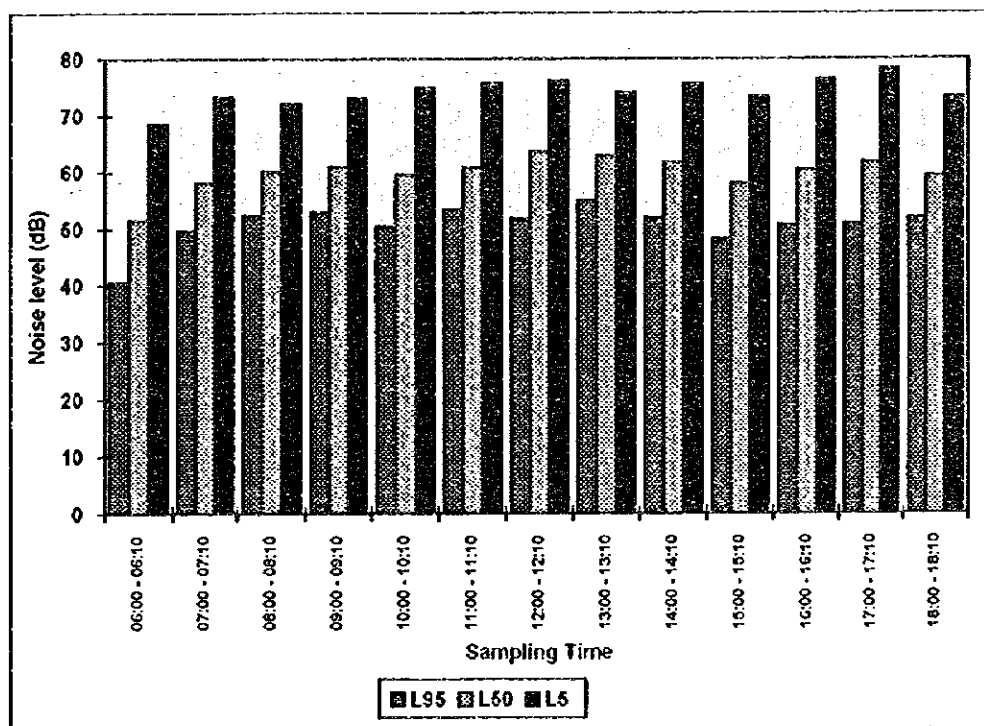
Figure 9-8: Noise level survey results at station A2: New Bagamoyo Road, near to the proposed disposal site on the south-east side: 30 January 1997

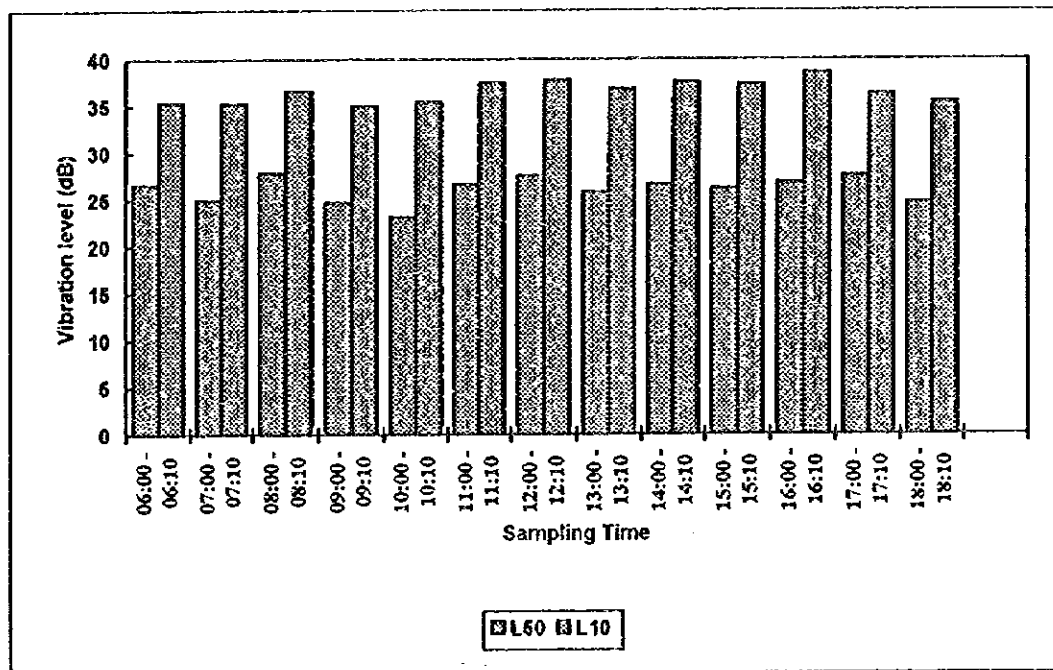
Figure 10-1: Vibration level survey results at station A1: New Bagamoyo Road, 150 m north of the intersection with Sam Nujoma Road: 21 January, 1997

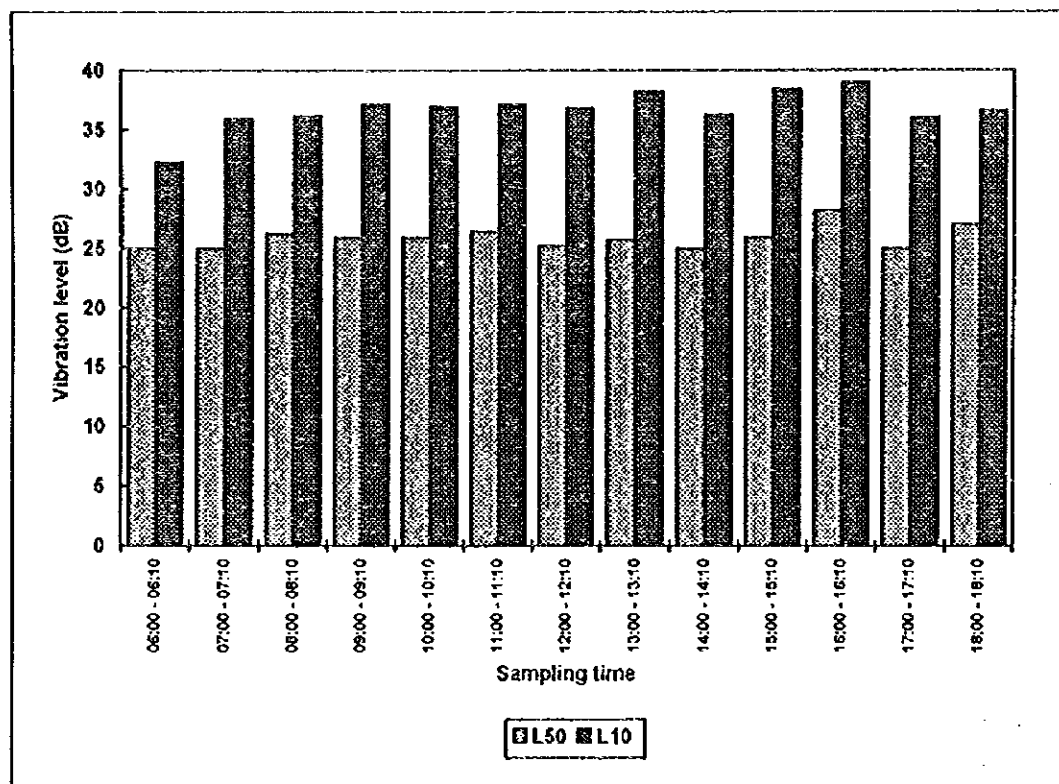
Figure 10-2: Vibration level survey results at station A1: New Bagamoyo Road, 150 m north of the intersection with Sam Nujoma Road: 22 January 1997

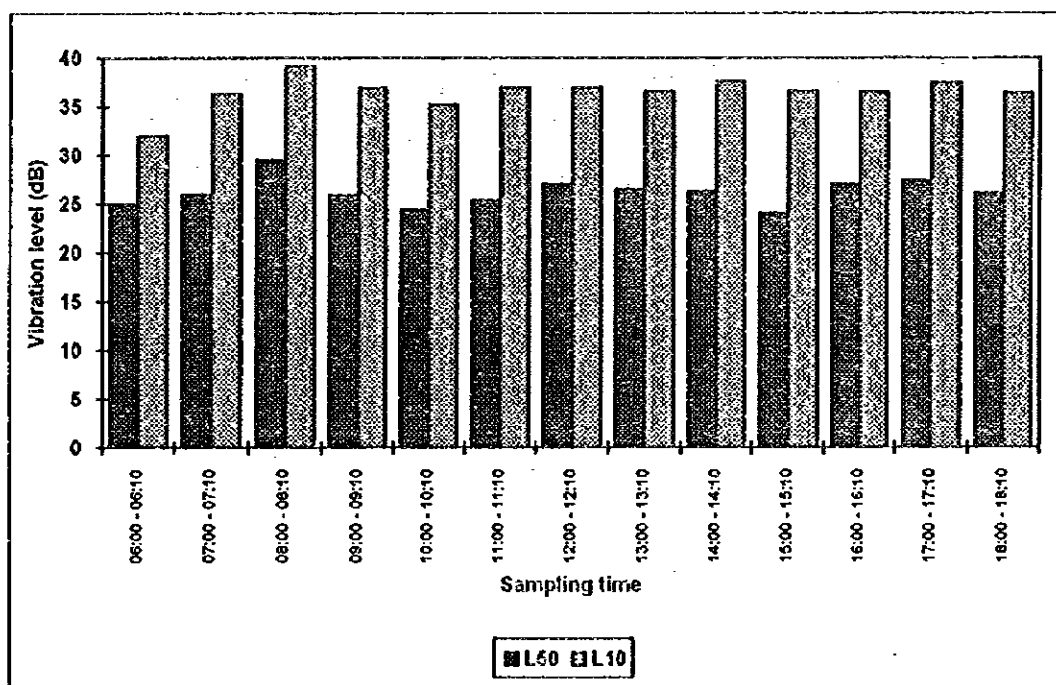
Figure 10-3: Vibration level survey results at station A1: New Bagamoyo Road, 150 m north of the intersection with Sam Nujoma Road: 23 January 1997

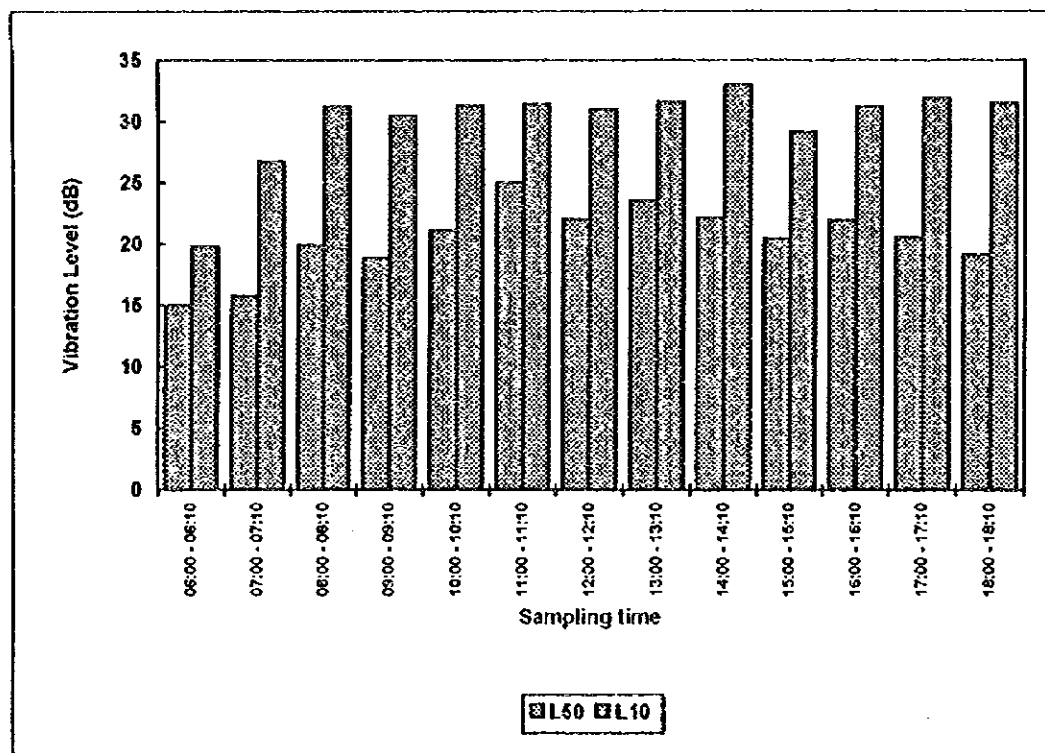
Figure 10-4: Vibration level survey results at station A2: New Bagamoyo Road, near to the proposed disposal site on the south-east side: 28 January 1997

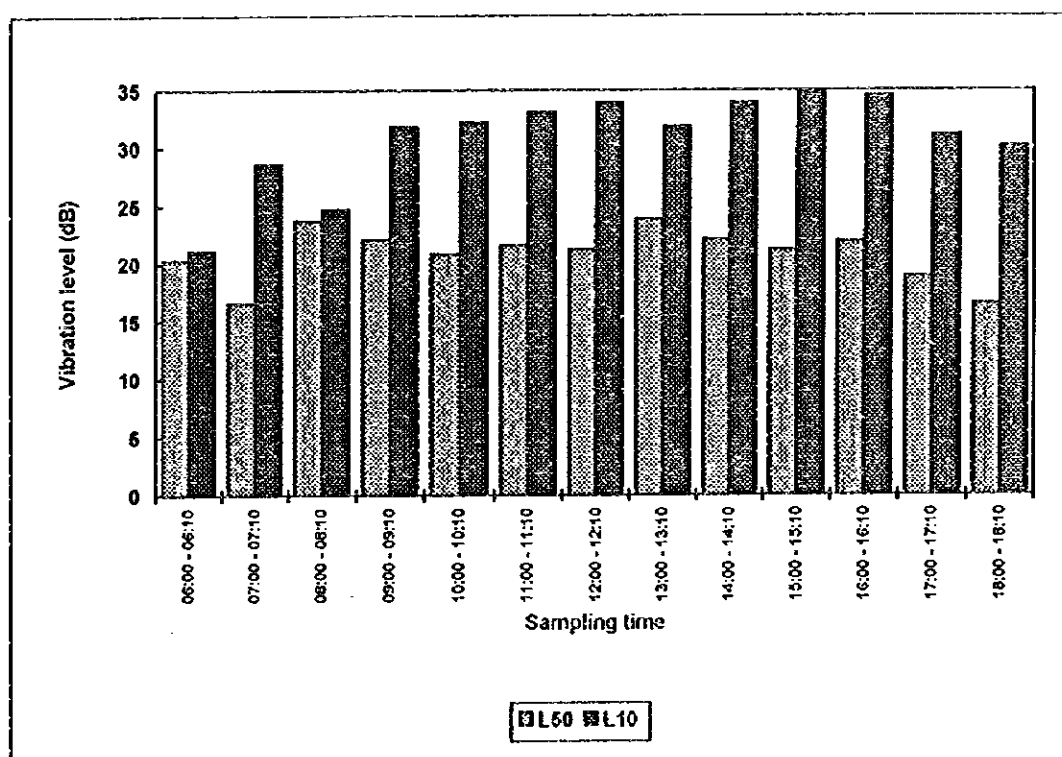
Figure 10-5: Vibration level survey results at station A2: New Bagamoyo Road, near to the proposed disposal site on the south-east side: 29 January, 1997

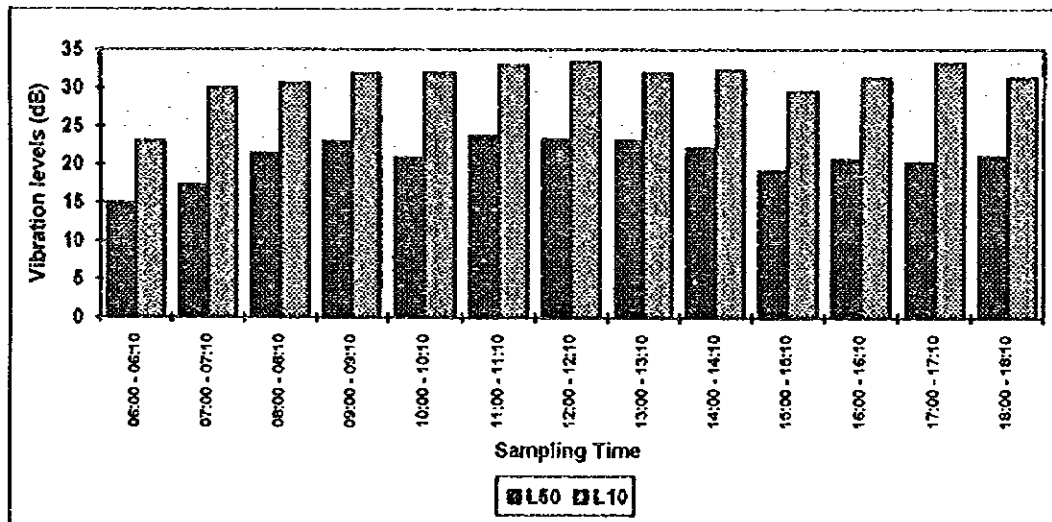
Figure 10-6: Vibration level survey results at station A2: New Bagamoyo Road, near to the proposed disposal site on the south-east side: 30 January, 1997

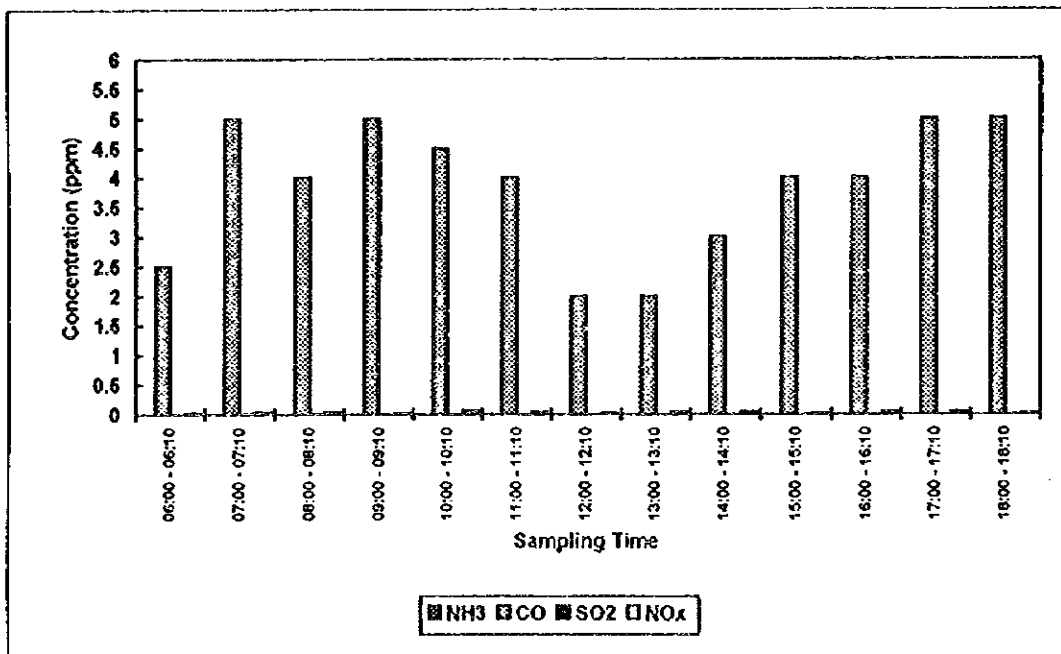
Figure 11-1: Ambient air survey results at station A1: New Bagamoyo Road, 150 m north of the intersection with Sam Nujoma Road: 21 January, 1997

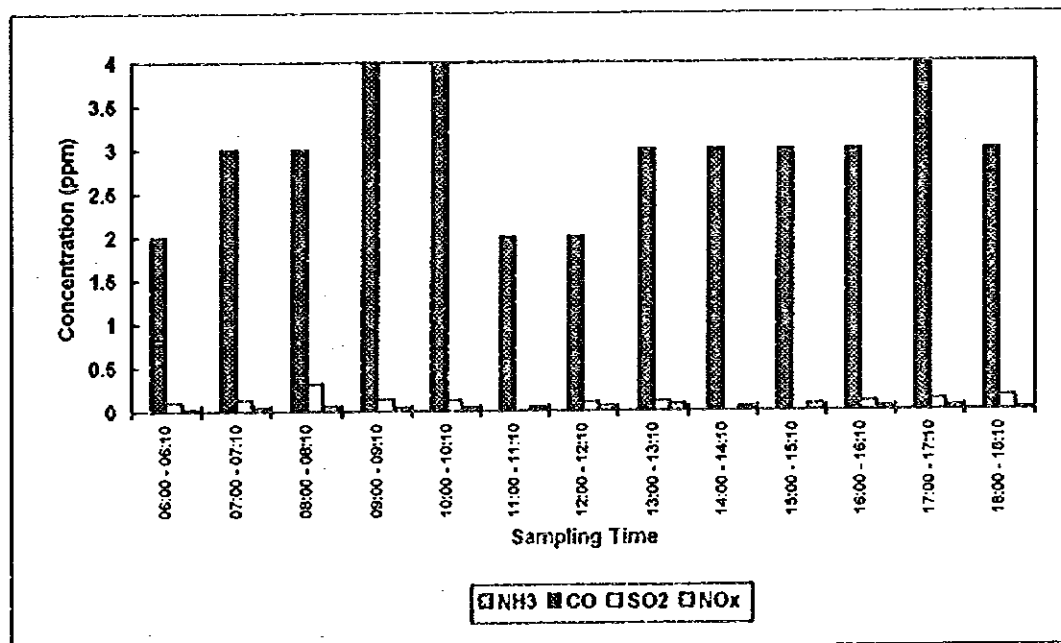
Figure 11-2: Ambient air survey results at station A1: New Bagamoyo Road, 150 m north of the intersection with Sam Nujoma Road: 22 January, 1997

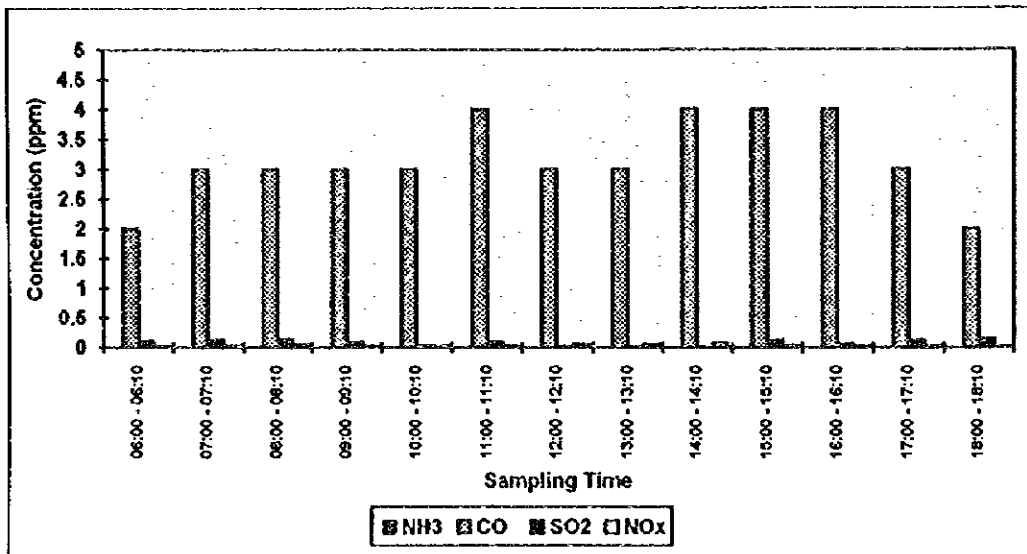
Figure 11-3: Ambient air survey results at station A1: New Bagamoyo Road,  
150 m north of the intersection with Sam Nujoma Road: 23 January, 1997

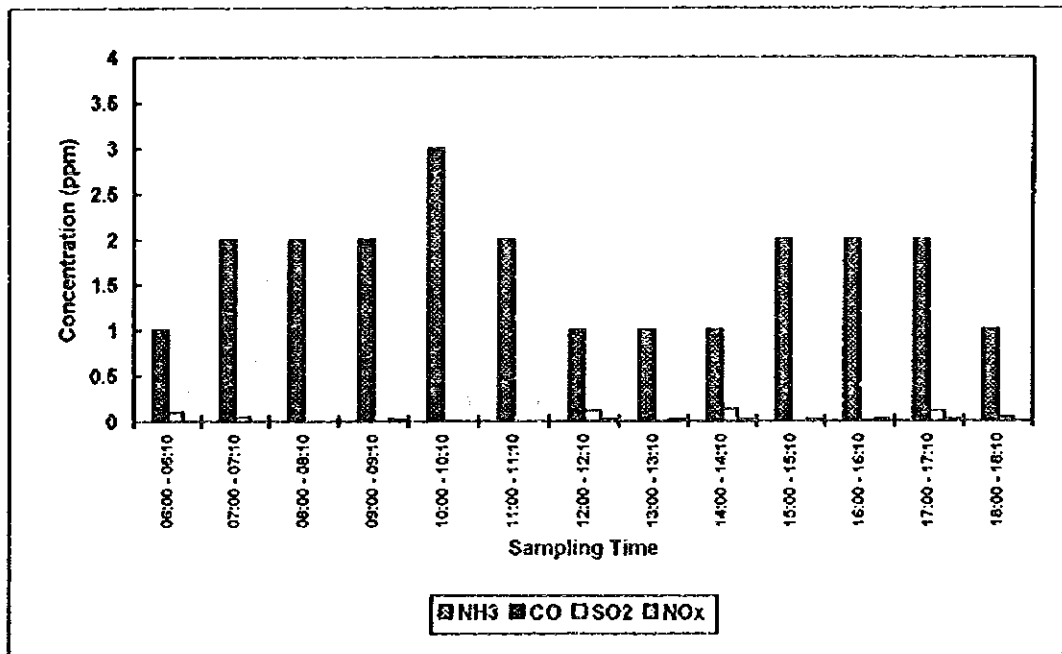
Figure 11-4: Ambient air survey results at station A2: New Bagamoyo Road, near to the proposed disposal site on the south-east side: 28 January, 1997

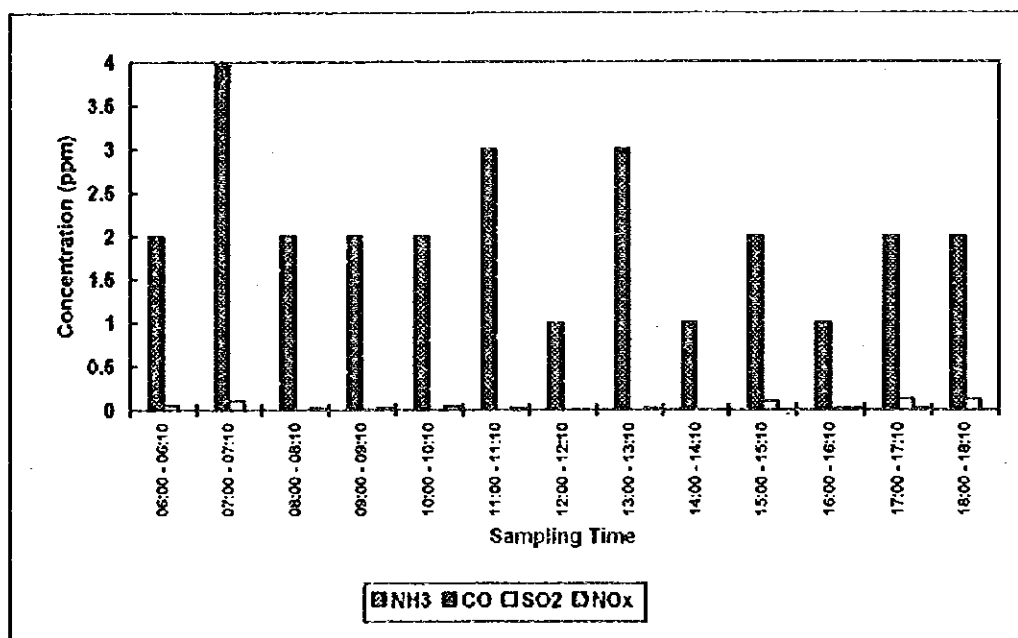
Figure 11-5: Ambient air survey results at station A2: New Bagamoyo Road, near to the proposed disposal site on the south-east side: 29 January, 1997

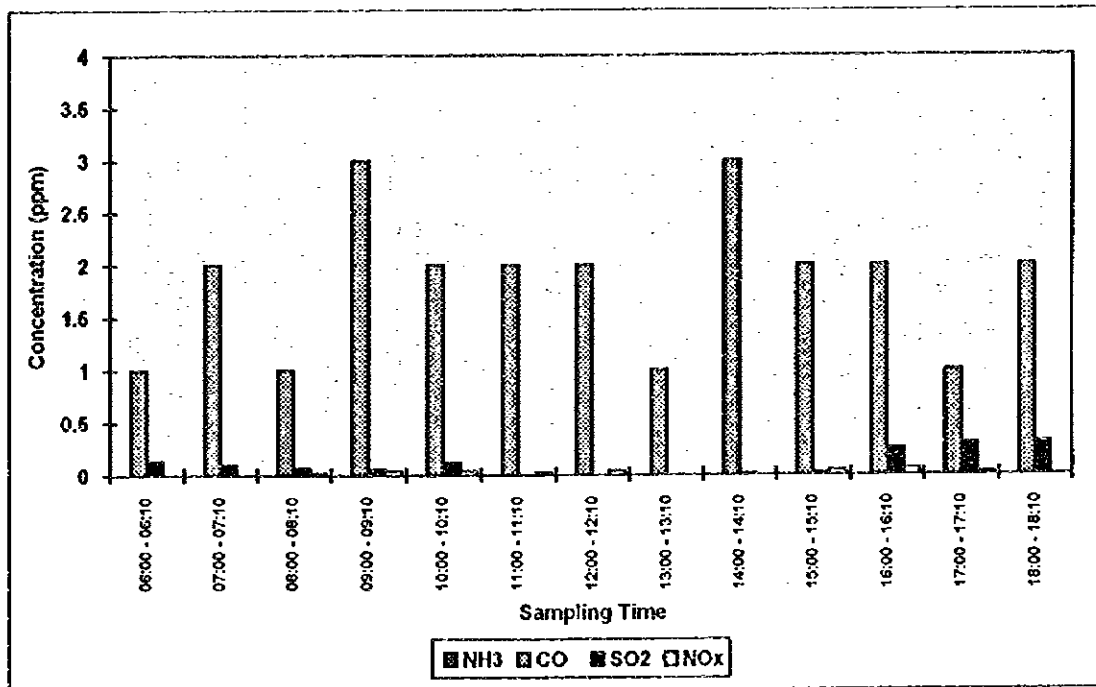
Figure 11-6: Ambient air survey results at station A2: New Bagamoyo Road, near to the proposed disposal site on the south-east side: 30 January, 1997

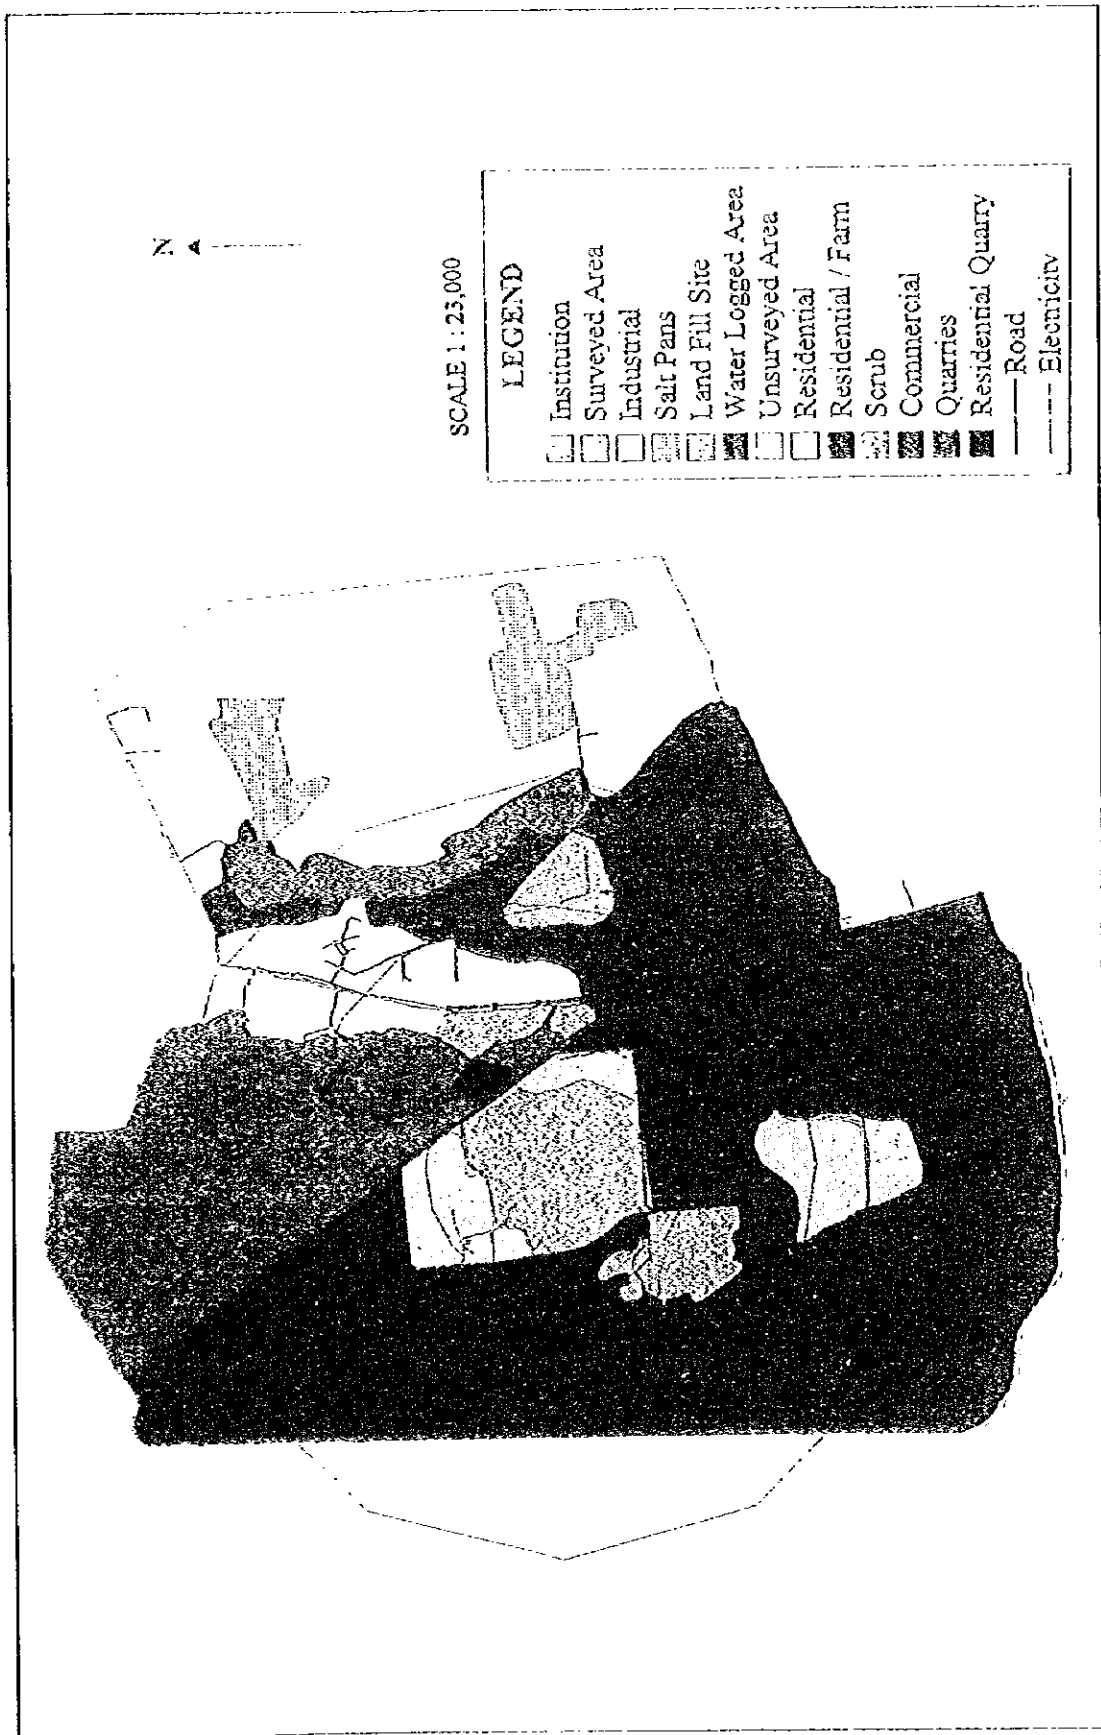
Figure 12-2: Existing Landuse within the Study Area

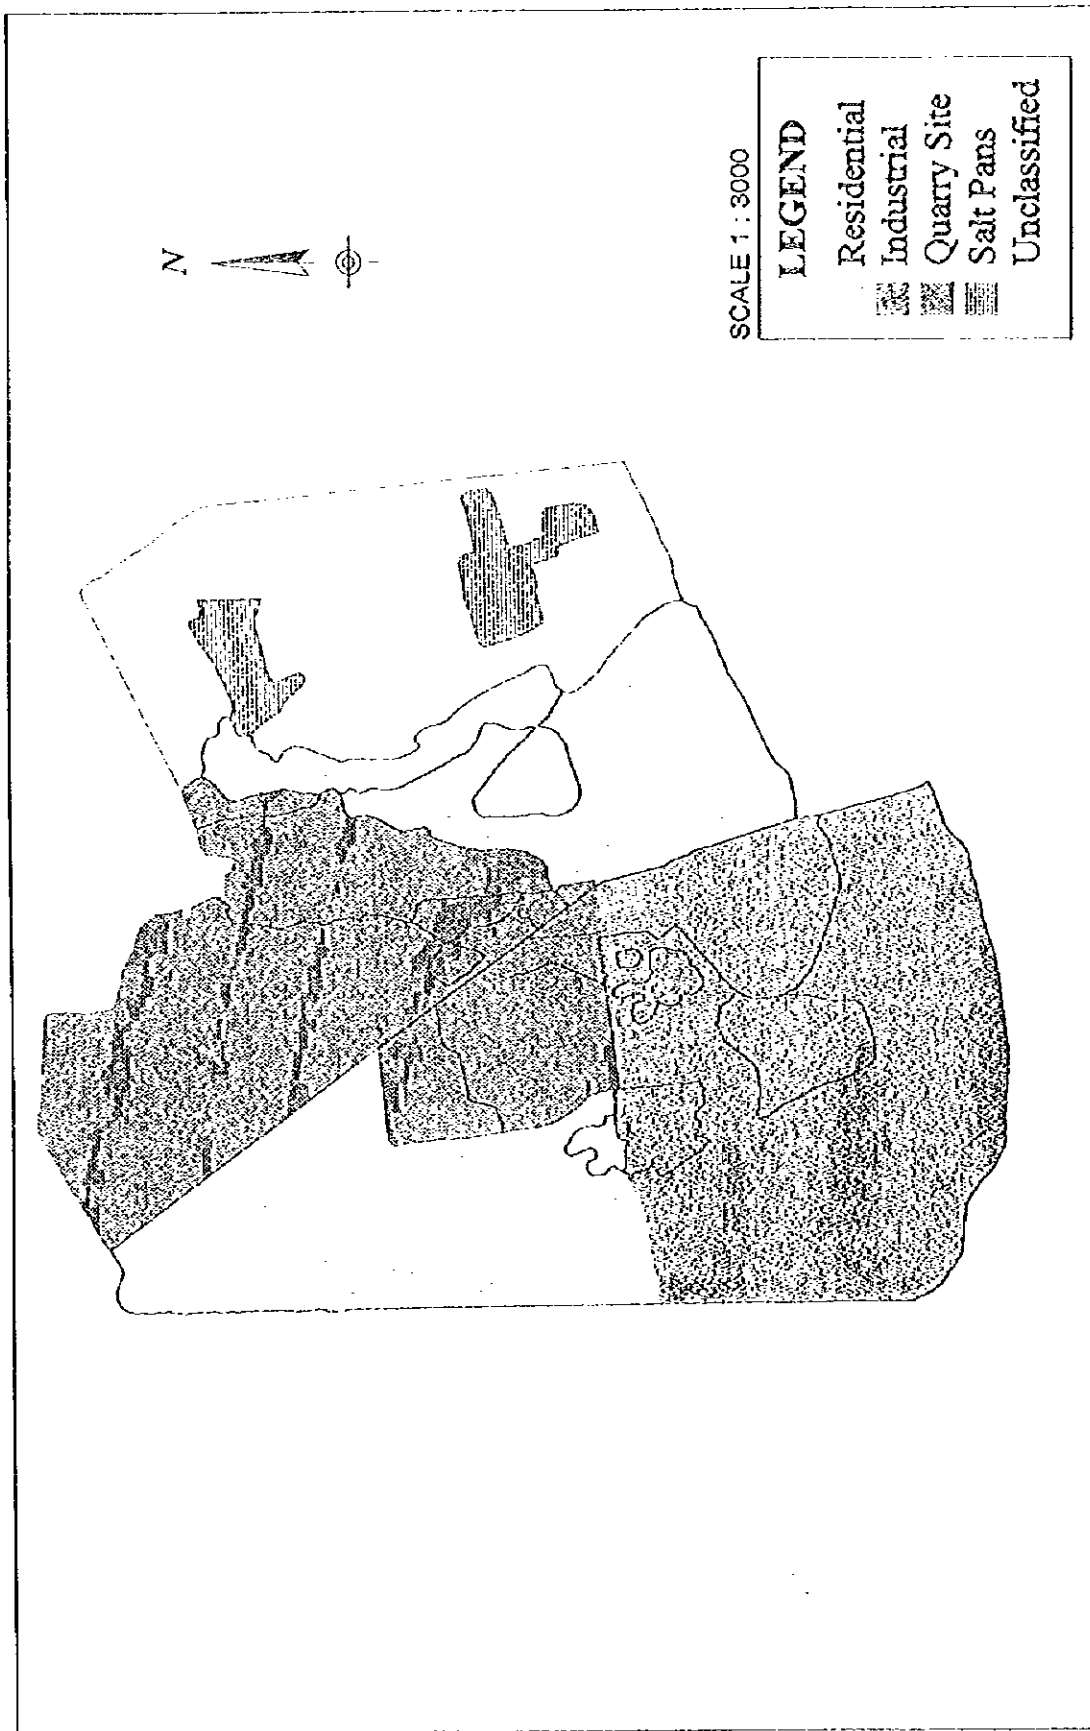
Figure 12-3: Proposed Future Landuse within the Study Area
