Appendix-5. Other Relevant Data

5-2 Assessment of Soil Yield

Technical Notes
Basic Design Study
on
the Project for Reconstruction of Umi Bridge Along the Highlands Highway
in
Papua New Guinea

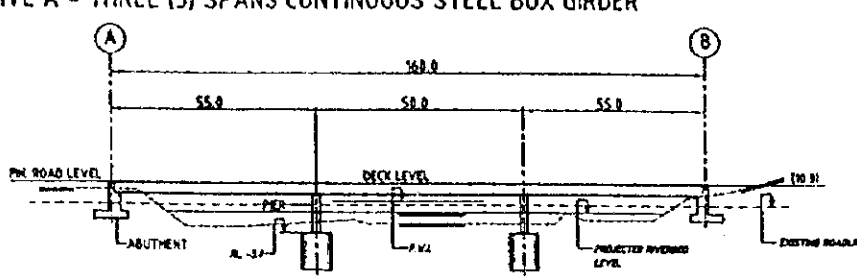
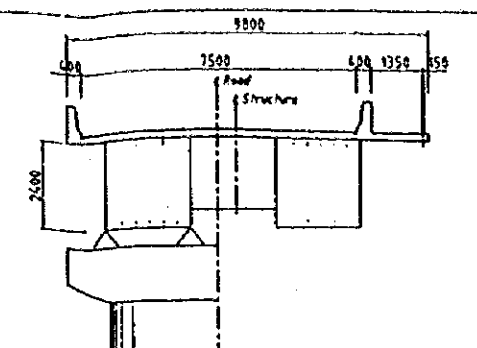
FIGURE 2

ALTERNATIVES	CROSS SECTION	EVALUATION ITEM	EVALUATION	OVERALL RATING
ALTERNATIVE A - THREE (3) SPANS CONTINUOUS STEEL BOX GIRDER

STRUCTURAL ASPECT	STABLE STRUCTURE	FAIR
		CONSTRUCTION COST	THE MOST EXPENSIVE AMONG STEEL BRIDGES (1.15 RATIO AGAINST THE COST OF ALTERNATIVE B)	
		CONSTRUCTION PERIOD	THE MOST SHORTEST CONSTRUCTION PERIOD AMONG 5 ALTERNATIVES (ABOUT 15 MONTHS)	
		FIELD WORK ASPECT	ENSURED PROGRESS AND QUALITY CONTROL	
		MAINTENANCE	PERIODICAL CLEANING AND REPAINTING OF HANDRAIL AND GRIDERS ARE REQUIRED	
		ASEISMICITY	HIGH ASEISMICITY DUE TO LIGHT SUPERSTRUCTURE	
		HYDRAULIC ASPECT	NO SPECIFIC PROBLEMS	
		OTHER ASPECT		
ALTERNATIVE B - THREE (3) SPANS CONTINUOUS STEEL PLATE GIRDER

The evaluation of each alternative is carried out as shown in Figure- 2.

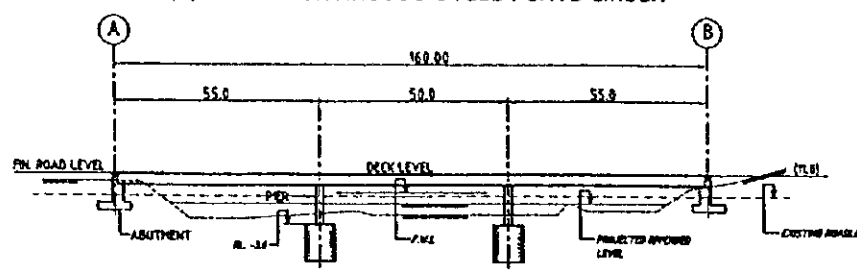
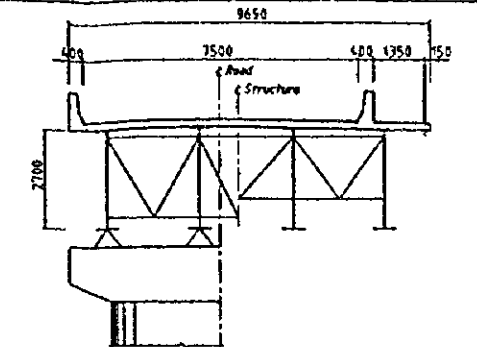
STRUCTURAL ASPECT	STRUCTURALLY UPPER LIMIT SPAN LENGTH OF PLATE GIRDER TYPE	EXCELLENT
		CONSTRUCTION COST	THE 2nd MOST ECONOMICAL FOLLOWING ALT. E AMONG FIVE ALTERNATIVES (1.00 RATIO AGAINST THE COST OF OTHER ALTERNATIVES)

CONSTRUCTION PERIOD	RELATIVELY SHORT CONSTRUCTION PERIOD AMONG 5 ALTERNATIVES (ABOUT 16 MONTHS)	
		FIELD WORK ASPECT	ENSURED PROGRESS AND QUALITY CONTROL	
		MAINTENANCE	PERIODICAL CLEANING AND REPAINTING OF HANDRAIL AND GRIDERS ARE REQUIRED	
		ASEISMICITY	HIGH ASEISMICITY DUE TO LIGHT SUPERSTRUCTURE	
		HYDRAULIC ASPECT	NO SPECIFIC PROBLEMS	
		OTHER ASPECT		
ALTERNATIVE C - THREE (3) SPANS CONTINUOUS STEEL TRUSS

Based upon the above mentioned construction situation in PNG and the results of alternative evaluations, Alt-B i.e. the 3 spans continuous steel plate girder type of bridge is selected as an optimum bridge type for Umi bridge.

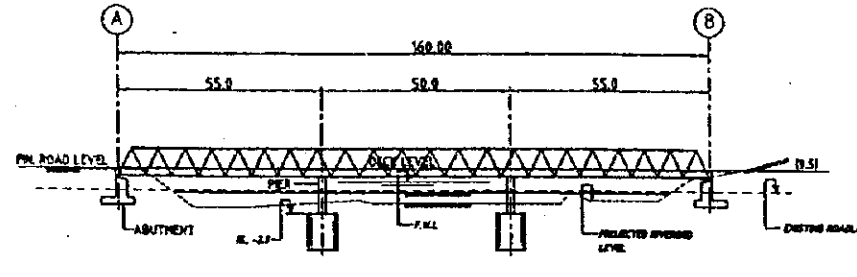
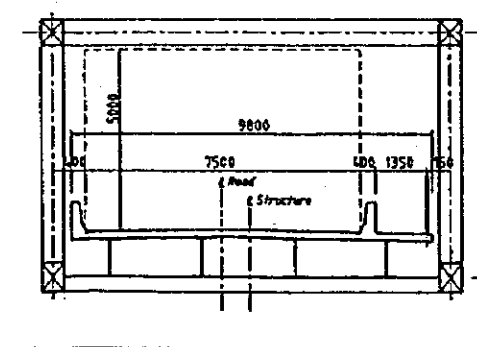
STRUCTURAL ASPECT	THE LOWEST FINISH GRADE DUE TO THROUGH TYPE BRIDGE	POOR
		CONSTRUCTION COST	THE 3rd ECONOMICAL BRIDGE AMONG OTHER BRIDGES (1.05 RATIO AGAINST THE COST OF ALTERNATIVES B)	
		CONSTRUCTION PERIOD	THE LONGEST CONSTRUCTION PERIOD AMONG STEEL BRIDGE ALTERNATIVES (ABOUT 18 MONTHS)	
		FIELD WORK ASPECT	ENSURED PROGRESS AND QUALITY CONTROL	
		MAINTENANCE	MOST COSTLY MAINTENANCE REQUIRED BECAUSE OF RELATIVELY WIDER PAINTING AREA THAN STEEL BRIDGES	
		ASEISMICITY	HIGH ASEISMICITY DUE TO LIGHT SUPERSTRUCTURE

HYDRAULIC ASPECT	NO SPECIFIC PROBLEMS	
		OTHER ASPECT	POSSIBLE MEMBER DEFORMATION DUE TO OVERSIZED VEHICLE COLLISION AND DIFFICULTY OF BRIDGE WIDENING IN FUTURE	
ALTERNATIVE D - THREE (3) SPANS CONTINUOUS P.C. BOX GIRDER

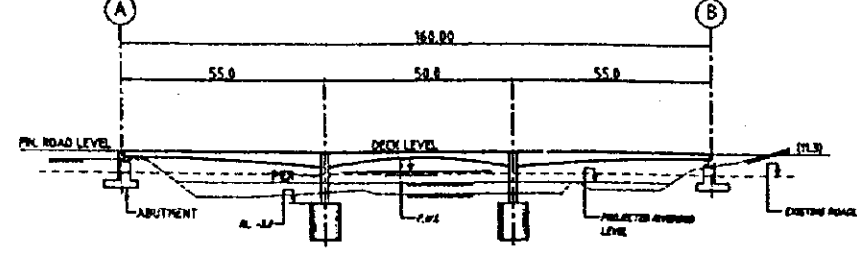
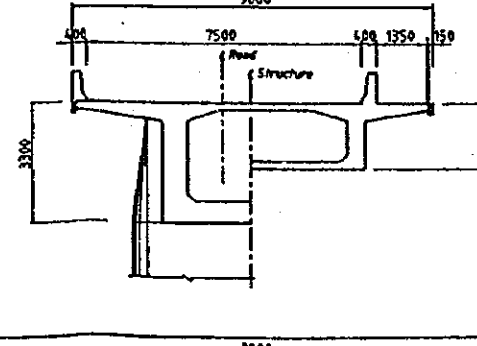
STRUCTURAL ASPECT	HIGH DUCTILE AND FULL MONOLITHIC BRIDGE	VERY POOR
		CONSTRUCTION COST	THE MOST EXPENSIVE BRIDGE AMONG OTHER BRIDGES (1.35 RATIO AGAINST THE COST OF ALTERNATIVE B)	
		CONSTRUCTION PERIOD	THE LONGEST CONSTRUCTION PERIOD AMONG 5 ALTERNATIVES (ABOUT 20 MONTHS)	
		FIELD WORK ASPECT	DIFFICULTY OF AND QUALITY AND PROGRESS CONTROL	
		MAINTENANCE	ONLY MINIMAL MAINTENANCE	
		ASEISMICITY	HIGH ASEISMICITY	
		HYDRAULIC ASPECT	NO SPECIFIC PROBLEMS	
		OTHER ASPECT		
ALTERNATIVE E - FOUR (4) SPANS CONTINUOUS P.C. I SECTION GIRDER

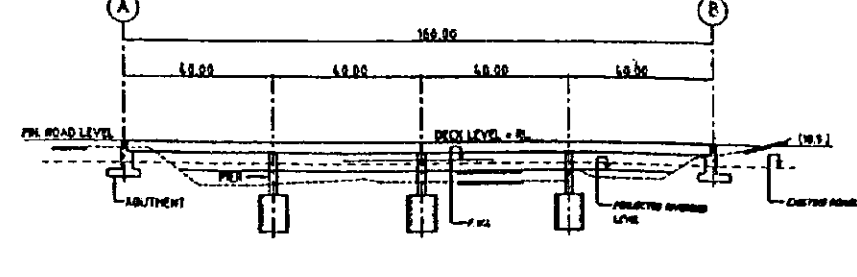
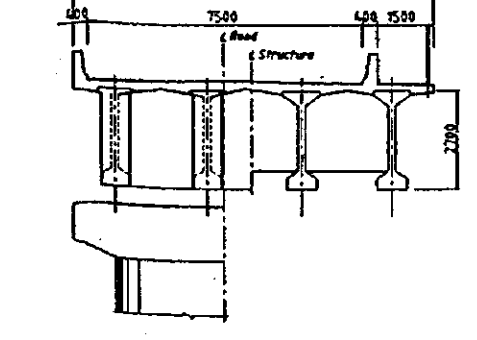
STRUCTURAL ASPECT	STANDARD STRUCTURE OF P.C. GRIDERS	POOR
		CONSTRUCTION COST	SLIGHTLY MORE ECONOMICAL THAN ALTERNATIVE B (0.95 RATIO AGAINST THE COST OF ALTERNATIVES B)

CONSTRUCTION PERIOD	RELATIVELY LONG CONSTRUCTION PERIOD AMONG 5 ALTERNATIVES (ABOUT 18 MONTHS)	
		FIELD WORK ASPECT	DIFFICULTY OF QUALITY AND PROGRESS CONTROL	
		MAINTENANCE	ONLY MINIMAL MAINTENANCE	
		ASEISMICITY	HIGH ASEISMICITY	
		HYDRAULIC ASPECT	REDUCED BRIDGE OPENING AND HIGH FLOW OBSTRUCTION RATIO (62% HIGH RISK OF BRIDGE OPENING TO BE CLOGGED DUE TO SHORT DISTANCE (LESS THAN 25m) BETWEEN NEW AND OLD PIERS DURING THE CONSTRUCTION	
		OTHER ASPECT
