THE STUDY
ON
ADDIS ABABA FLOOD CONTROL PROJECT
IN
THE FEDERAL DEMOCRATIC REPUBLIC OF ETHIOPIA

FINAL REPORT
VOLUME IV
SUPPORTING REPORT
OF
PHASE II STUDY
(FEASIBILITY STUDY)

MAY 1998

NIPPON KOEI CO., LTD.
NIKKEN CONSULTANTS, INC.

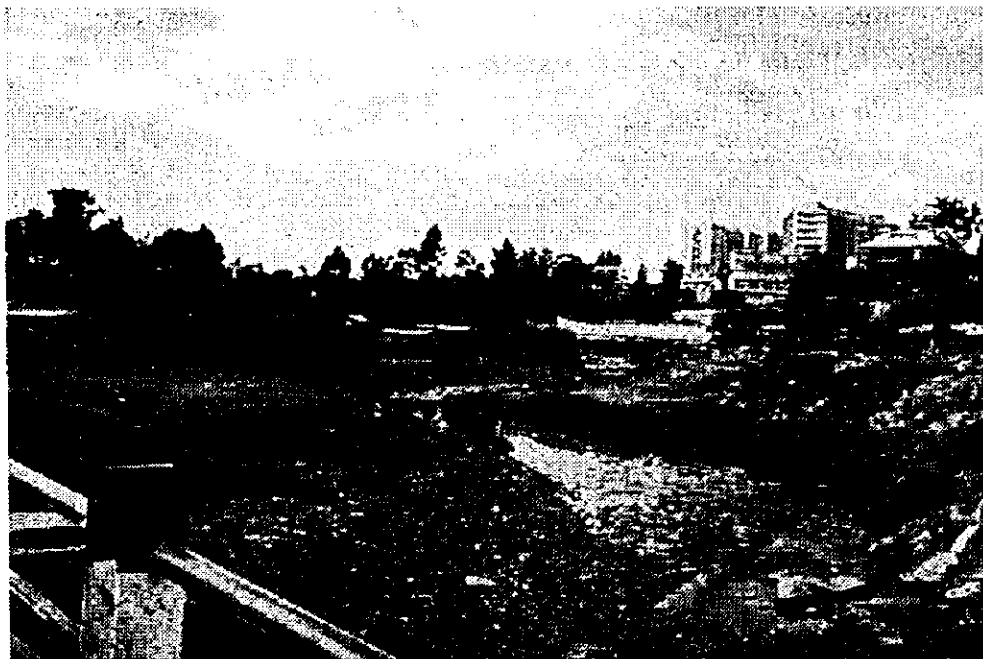
The photo below shows a view just upstream from the Bantiyketu bridge.

In this reach of the Bantiyketu, there exist many houses on the right riparian area. Such houses are prone to flooding. On the other hand, a continuous floodwall on the left has been constructed to protect ECA area. There exists a drainage culvert from ECA area at the middle point of this reach.

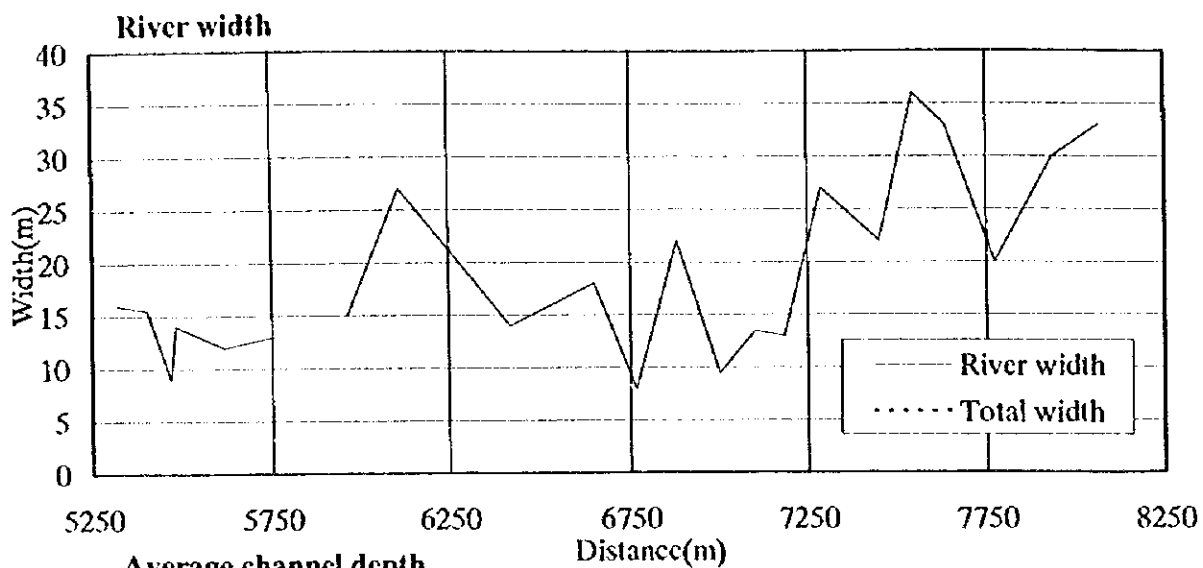
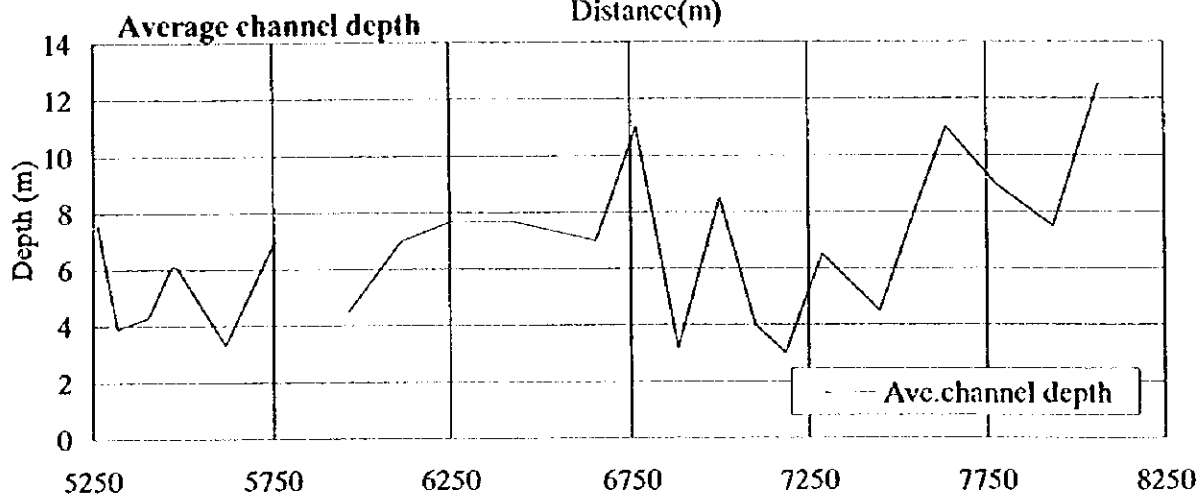
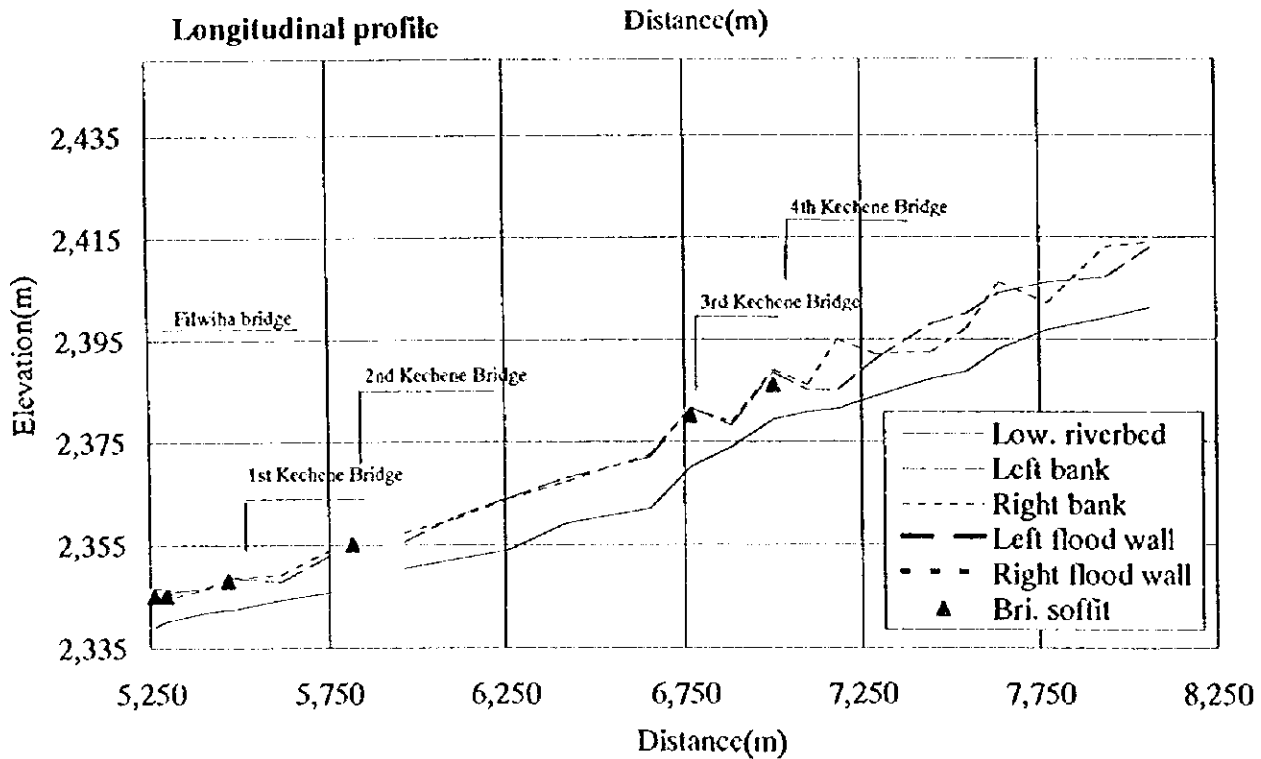
Figure 2.1.3

Features of Lower Kechene River

Figure 2.1.1 shows a location map of rivers and related structures. The river profiles and dimensions of the structures are shown in Figures 2.1.2 to 2.1.3 and Table 2.1.1, respectively.

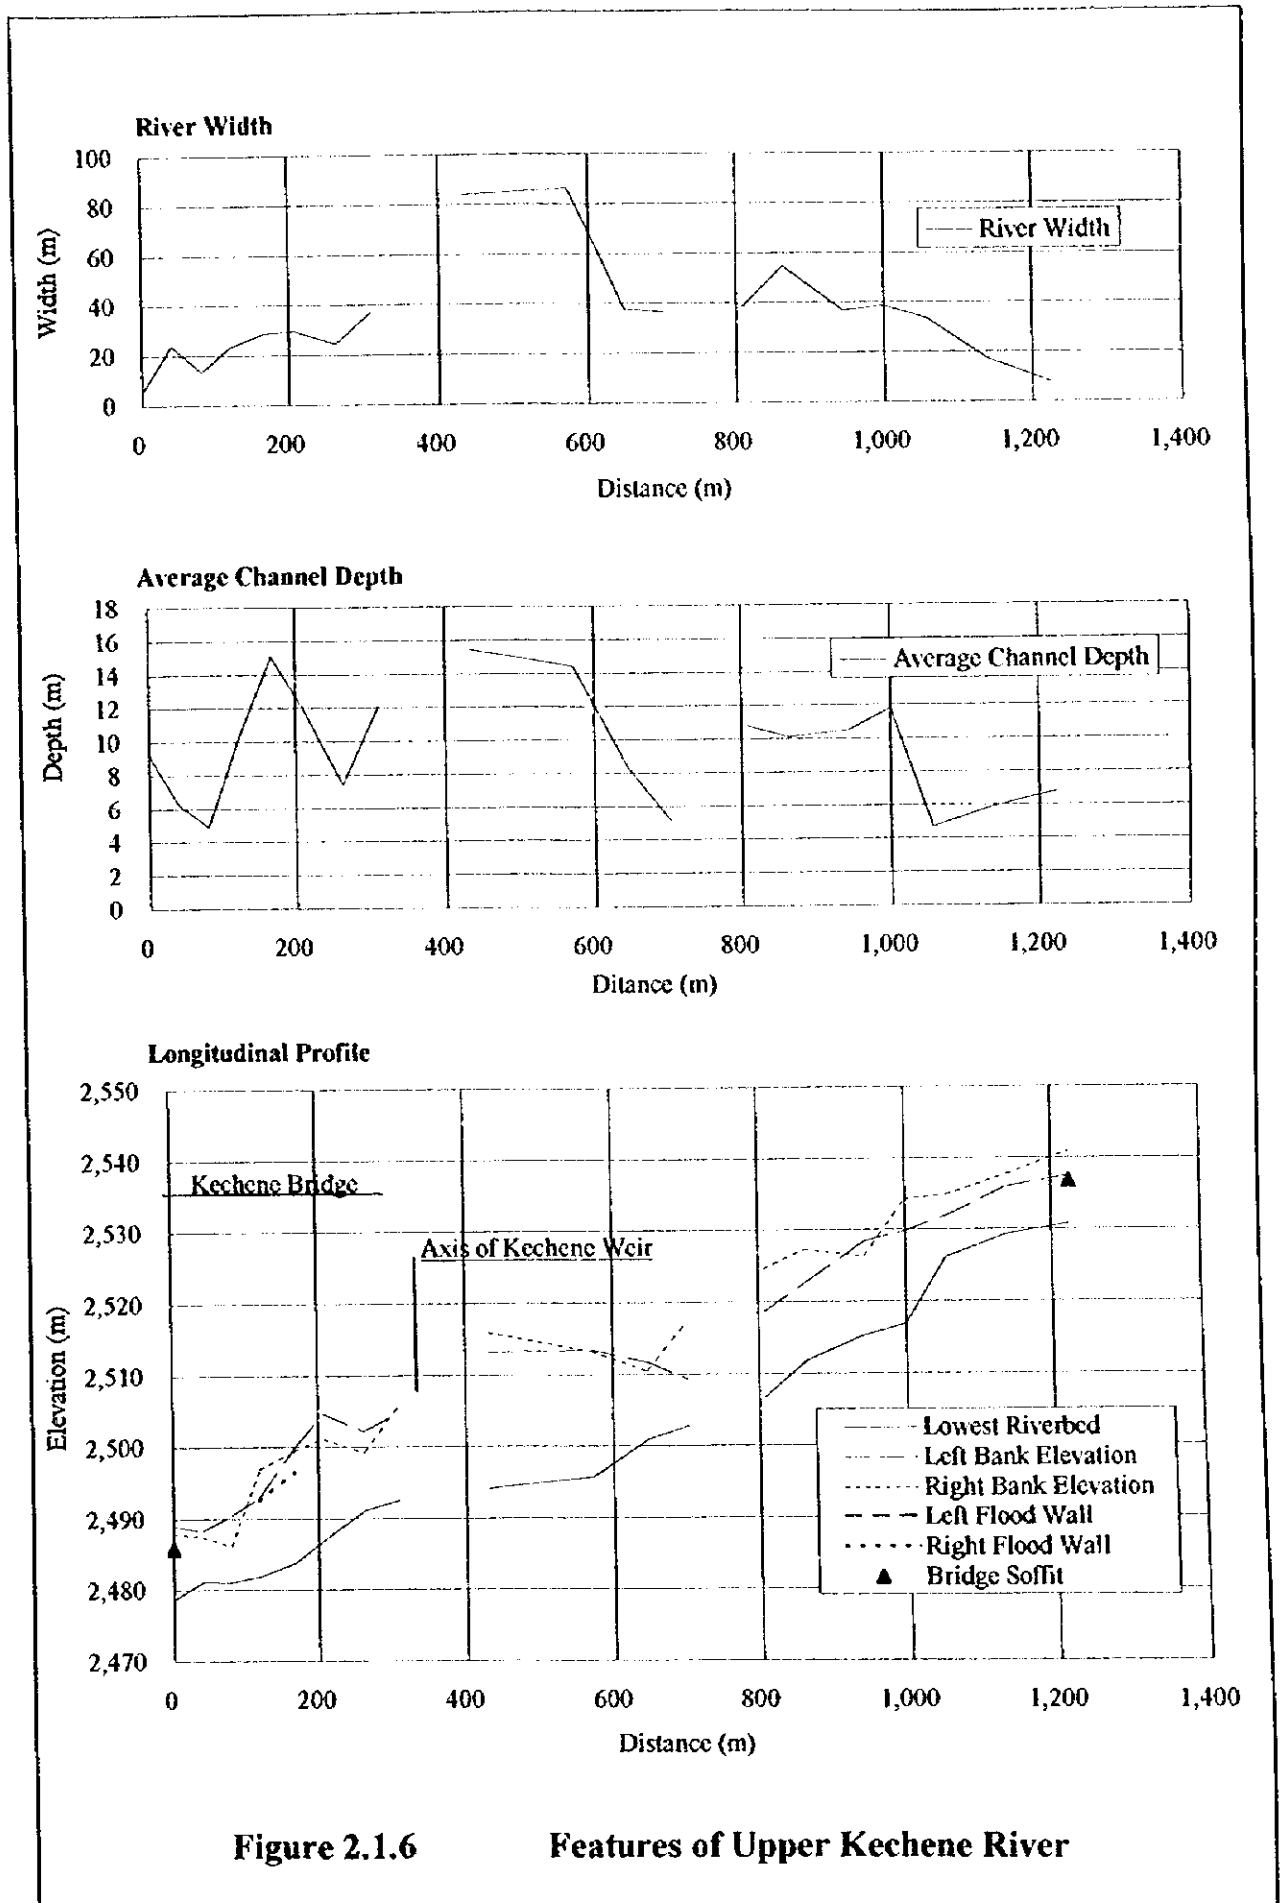
Figure 2.1.6

Features of Upper Kechene River
