ROAD NETWORK STUDY IN CENTRAL AND SOUTHEAST SULAWESI IN THE REPUBLIC OF INDONESIA

VOLUME III:
FEASIBILITY STUDY FOR TAWAELI-TOBOLI ROAD

DECEMBER 1998

PACIFIC CONSULTANTS INTERNATIONAL
YACHIYO ENGINEERING CO., LTD.

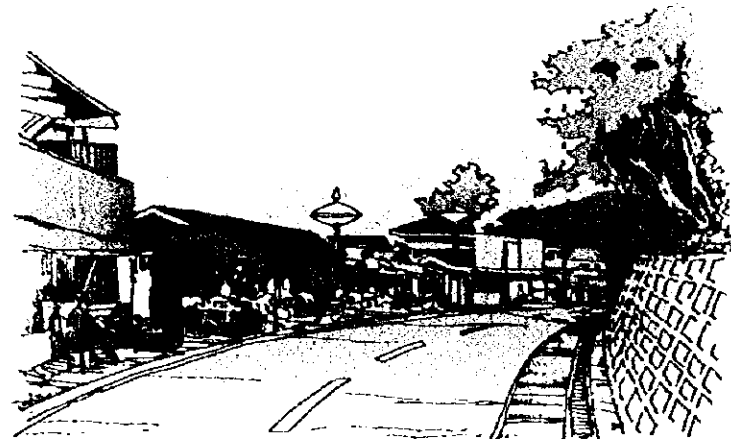
4 Road Improvement with Slope Protection at Kebunkopi

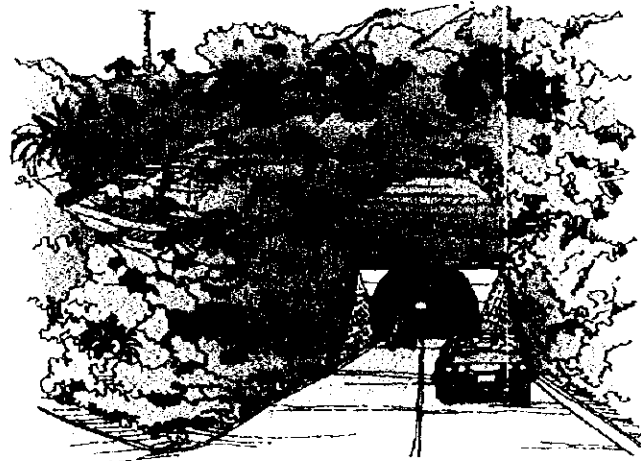
5 Proposed Tunnel of 620m in Length

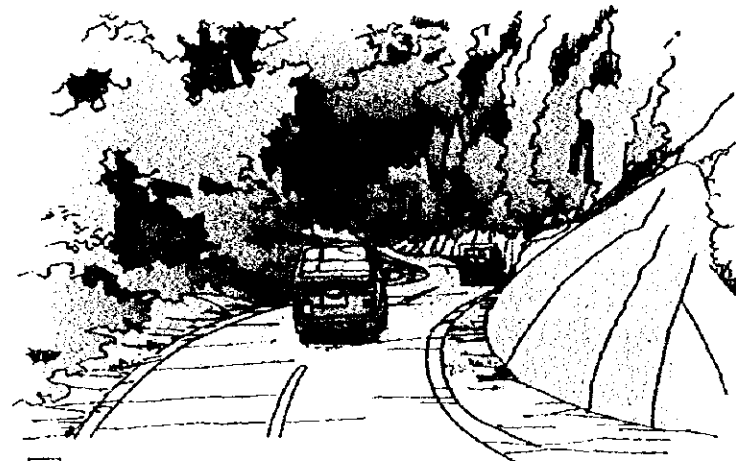
6 Road Improvement with Slope Protection by Concrete Shot

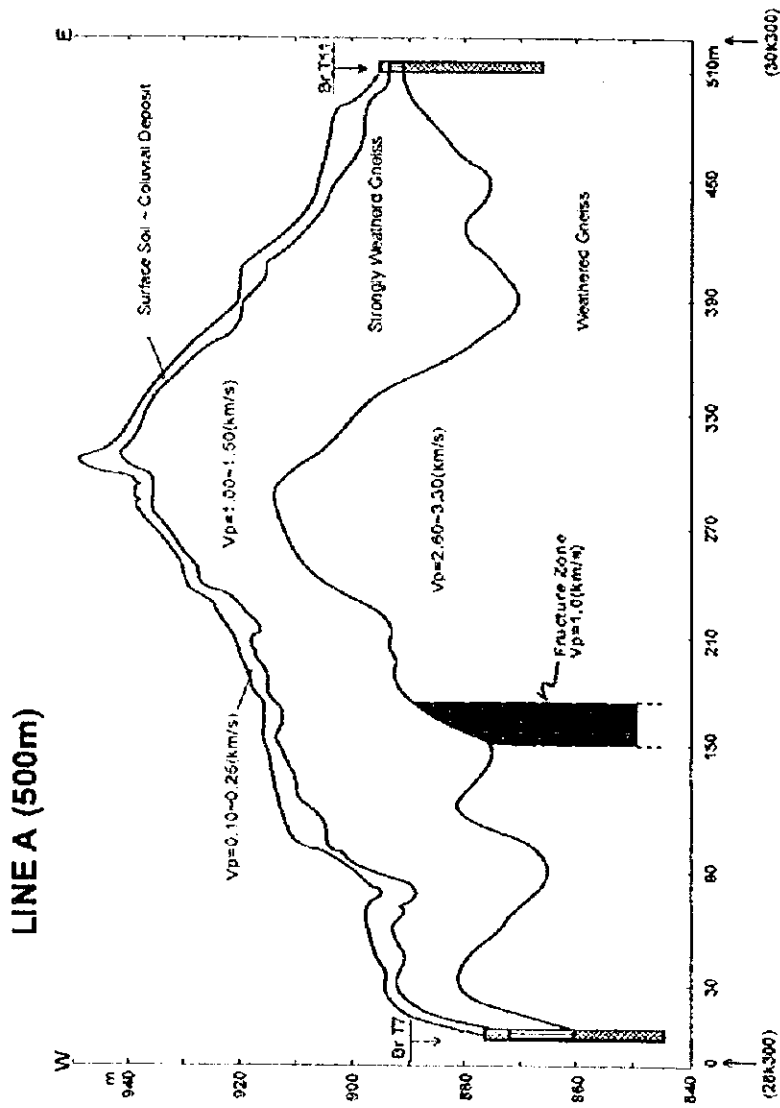
Figure 4-3-1 Line A

Velocity layer	Depth	Velocity(km/sec)	Geological Condition
1 st	Thickness less than 10m.	0.10~0.25	Colluvial deposit to deeply weathered gneiss
2 nd	Thickness less than 45m.	1.00~1.50	Deeply weathered
3 rd	Velocity basement	2.60-3.30	Weathered gneiss
