STUDY ON INTEGRATED PLAN FOR FLOOD MITIGATION IN CHAO PHRAYA RIVER BASIN | Fig. 3.1.1 INDEX MAP OF LANDSAT TM DATA CTI ENGINEERING CO., LTD. AND INA CORPORATION

STUDY ON INTEGRATED PLAN FOR FLOOD MITIGATION IN CHAO PHRAYA RIVER BASIN

CTI ENGINEERING CO., LTD AND INA CORPORATION

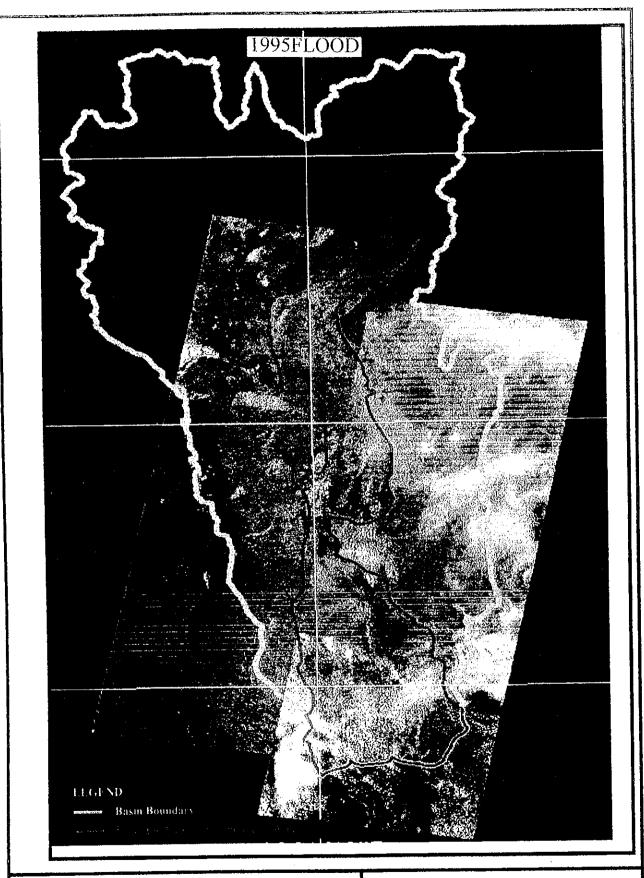
Fig.3.1.2 (1/2)
PROCESSED FALSE COLOR IMAGES

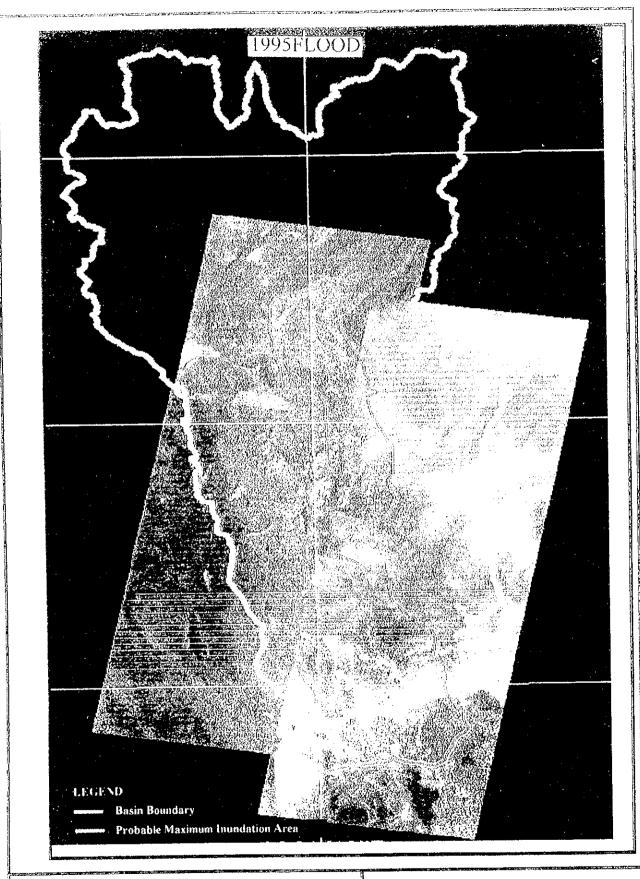
Fig.3.1.2 (1/2) PROCESSED FALSE COLOR IMAGES

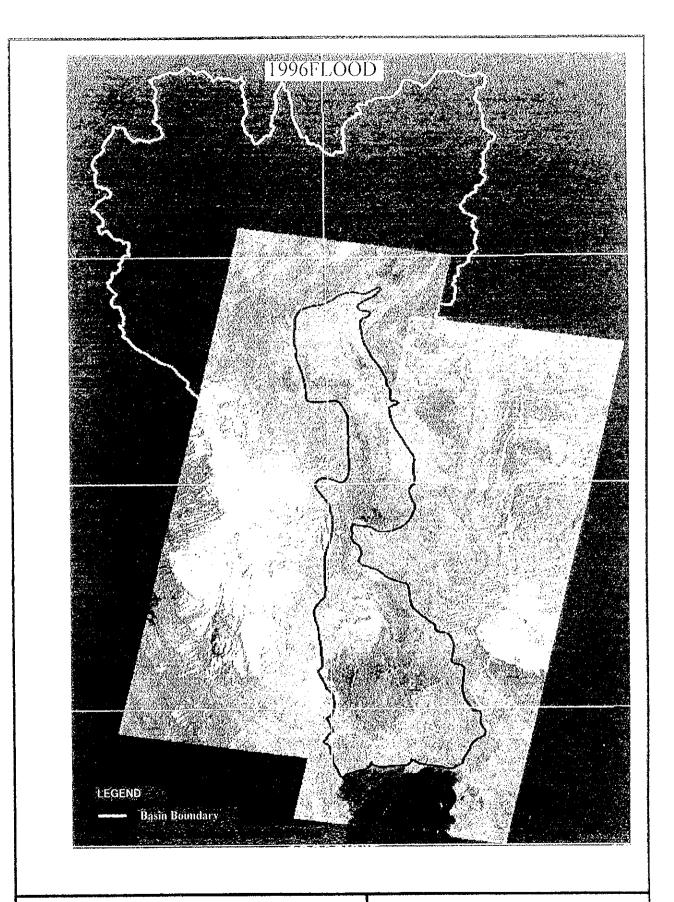
Fig.3.1.2 (2/2) PROCESSED FALSE COLOR IMAGES

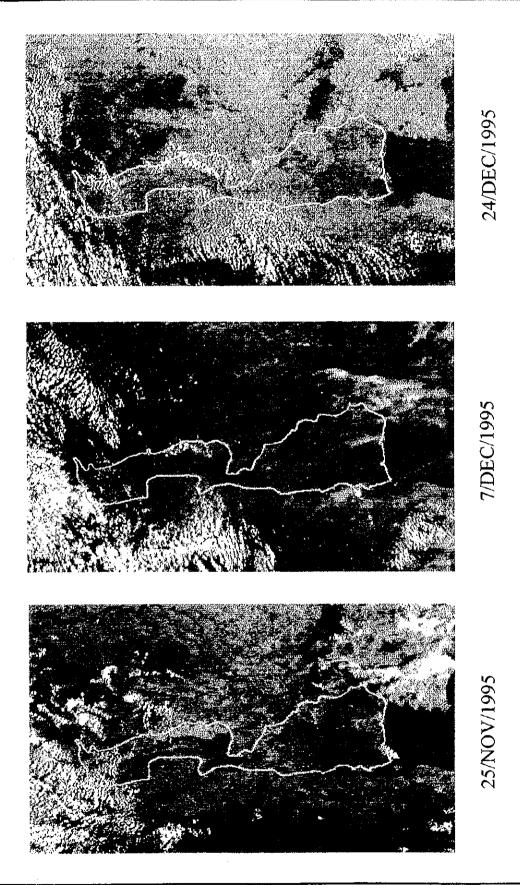
Fig.3.1.3 (2/2) TRADITION OF FLOOD

INUNDATION AREA IN 1995 BY

NOAA FALSE COLOR IMAGES

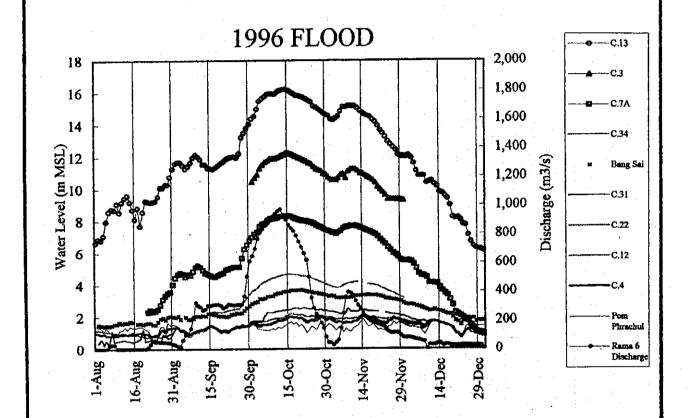
Fig.3.1.4 (3/3) DAILY MAXIMUM WATER

LEVEL IN LOWER CHAO

PHRAYA RIVER

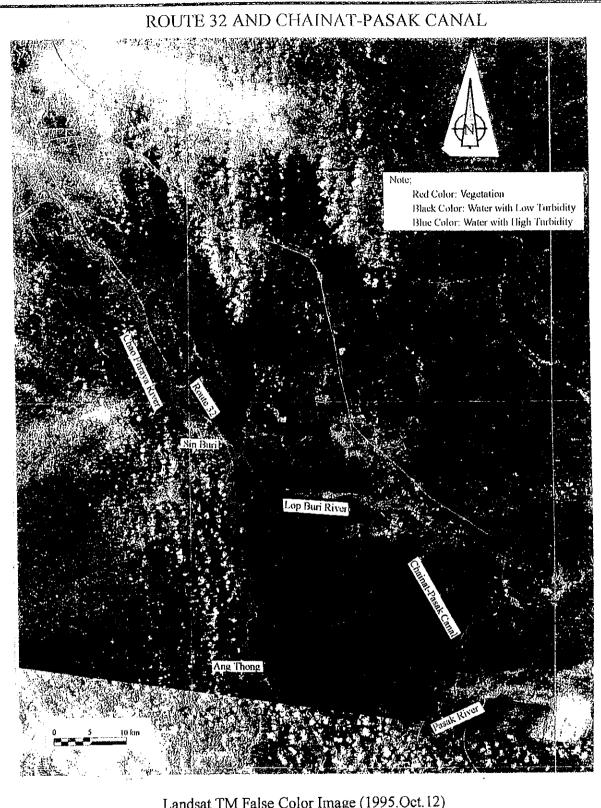
Landsat TM False Color Image (1995.Oct.12)

STUDY ON INTEGRATED PLAN FOR FLOOD Fig. 3.1.7 (1/2) EMBANKMENT AFFECTING FLOODING MITIGATION IN CHAO PHRAYA RIVER BASIN CTI ENGINEERING CO., LTD. AND INA CORPORATION

CONDITION

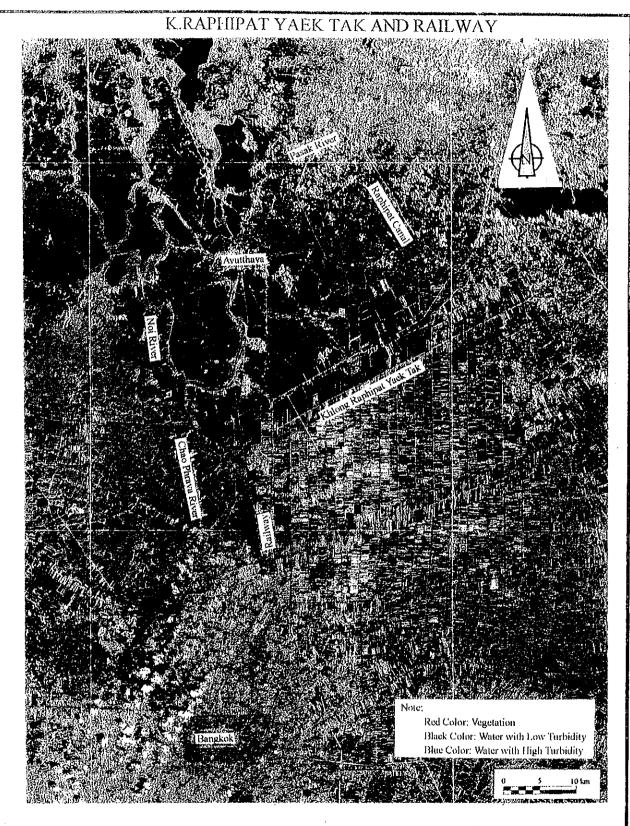
Landsat TM False Color Image (1996.Nov.15)

Fig.3.1.7 (2/2) EMBANKMENT AFFECTING FLOODING CONDITION
