STUDY ON INTEGRATED PLAN FOR FLOOD MITIGATION IN CHAO PHRAYA RIVER BASIN

CTI ENGINEERING CO., LTD AND INA CORPORATION

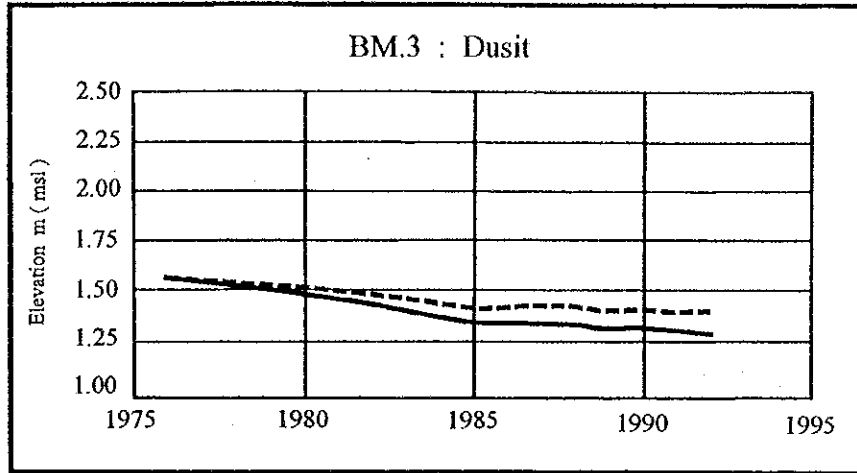
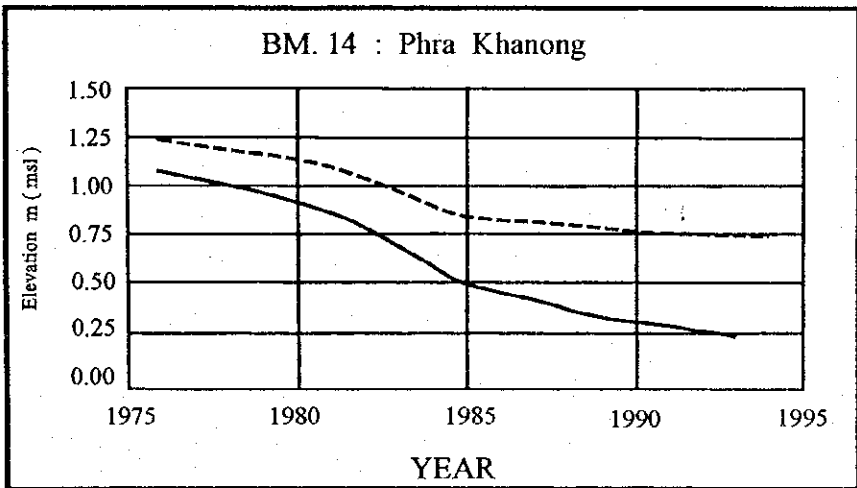
Fig. 2.3.5  
FLOOD PROTECTION AND DRAINAGE SYSTEMS IN EASTERN SUB - URBAN BANGKOK

Surface Station  
 Deep Station (22m. - MSL approx.)
