APPENDIX

HARDNESS TEST

CONCRETE STRESS STRENGTH TEST SHEET (1/34)

**GRAPHICAL RECORDING OF CHARACTERISTIC
DAMAGES OF THE WALLS OF STRUCTURE OBJECT N^o 5
AND 3 AS PART OF WASTE WATERS FILTER COMPLEX-
SARAJEVO**

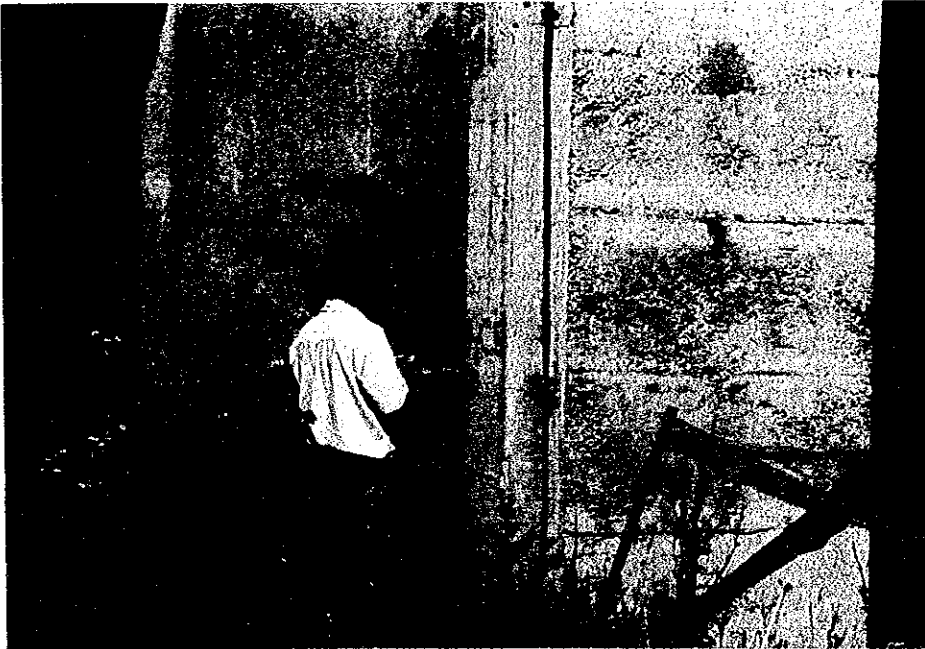
Facility No: 1	Raw Water Pumping Station
Structure Member: 1 - CE	Column - East Side
Schmidt Hammer Test Value	Mean Rebound Number, $N = 41$ Cube Compressive Strength, $W_m = 432 \text{ kg/cm}^2$ Cylinder Compressive Strength, $Z_m = 367 \text{ kg/cm}^2$

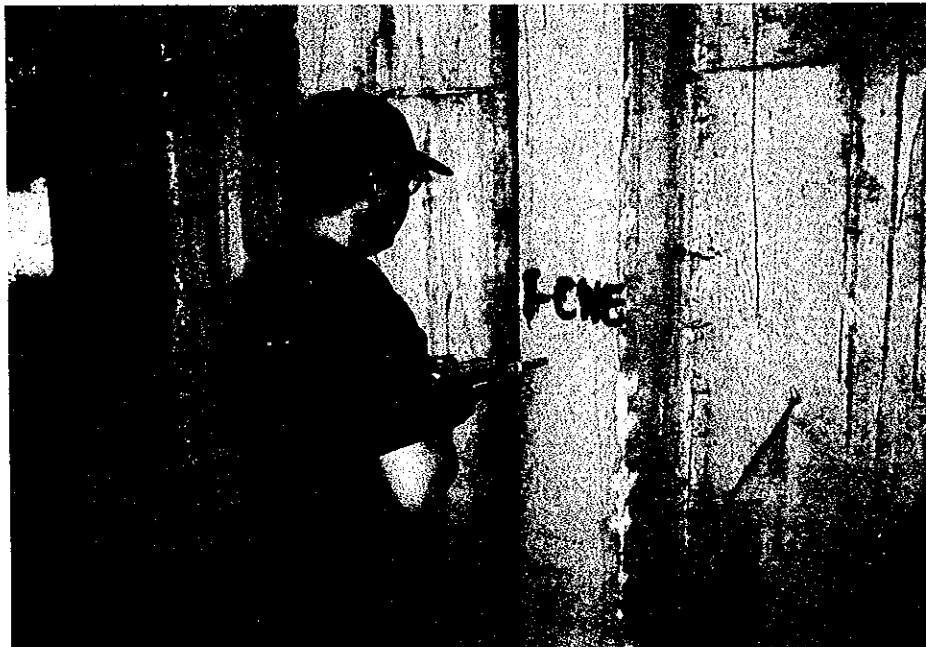
Facility No: 1	Raw Water Pumping Station
Structure Member: 1 - CNE	Column - Northeast Side
Schmidt Hammer Test Value	Mean Rebound Number, $N = 44$ Cube Compressive Strength, $W_m = 488 \text{ kg/cm}^2$ Cylinder Compressive Strength, $Z_m = 415 \text{ kg/cm}^2$

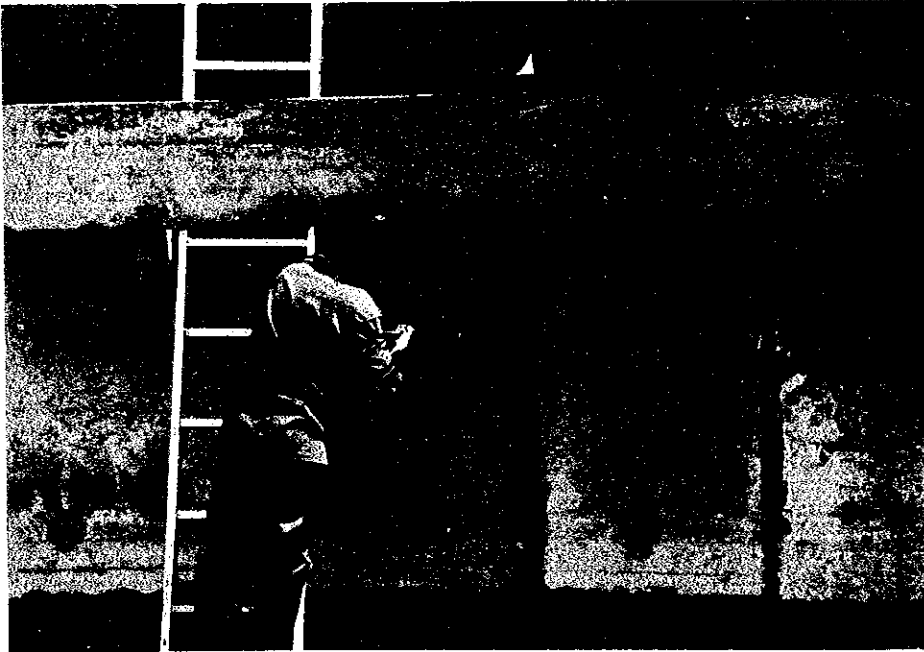
Facility No: 6 - 2	Final Sedimentation Tank No. 2
Structure Member: 6 - 2IE	Inner Wall - East Side
Schmidt Hammer Test Value	Mean Rebound Number, $N = 43$ Cube Compressive Strength, $W_m = 469 \text{ kg/cm}^2$ Cylinder Compressive Strength, $Z_m = 399 \text{ kg/cm}^2$
