**THE STUDY ON
SOLID WASTE MANAGEMENT
FOR ALMATY CITY
IN THE REPUBLIC OF KAZAKHSTAN**

FINAL REPORT

SUPPORTING REPORT

FINAL DISPOSAL AND ENVIRONMENTAL STUDY

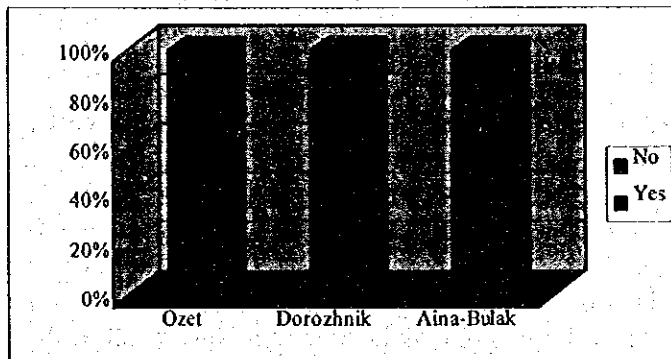
Figure 1.3.1 Proportion of the Questionnaire Results by Each Residential Area

Q1:
Know the Transfer Station and/or compost plant?

Q2:
Any unpleasant matters now?

Q3:
Any unpleasant matters before?

This survey shows that about 80-90% of respondents are aware of the existence of transfer station and the former compost plant. Serious impacts that are making the residents unpleasant were not reported, although around 20% of respondents in Ozet and Dorozhnik and 40% of Aina-Bulak's feel uncomfortable with odor and smoke from the transfer station at present. On the other side, more than half of the respondents had a disagreeable experience with odor and smoke when the transfer station and compost plant were normally operating before. Especially, all the respondents in Dorozhnik and Aina-Bulak who know the transfer station and compost plant had felt unpleasant.

A simple questionnaire survey was conducted on 31 March 1999 with the residents near the transfer station, i.e., residents of Ozet, Dorozhnik and Aina-Bulak. Dorozhnik neighbors Aina-Bulak and is located just south of it. Results of the survey are presented in Table 1.3.1 and Figure 1.3.1 below.
