## **2.3 ROAD ALIGNMENT PLANNING CRITERIA AND METHOD**

### **2.3.1 Alignment Planning Policy and Methodology**

**BASIC DESIGN STUDY ON THE PROJECT FOR CONSTRUCTION OF SINDHULI ROAD  
(SECTION II : SINDHULI BAZAR - KHURKOT)  
POTENTIAL OF ANNUAL SOIL YIELD MAP**

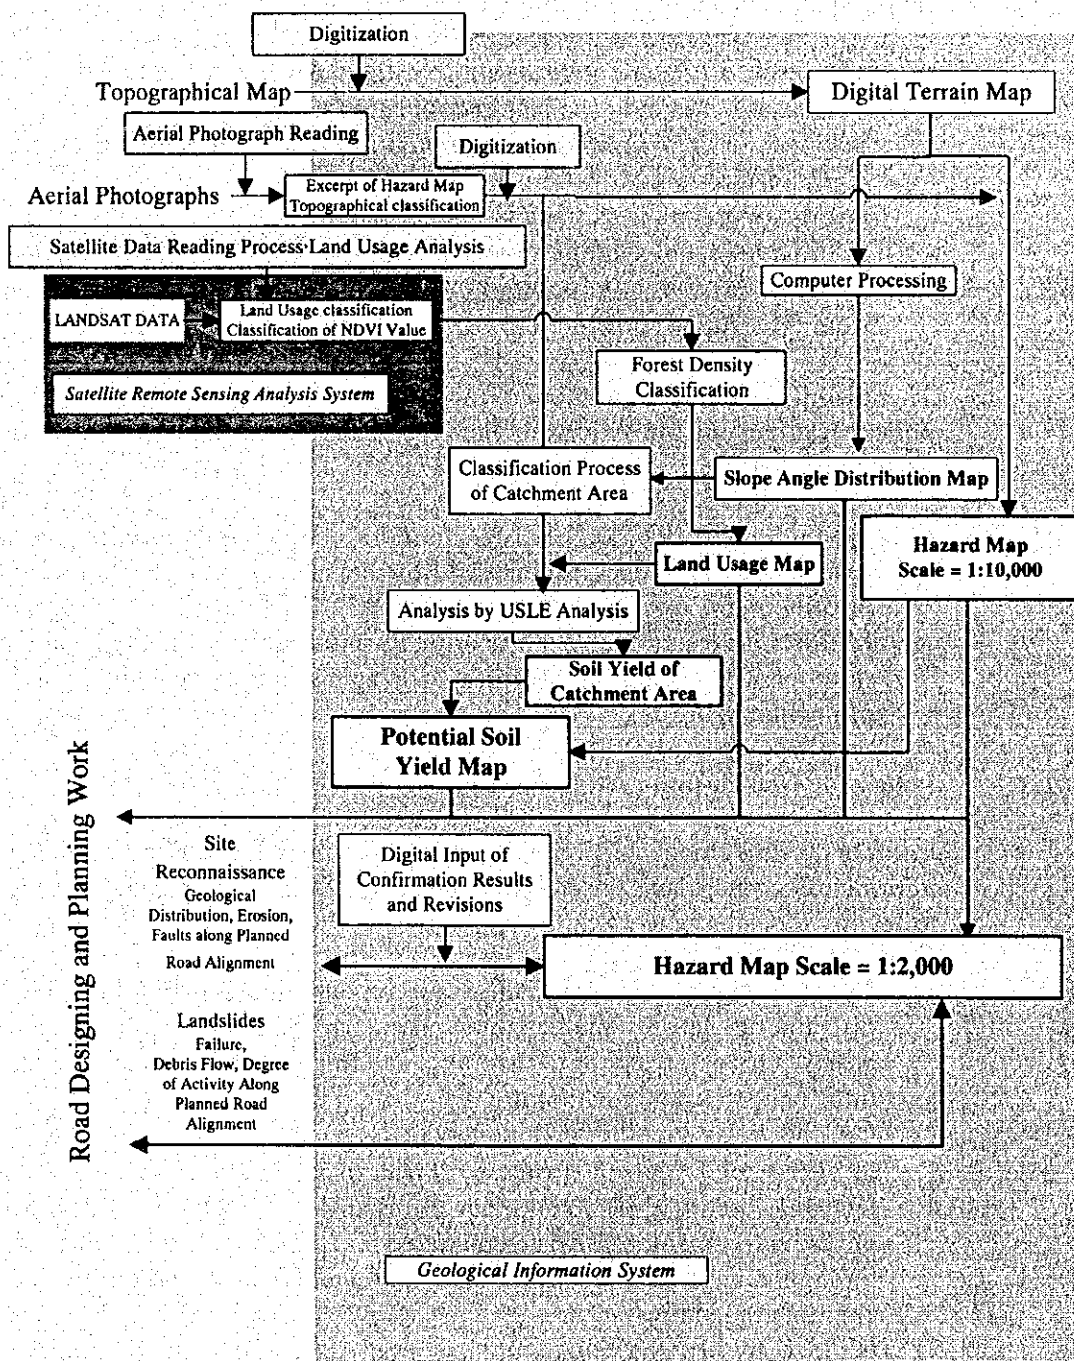
Figure 2.3.1 The Work process to Determine the Alignment

Figure 2.3.1 indicates the work process to determine the alignment. Figures 2.3.2 to 2.3.5 indicate the generated land use distribution, landslide hazard zones, distribution of the slope gradient, and the potential deposit yield.

In order to implement and realize the two policies, technology of the geographic information system was applied to determine the alignment. Specifically, the following procedures were followed:

- 1) Generate figures on 1:10,000 scale topographical map indicating land use distribution, hazard map, natural slope angle, and potential sediment yield based on aerial photo reading, satellite remote sensing, geographical information system technology.

- 2) On the basis of the geographical information obtained from 1), extract locations of saddle of ridges, forested area, slope gradient distribution, landslide hazard zones, and other information that would control the planning of the alignment. These integrated information would then be filtered through comprehensive evaluation and judgment to determine the area for alignment planning.

- 3) Digitize the 1:2,000 topographical map data and plan an optimal route (a tentative route) within the constraints of the alignment by trial and error process on a computer.

- 4) Confirm and revise the geographic information along the tentative route by incorporating data acquired through site reconnaissance and topographical

- survey and generate digital terrain data.  
 5) Finalize the road alignment based on the digital terrain data.

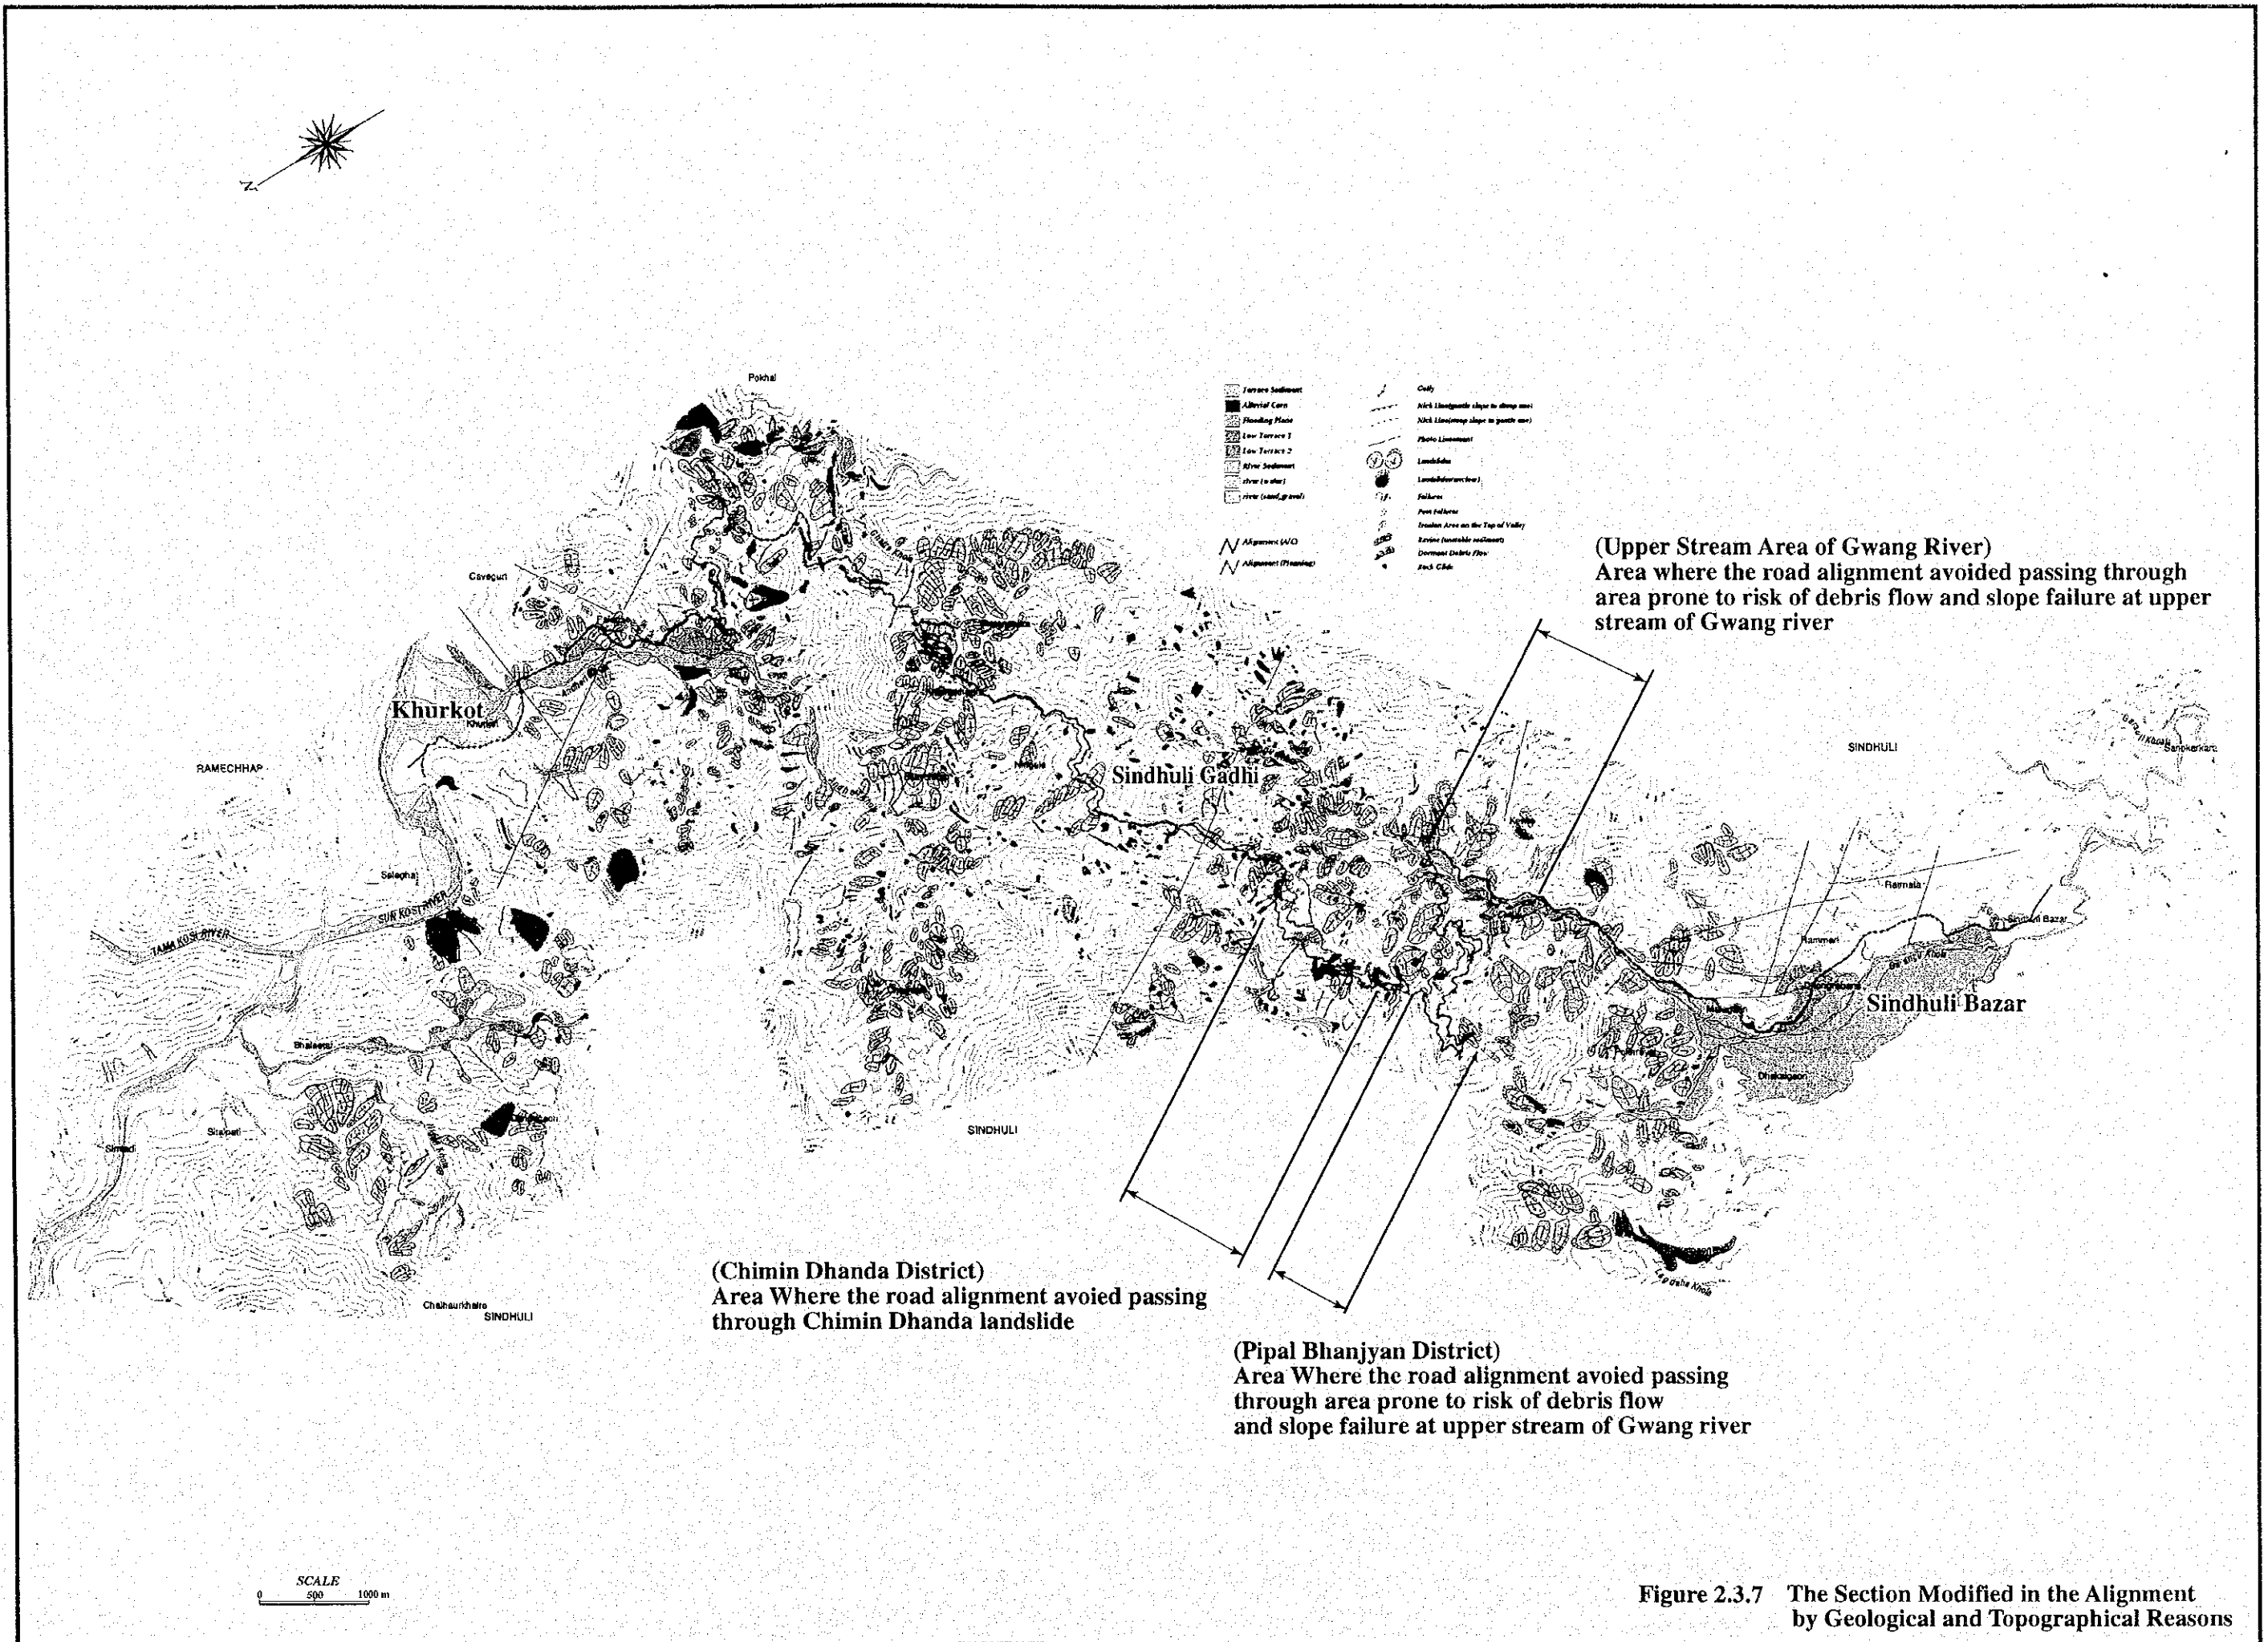
According to the geological information obtained through the hazard map, slope gradient distribution map, findings on the field investigation in the first field survey and recommendations in the reconnaissance report prepared by DOR after 1993 heavy rainfall, the alignment planned in the Aftercare Study was modified at three sections as shown in Figure 2.3.7 and are described below.

The upper stream of Gwang River basin shows progression of dissection and forms a dendrite drainage pattern. The 1993 heavy rain has caused many debris slides on the slopes along the upper stream, and hazard maps indicate that many slope failures and large-scale landslides are triggered by the active MBT and MCT faults. Boulders, with maximum diameter of 5 meters, are scattered on the flood plain that is 3m higher than the existing river bed. So the upper stream of Gwang River is an area subject to intense movements of debris. Also, the route planned in the Aftercare Study, which crosses many rivers by crossing structures including the three bridges planned over the Gwang River, is prone to risks of slope failures and debris flow. Thus, the alignment in this area was modified to cross the Gwang River prior to entering the area of intense flow movements.

Many failures had occurred at the slopes on the upper stream area of Gwang tributary river due to the heavy rain in 1993. The upper stream area of Gwang tributary river is prone to mass movements of debris. Thus, the original alignment that passes through this area, established in the Aftercare Study, is subject to risks of slope failures and debris flow. On the other hand, the ridge in the vicinity of Pipal Bhanjyan area is formed of stable sandstone and conglomerate. Thus, the route originally planned in the Aftercare Study was modified so as to avoid passing through the area of potential intense debris movement, and the road would be safer to climb up along the ridgeline by zigzag sections.

A large-scale landslide occurred on the northwest slope of the Chimin Dada area due to the 1993 heavy rain. This landslide is the partial reactivation of the massive landslide that originates near the ridge at the elevation of 1200m. The width and the length of this massive landslide is 100m and 250m, respectively. The route conceived during the Aftercare Study was to pass through the center of this huge landslide. To avoid potential landslide hazards, this route was modified so as to climb the steep slopes in Dhancheldada village by five layers of zigzag sections and raising the alignment up to the ridge, prior to coming into this section.
