2.4 ROAD DESIGN CRITERIA AND METHOD

2.4.2 Road Design

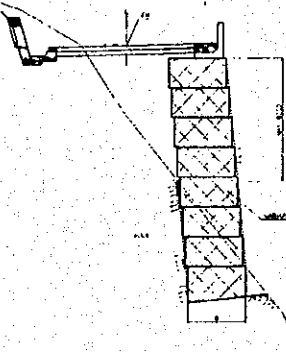
The retaining walls using locally available materials and techniques such as gabion and masonry will be adopted in the design mainly. The sections where common types of walls are not applicable, special type of walls as shown in Table 2.4.9 will be adopted based on the site conditions.

Gravity Wall with Replaced Concrete Foundation	Large Gabion Box Wall	Earth Reinforcement Wall
Typical Section

Working conditions and Workability	<ul style="list-style-type: none"> - Prompt construction work - Flexible against change of the site conditions - Require concrete mixing place 	<ul style="list-style-type: none"> - Prompt construction work - Flexible against change of the site conditions - Require boulder stock yard 	<ul style="list-style-type: none"> - All material can be carry by man power. - Manual construction - Inflexible against change of the site conditions - Require careful quality control
Cost	15,000-20,000 (Japanese Yen/m ²)	15,000-30,000 (Japanese Yen/m ²)	25,000-40,000 (Japanese Yen/m ²)
Site and Working conditions to be selected	<p>Foundation: Weathered rock or hard rock</p> <p>Workability: Require easy concrete supply</p> <p>Maximum height: 8m</p>	<p>Foundation: Weathered rock or hard rock</p> <p>Workability: Require easy boulder supply</p> <p>Maximum height: 6m</p>	<p>Foundation: Hard rock with anchor</p> <p>Common-hard rock without anchor</p> <p>Workability: Require availability of selected back fill material</p> <p>Maximum height: Tentatively 13m</p>
