THE STUDY ON
REGIONAL ENVIRONMENTAL IMPROVEMENT PLAN
FOR THE BASIN OF LAKE FUQUENE

JAPAN INTERNATIONAL COOPERATION AGENCY

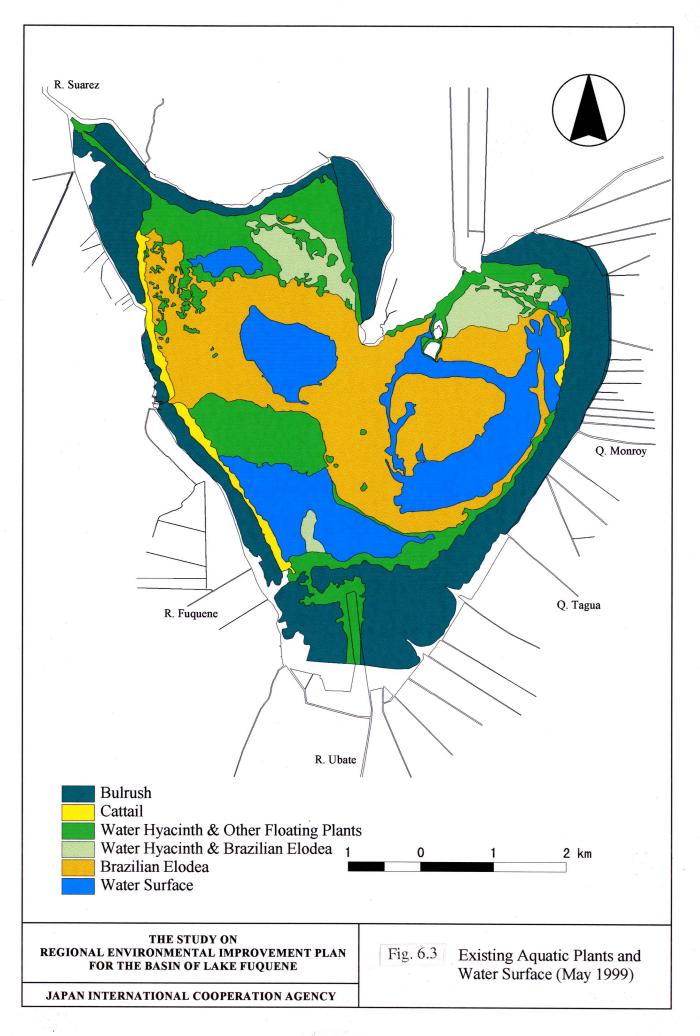
Fig. 6.4 Biomass Survey Results

No	Location		Water Depth Biomass Density in kg/sq.m (in wet condition)			
	N	W	in m	Upper 1m	1m - Bottom	Total
No.1	5deg 27.655'	73deg 45.960'	1.90	14.54	5.17	19.71
No.2	5deg 27.662'	73deg 45.301'	3.13	5.25	2.19	7.44
No.3	5deg 27.738'	73deg 45.515°	2.39	7.67	5.39	13.06
No.4	5deg 27.527	73deg 45.896'	1.95	20.56	5.18	25.74
No.5	5deg 27.980'	73deg 44.013	3.84	0.00	0.00	0.00
No.6	5deg 27.935'	73deg 43.987'	2.80	11.59	2.70	14.29
No.7	5deg 28.345'	73deg 43.920'	2.07	15.49	2.80	18.29
No.8	5deg 27.916'	73deg 44.007'	3.60	0.00	29.42	29.42
No.9	5deg 27.862'	73deg 44.700'	3.08	1.56	13.95	15.51
No.10	5deg 27.985'	73deg 43.422'	3.06	11.36	3.46	14.82
No.11	5deg 28.442'	73deg 43.181'	1.96	10.33	3.95	14.27
No.12	5deg 28.013'	73deg 45.057	4.56	0.00	0.00	0.00
No.13	5deg 27.794'	73deg 45.055°	3.55	1.33	11.63	12.96
No.14	5deg 28.064'	73deg 45.122'	3.95	0.00	0.00	0.00
No.15	5deg 28.149'	73deg 45.192'	3.33	1.78	6.37	8.14
No.16	5deg 26.725'	73deg 44.287	2.47	12.14	5.04	17.18

No.17	5deg 26.708'	73deg 44.999'	1.98	12.97	6.11	19.08
No.18	GPS was out of order		2.10	14.32	5.15	19.46
No.19	GPS was out of order		2.26	11.06	2.75	13.82
No.20	GPS was out of order		2.30	9.72	4.81	14.54
No.21	GPS was out of order		2.39	10.66	5.97	16.63
No.22	5deg 26.391'	73deg 44.900'	1.94	13.89	1.77	15.66
