People's Republic of Bangladesh
JAMUNA RIVER BRIDGE CONSTRUCTION PROJECT

TOPOGRAPHIC SURVEY REPORT

August, 1975

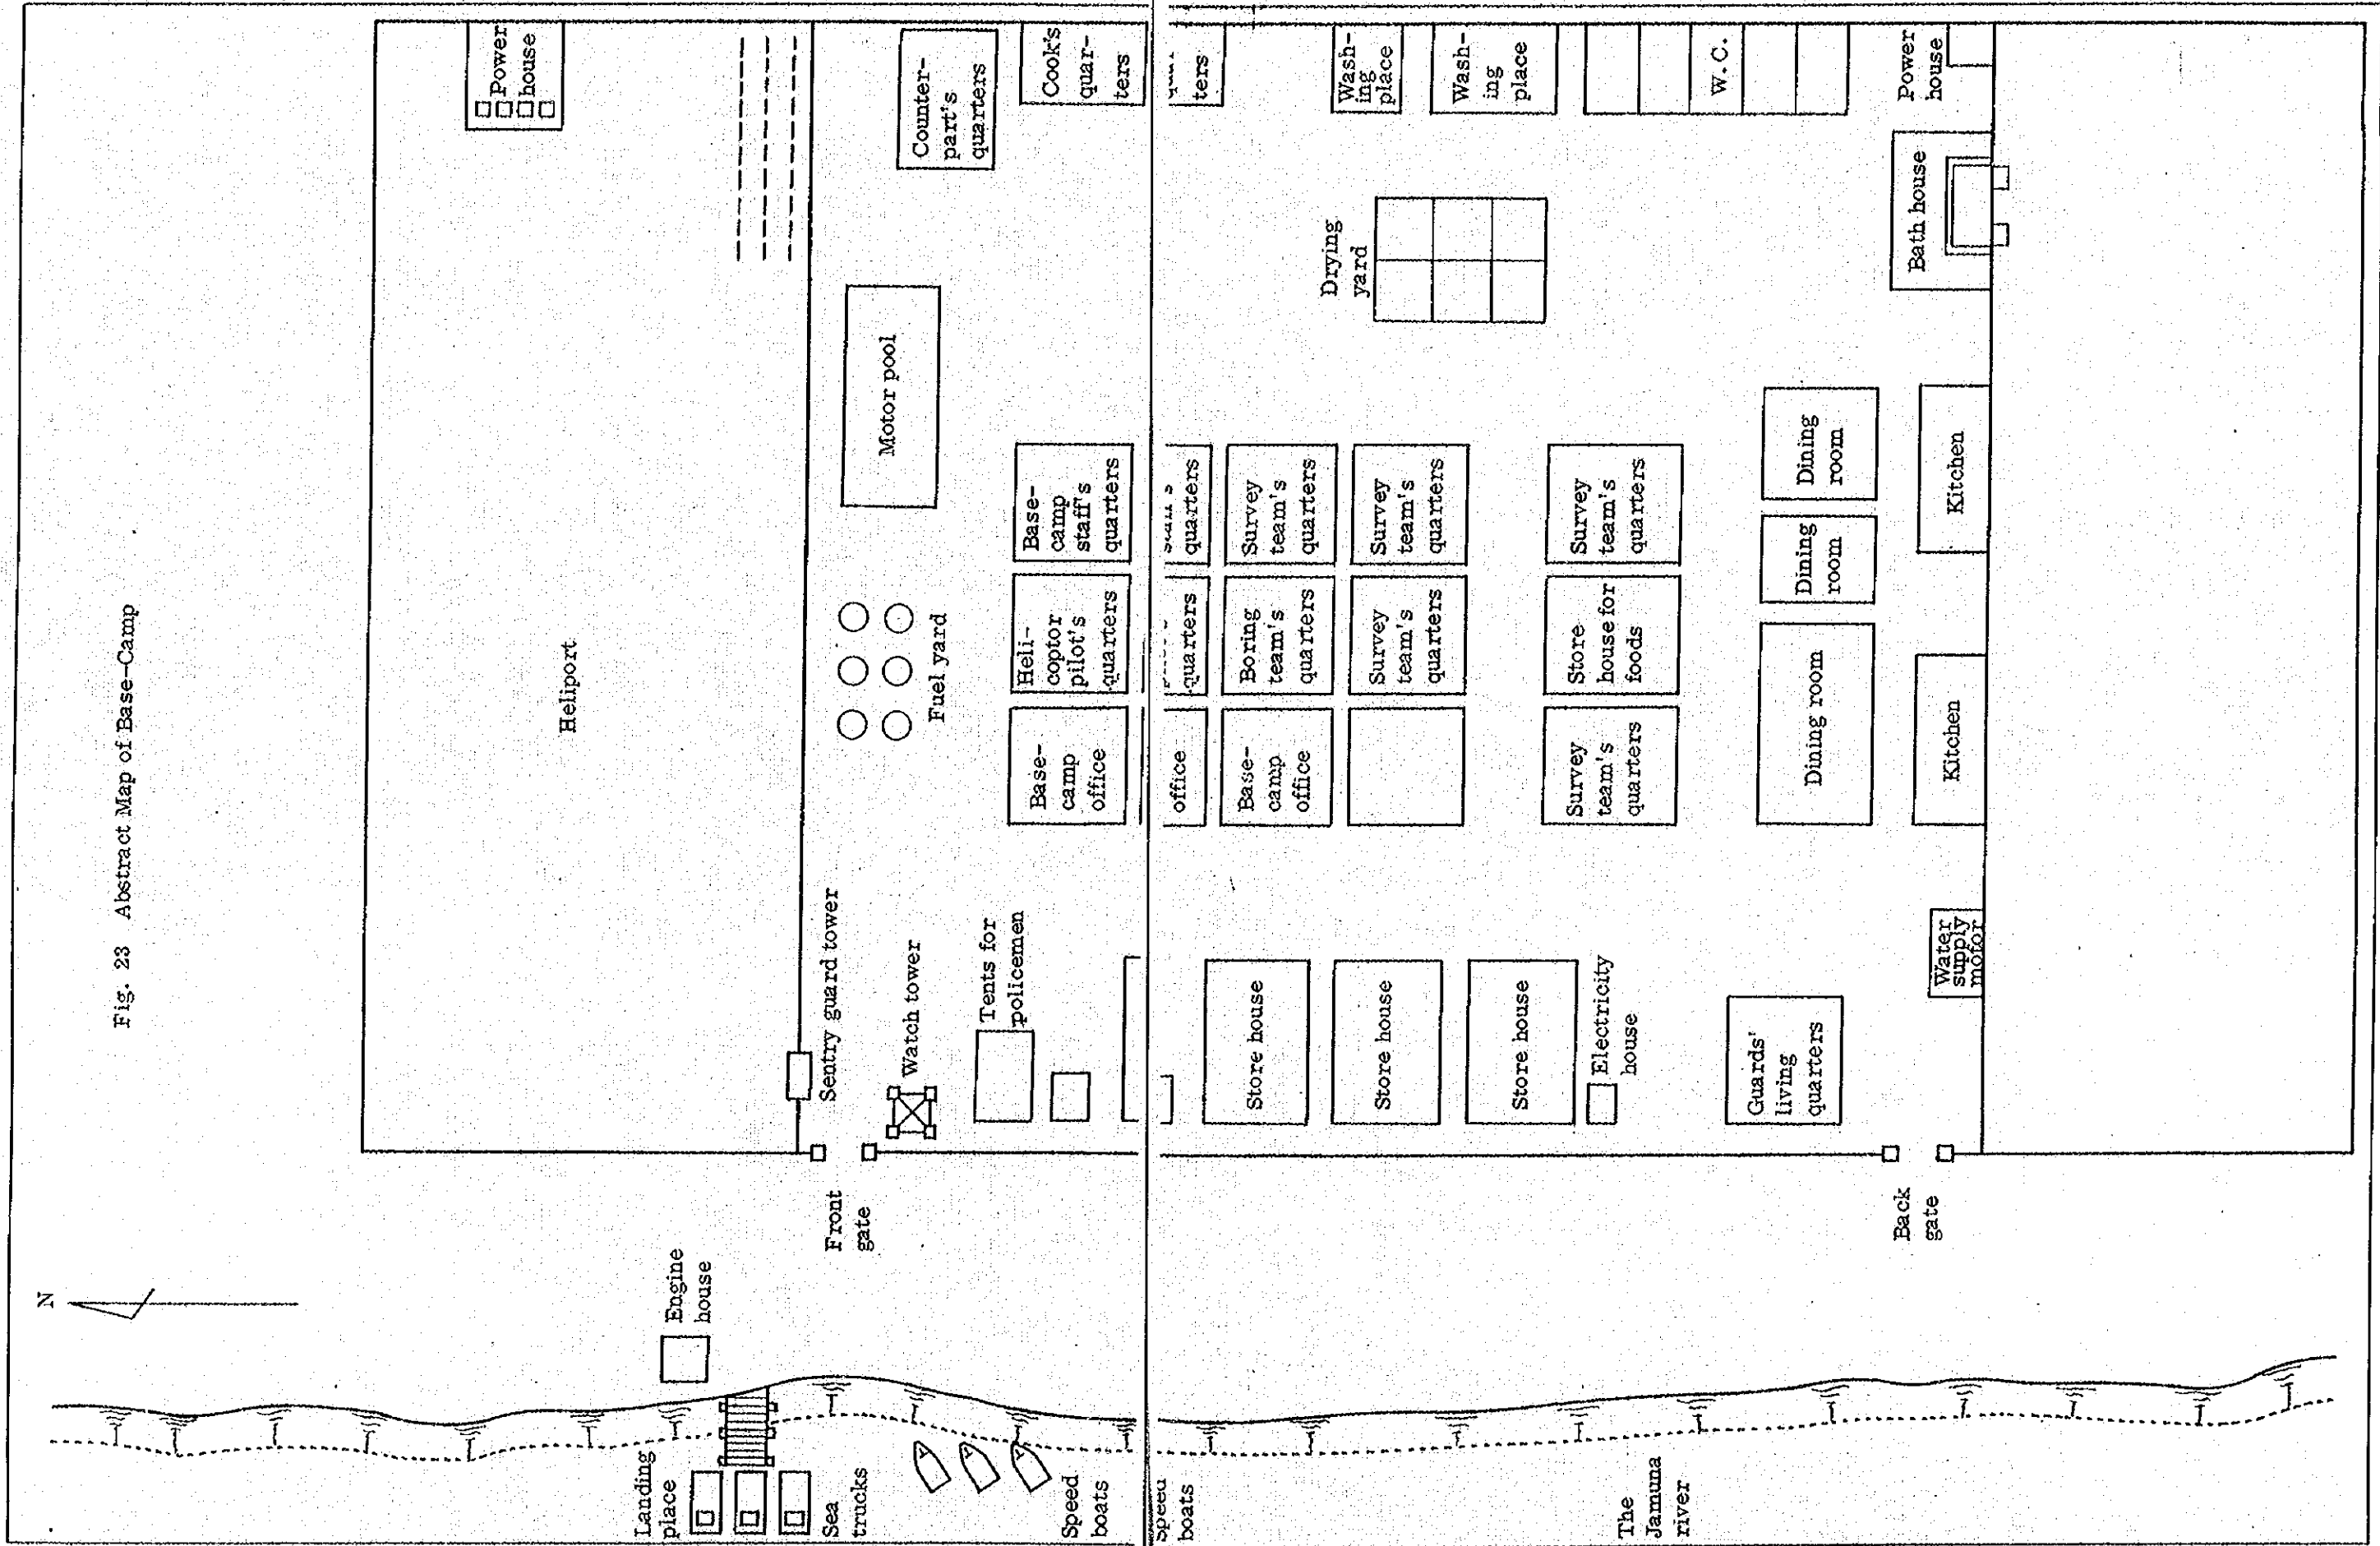
Fig. 23 Abstract Map of Base-Camp

An outline of the base camp has been shown in Fig.-23. Special attention was paid to tap water and bathing equipment, in addition to lodging, cooking and recreation. Its environment was very pleasant for living as well as survey working because it was equipped with an independent power generation for electric light and wiring.
