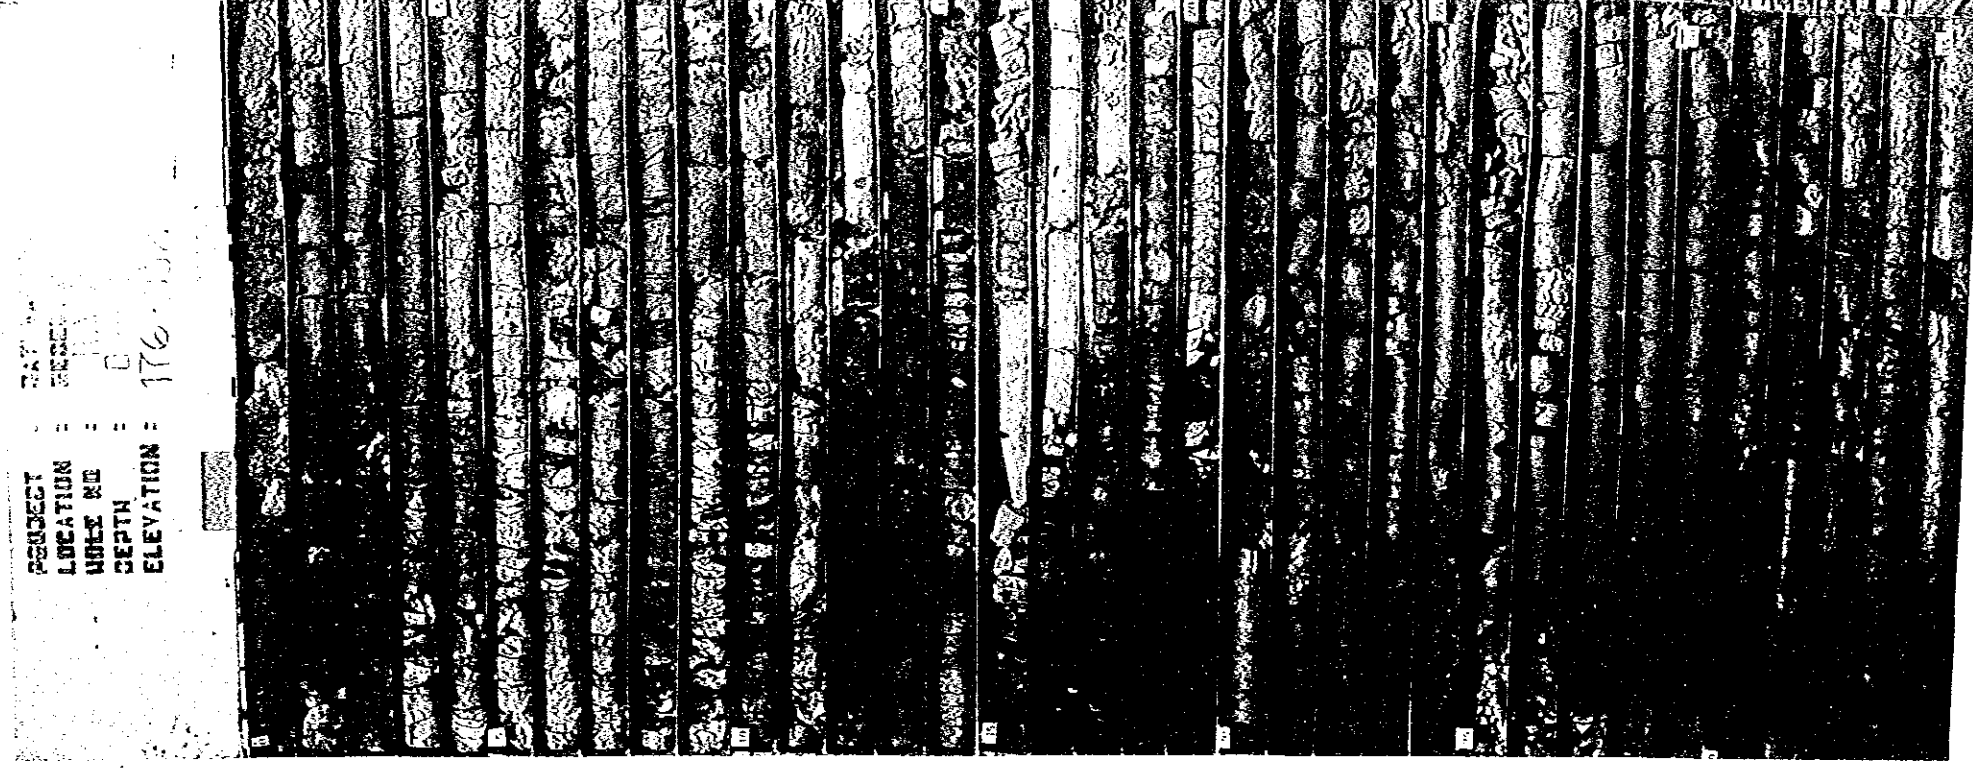
Photo 2.2.2 Drilling Core Photograph of Bore Hole No. RA - 2

Bore Hole No. : RA - 2  
Location : Reservoir Area  
Ground Elevation : EL. 176.36 m  
Total Depth : 35 m  
Depth : 0 ~ 35 m

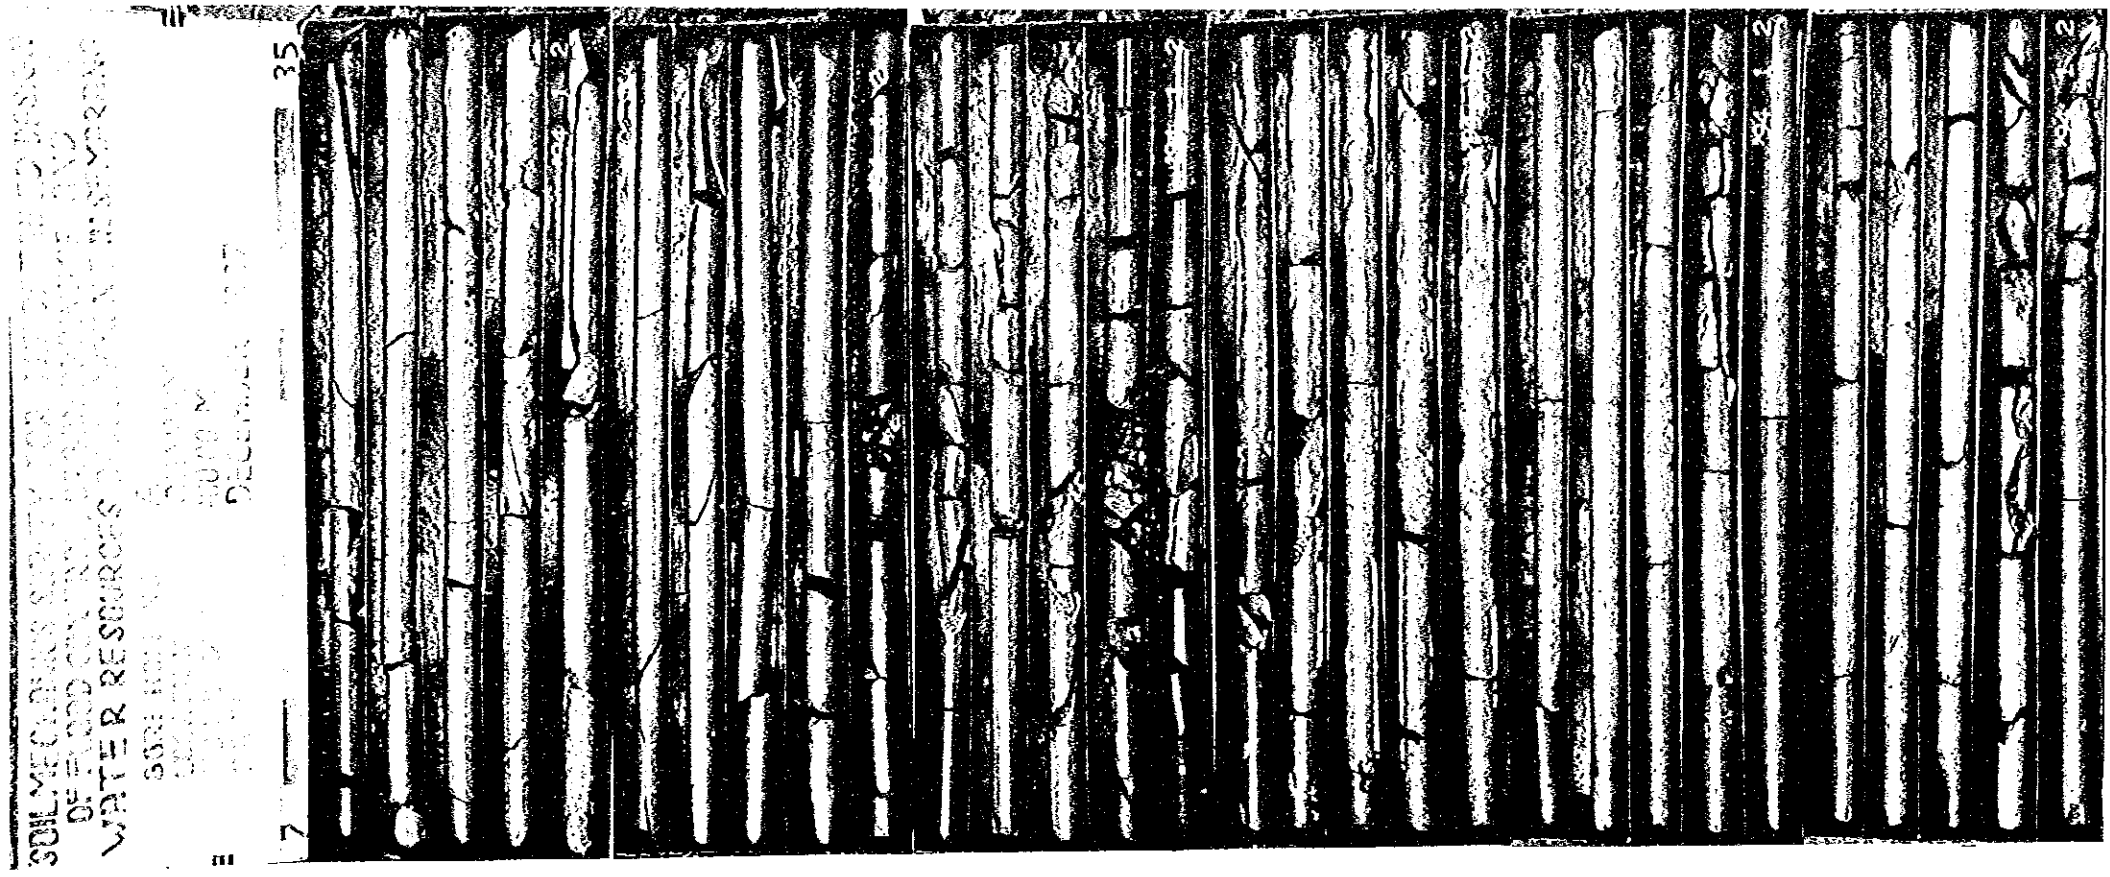
Photo 3.1.1 Drilling Core Photograph of Bore Hole No. A - 1 (2 of 4)

Bore Hole No. : A-1  
 Location : Quarry Site  
 Ground Elevation : EL. 571.511 m  
 Total Depth : 100 m  
 Depth : 30 ~ 60 m

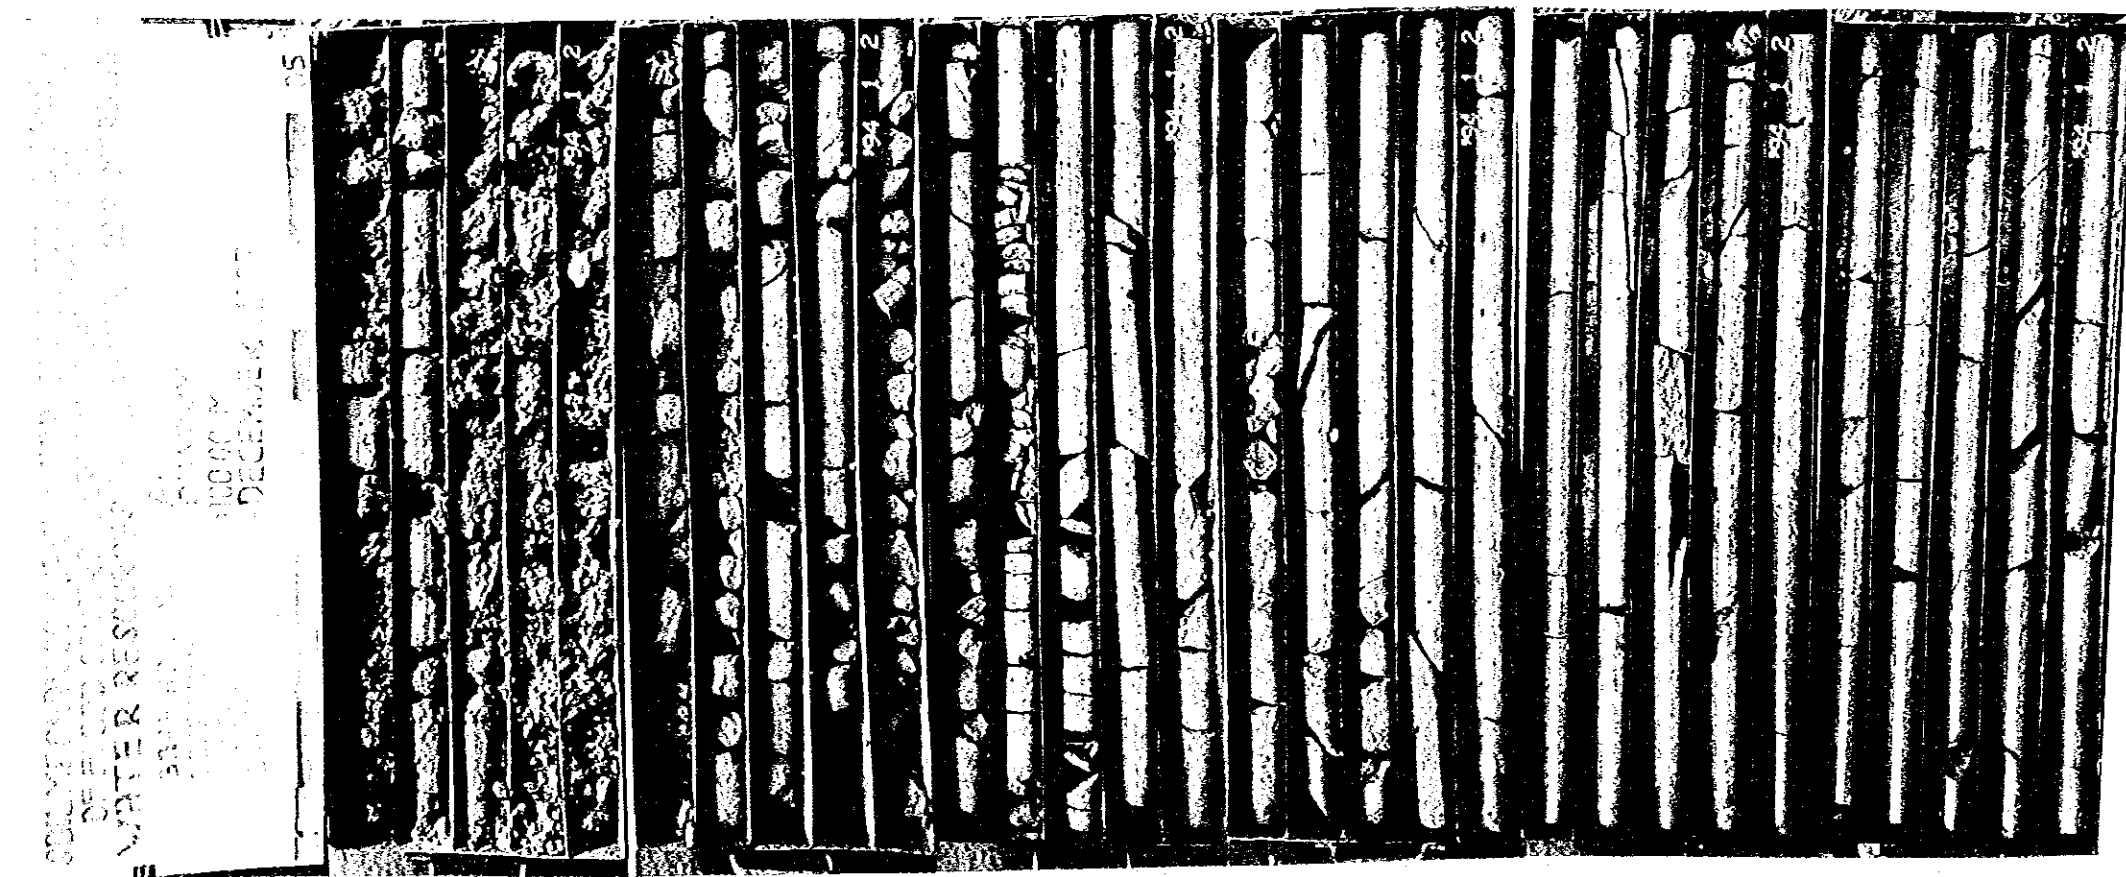
Photo 3.1.1 Drilling Core Photograph of Bore Hole No. A - 1 (1 of 4)

Bore Hole No. : A-1  
 Location : Quarry Site  
 Ground Elevation : EL. 571.511 m  
 Total Depth : 100 m  
 Depth : 0 ~ 30 m

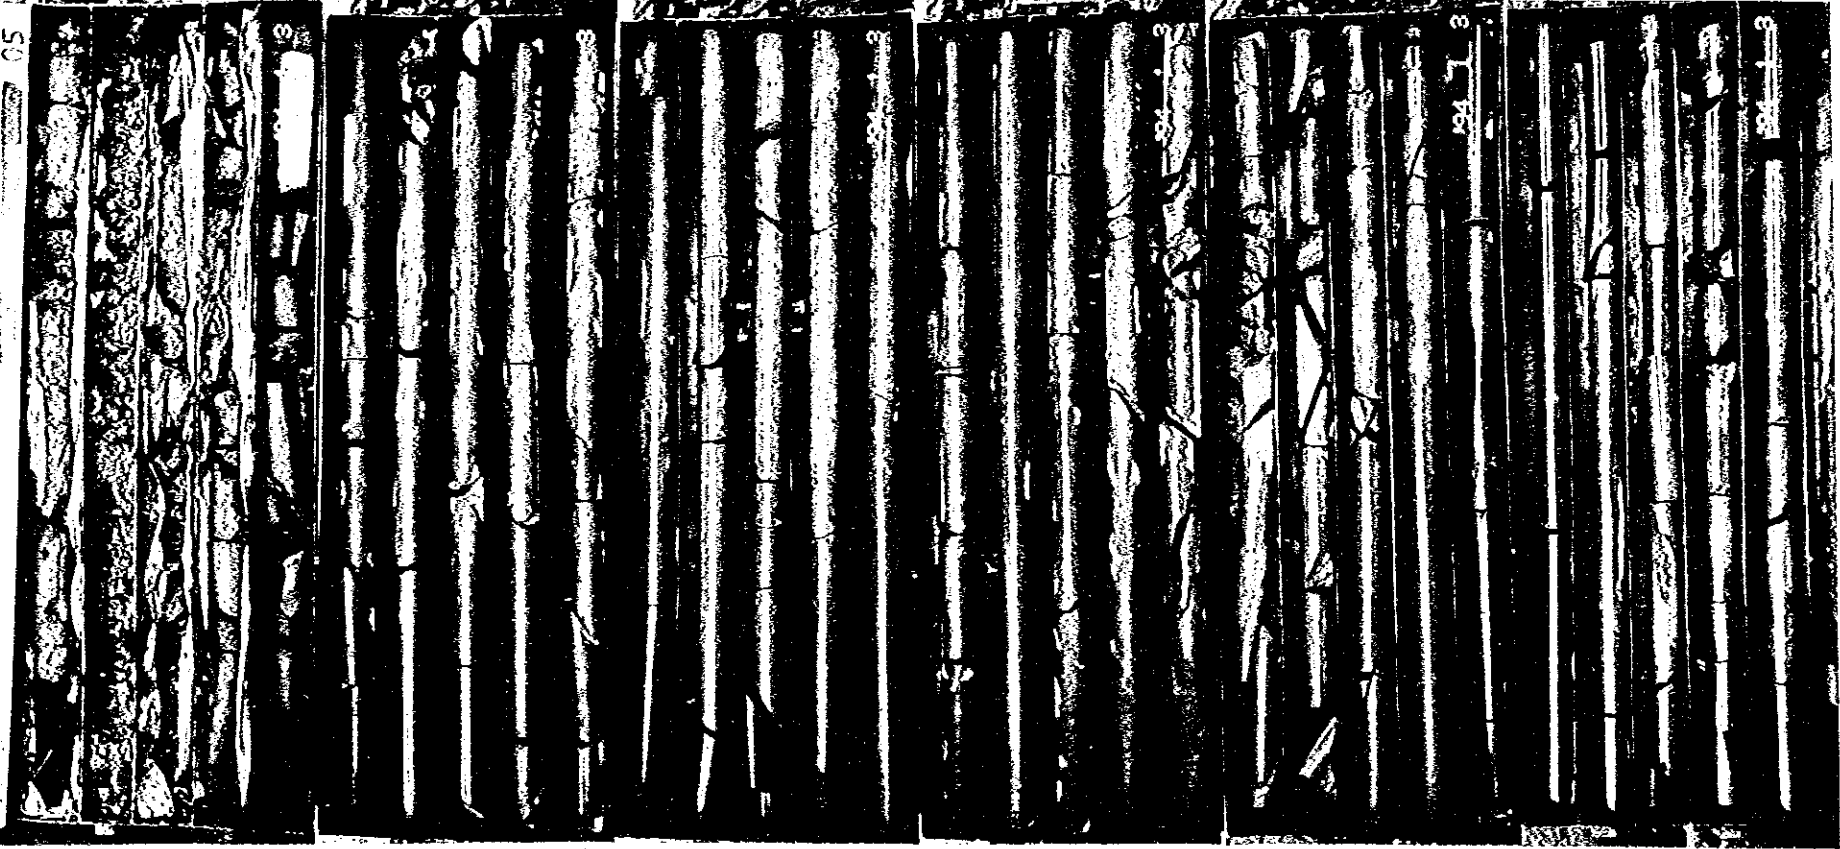
Photo 3.1.2 Drilling Core Photograph of Bore Hole No. A - 2 (1 of 3)

Bore Hole No. : A-2  
 Location : Quarry Site  
 Ground Elevation : EL. 563.482 m  
 Total Depth : 90 m  
 Depth : 0 ~ 30 m
