ADDITIONAL GEOLOGICAL SURVEY
 FOR THE DETAILED DESIGN OF FLOOD CONTROL,
 URBAN DRAINAGE AND WATER RESOURCES DEVELOPMENT IN
 IN SEMARANG IN THE REPUBLIC OF INDONESIA

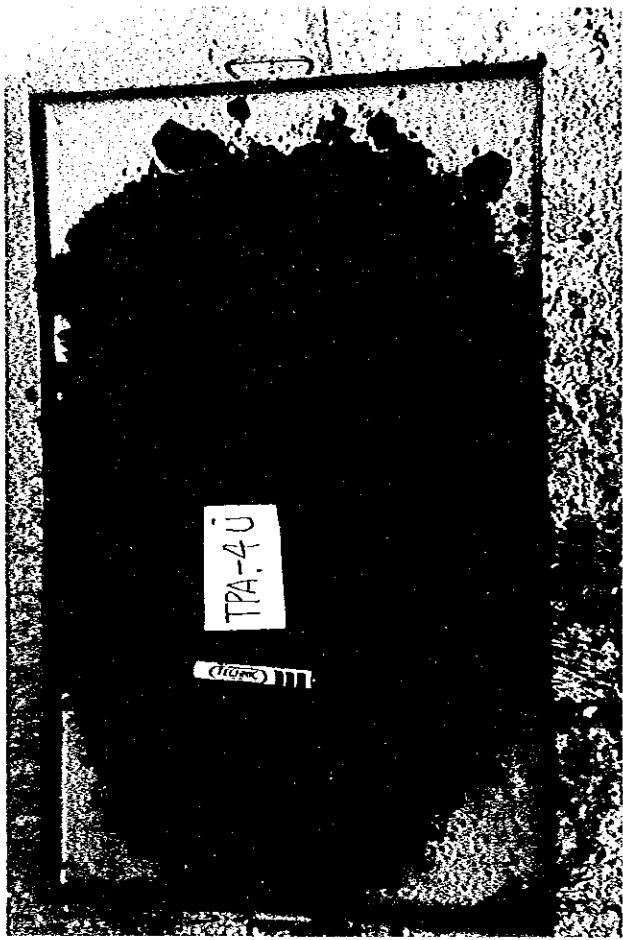
Photo 3.2.51 Photograph of Selected Fine Materials for Laboratory Testing taken from TPA - 4U, depth 1.50 m

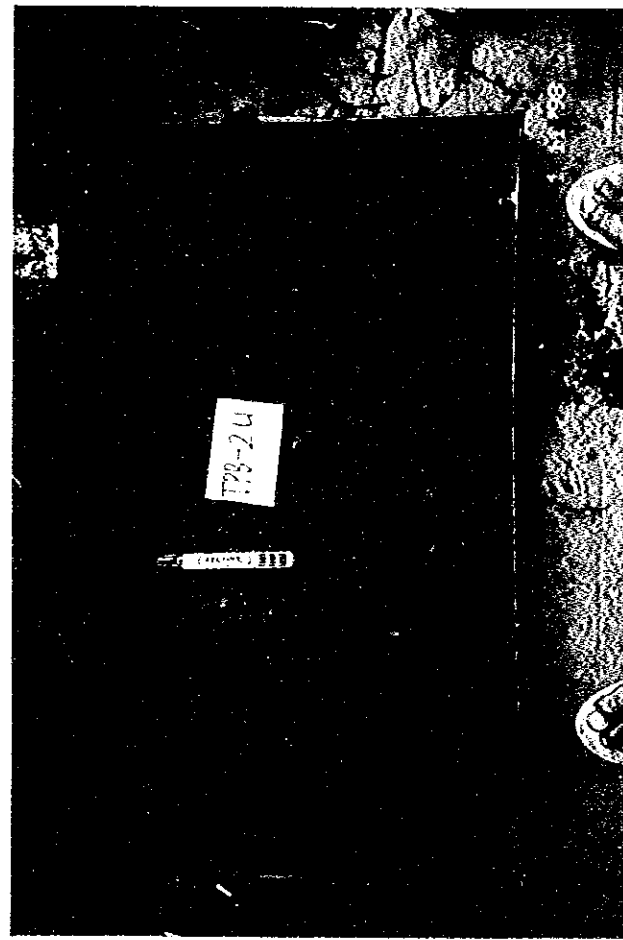
Photo 3.2.55 Photograph of Selected Fine Materials for Laboratory Testing taken from TPB - 2U, depth 2.00 m

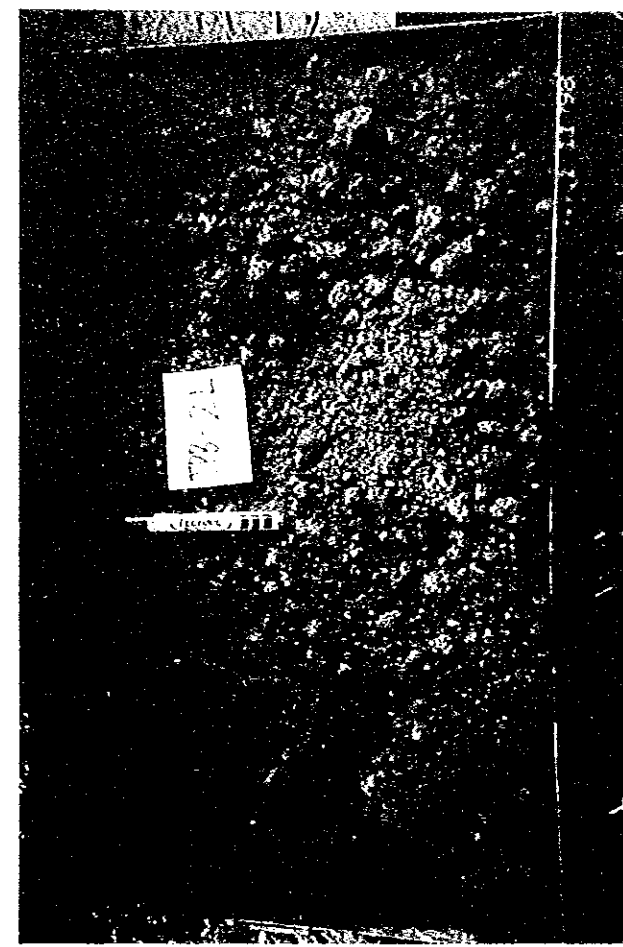
Photo 3.2.56 Photograph of Selected Fine Materials for Laboratory Testing taken from TPB - 2L, depth 4.00 m

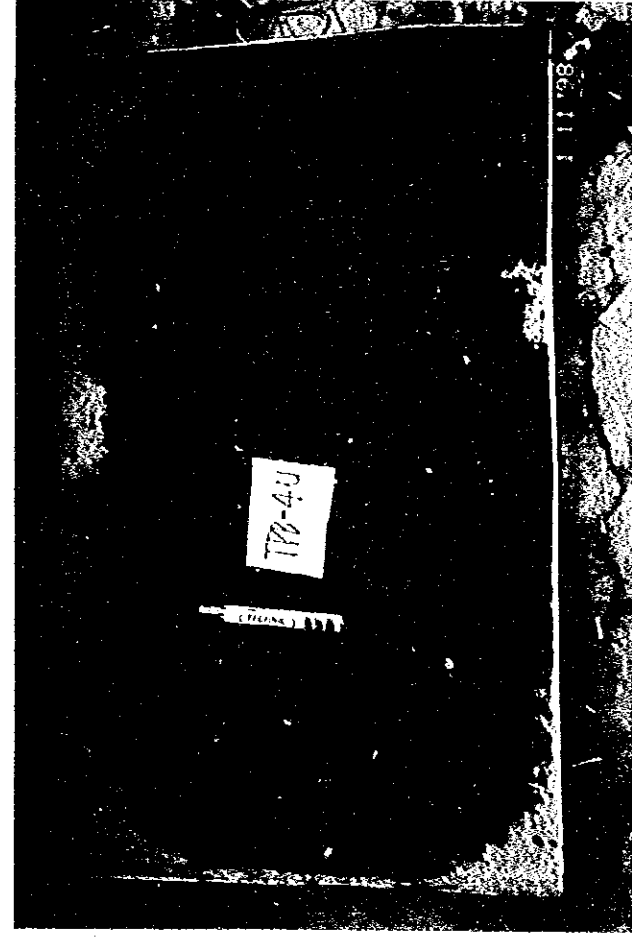
Photo 3.2.59 Photograph of Selected Fine Materials for Laboratory Testing taken from TPB - 4U, depth 2.50 m

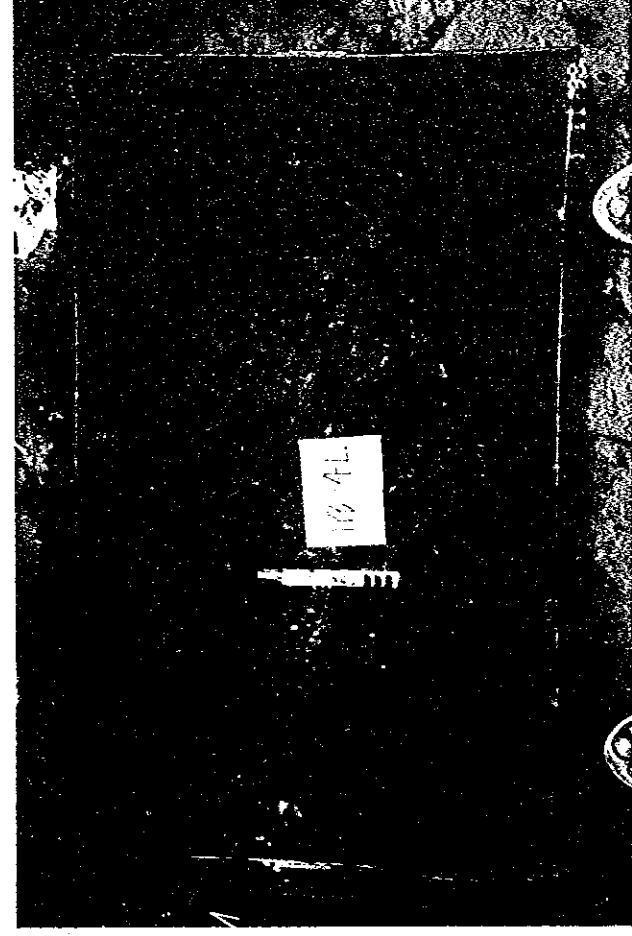
Photo 3.2.60 Photograph of Selected Fine Materials for Laboratory Testing taken from TPB - 4L, depth 4.50 m

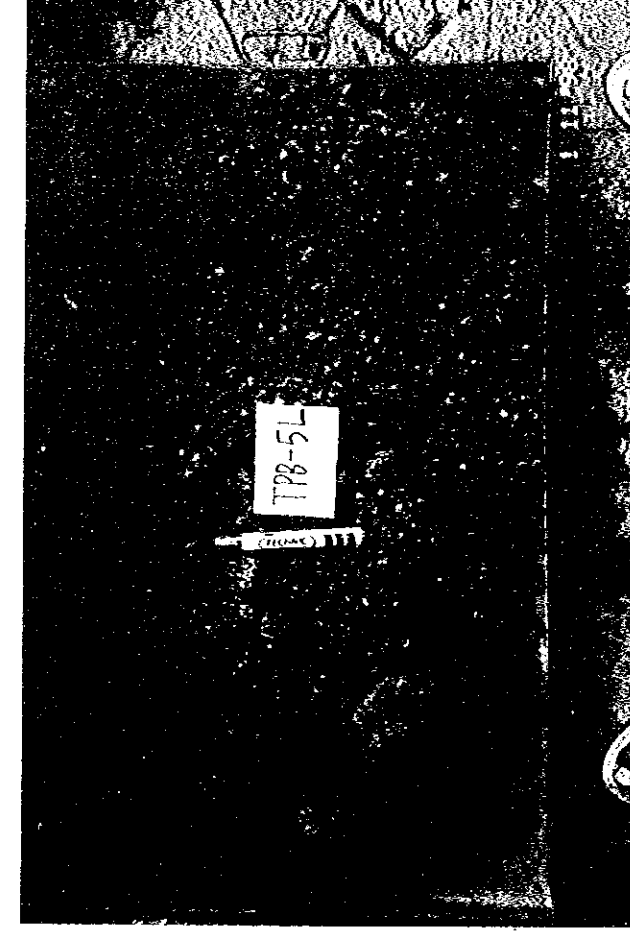
Photo 3.2.62 Photograph of Selected Fine Materials for Laboratory Testing taken from TPB - 5L, depth 4.50 m

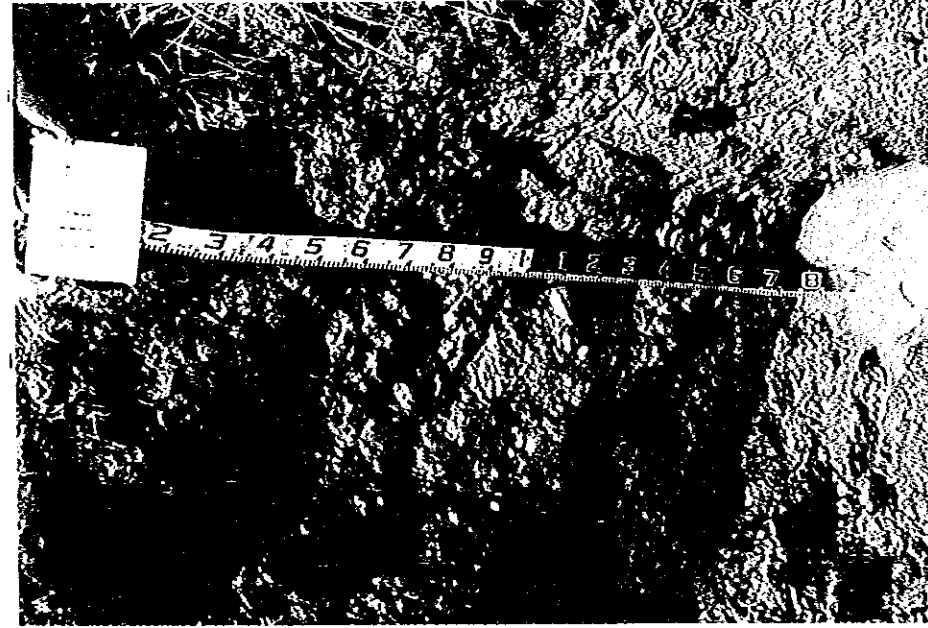
Photo 3.3.14 Test Pit No. TPC - 7 Photograph

Test Pit No. : TPC - 7
Location : Borrow Area C
Ground Elevation : EL. 124.184 m
Total Depth : 2.50 m
Depth : 0 ~ 2.50 m
