19.3 Mangrove Aqua Culture

19.4 Air Quality and Car Traffic

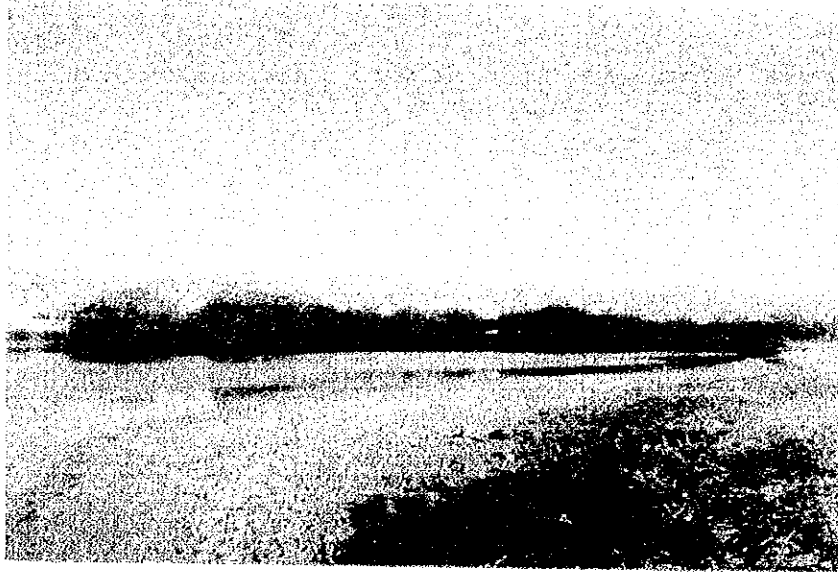
PLATE 1

EXTENT OF MANGROVES IN THE KHAWR AL QURM KABRI

Figure 19.3.2 and Plate 1 illustrate the distribution of mangrove in this area. This mangrove lay to the North east of the Salalah Hilton. The mangroves in the stand are *Avicennia marina*. The maximum height of the stand is 4-5m.

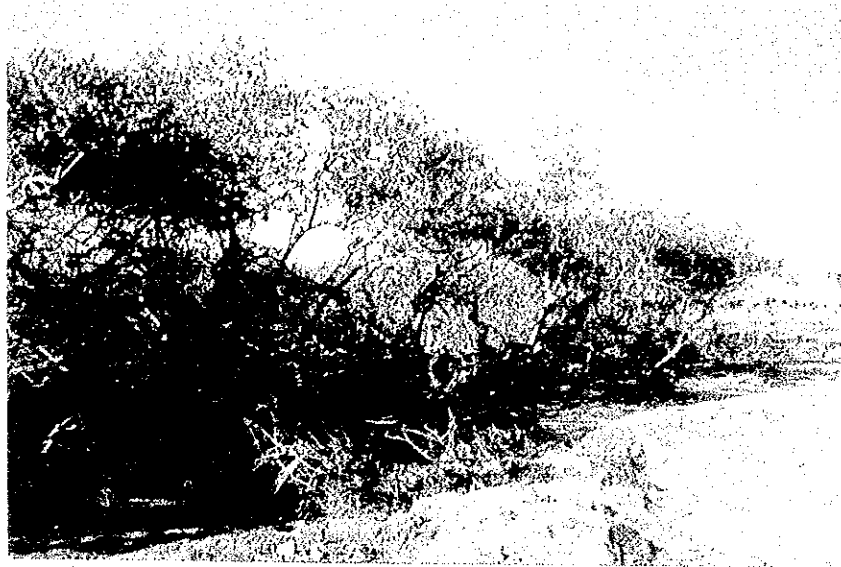
PLATE 3

THE MANGROVES ON THE NORTH EAST SIDE OF THE KHAWR

The mangrove trees were limited to the landward half (NW end) of the khawr. Parallel with the road the mangroves trees were most dense (see Plate 2). Trees along NE fringe were very bare except at top of tree (Plate 3). The mangrove trees depleted towards the seaward end, and the South East (nearest the sea) was devoid of mangroves (see Figure 19.3.2 and Plate 4).

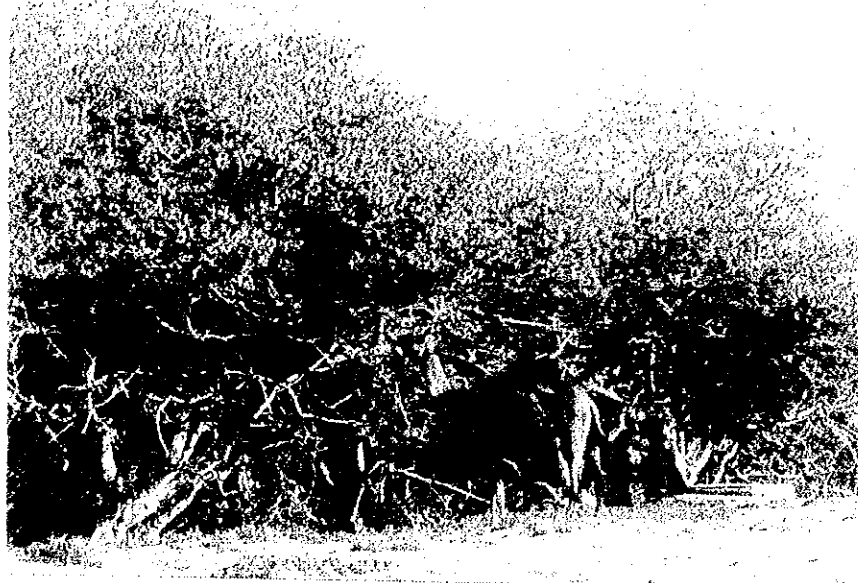
PLATE 7

Goats were kept on the NE side of the khawr (Plate 6), and empty feed bags were observed littering the mangrove roots. The feed was kept in cages/sheds, which were covered, in plastic sheeting. Camels wandered freely within the mangrove area, grazing the trees (Plate 7) and low lying vegetation growing on the surrounding land.

CAMEL GRAZING ON MANGROVE

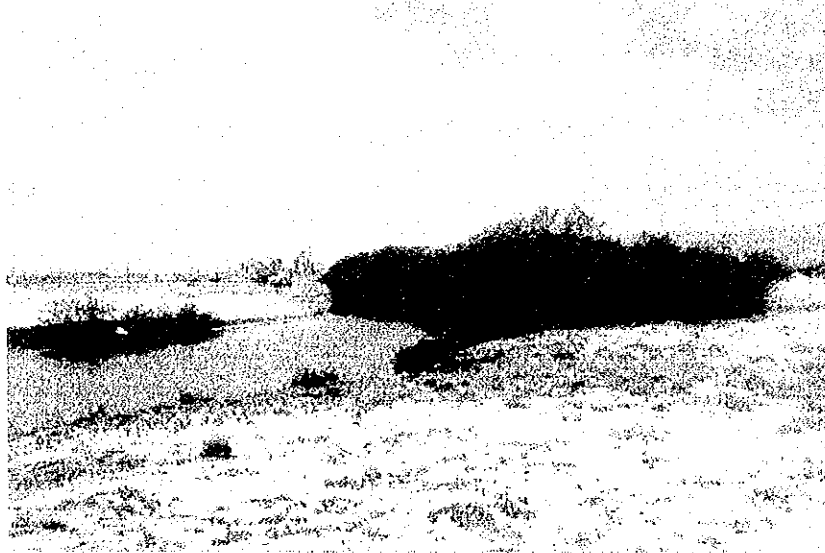
PLATE 9

DENSE MANGROVE AT THE ROADSIDE

The mangrove species present in the Khawr was *Avicennia marina*. The substrate of the khawr was more sandy than the other mangrove area and was firmer underfoot. The mature mangrove trees at the end of the khawr by the road formed a dense stand that averaged 4-5m in height (see Plate 9).

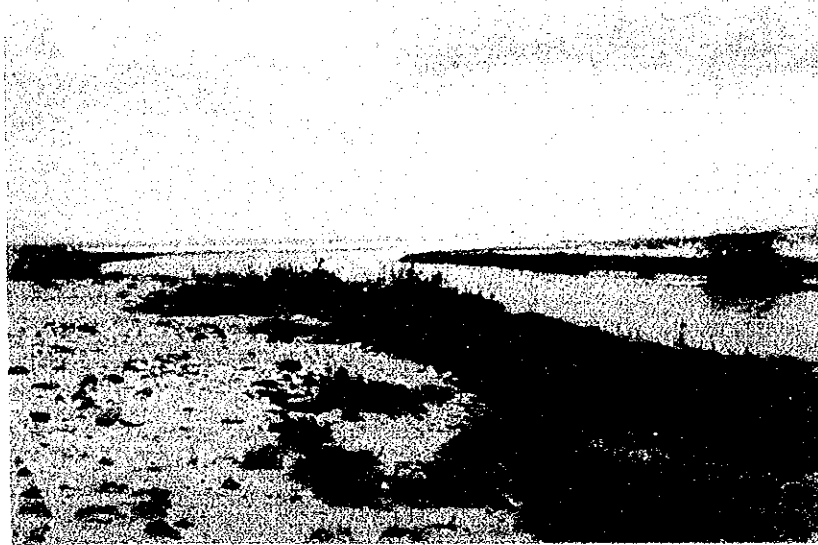
PLATE 11

THE SEAWARD END OF THE KHAWR WAS DEVOID OF MANGROVE

There were a high proportion of seedlings (50-70 cm height) at the edge of the mangrove stand (Plate 10). At the seaward end the banks were devoid of vegetation (see Figure 19.3.3 and Plate 11).

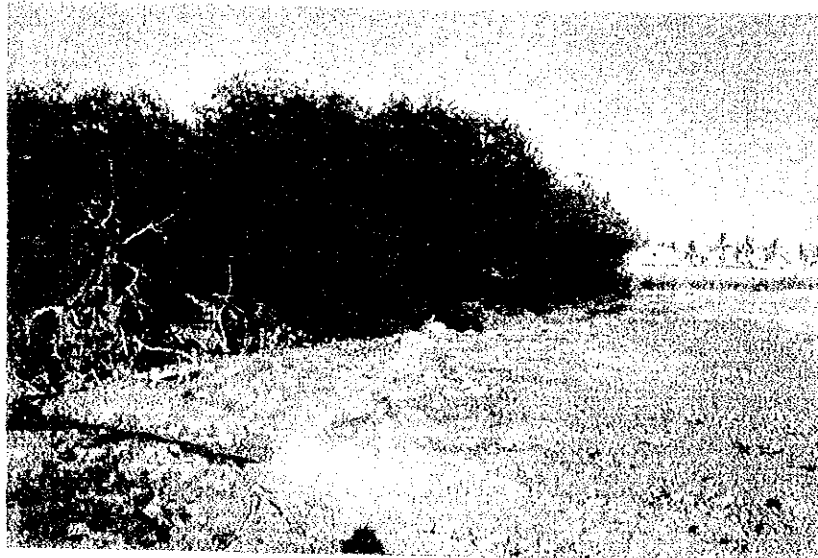
PLATE 12

RUBBLE WAS PRESENT ON THE SHORES OF THE KHAWR

The West shore showed evidence of mans influence where tarmac and rubble had been tipped next to the khawr (Plate 12).

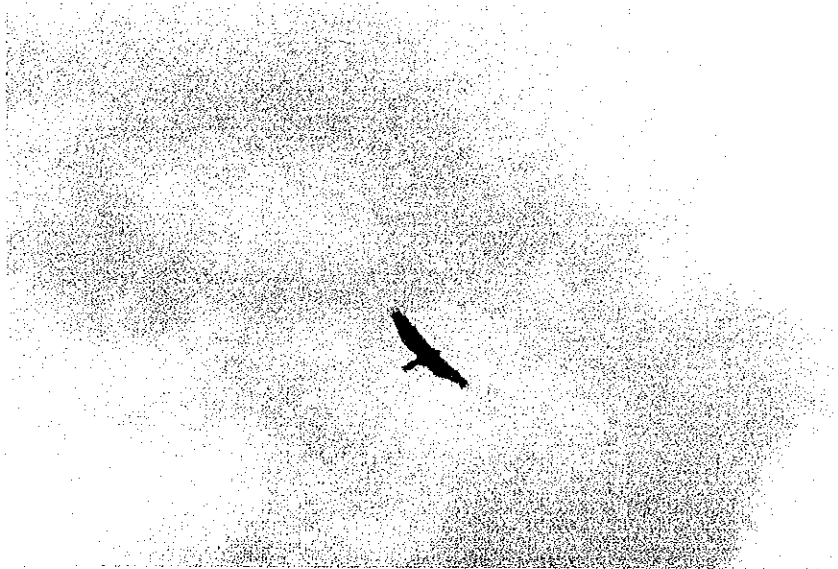
PLATE 13

Bird species observed during the study period included, Marsh Harriers (*Circus aeruginosus*)(Plate 13), Palm Doves (*Streptopelia senegalensis*) and an African Paradise Flycatcher (*Terpsiphone viridis*) in the mangrove trees. Feeding in the khwar were Curlew (*Numenius arquata*) (Plate 14), Little Green Heron (*Butorides striatus*), Grey Heron (*Ardea cinerea*) (Plate 15), Great White Egret (*Egretta alba*) and Plover (*Chradrius* sp.).

**MARSH HARRIER [CIRCUS AERUGINOSUS] SOARING ABOVE
MANGROVE STAND**

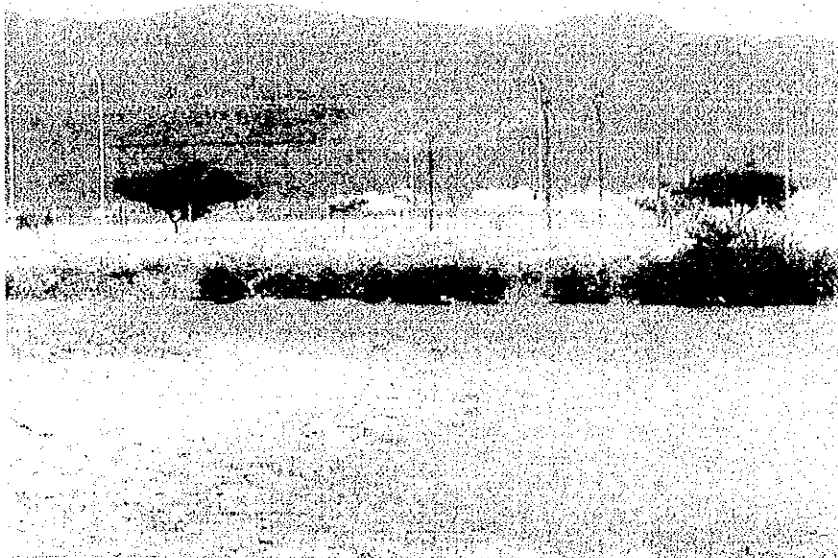
PLATE 14

A PAIR OF CURLEW [NUMENIUS ARQUATA] FEED AT WATERS EDGE
