(32) Tra Tan (Tien Giang Province)

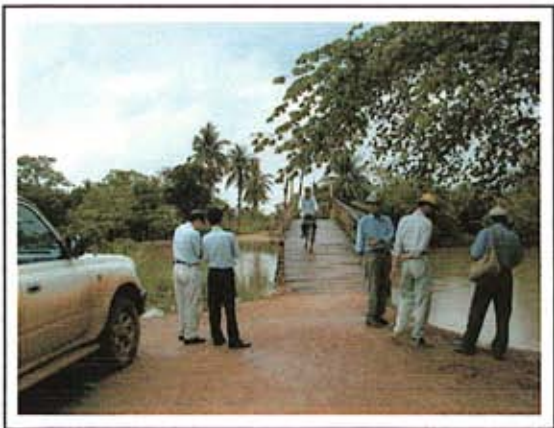
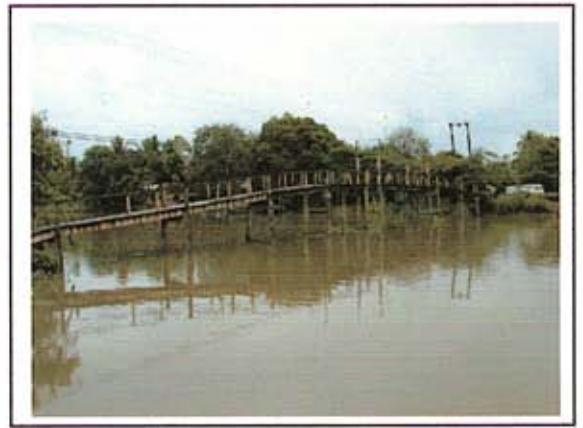
Picture 1: ①

- 1) Existing vertical clearance is 3.0m, 4.5m requested by the Department of Transport.
- 2) A bridge with 8.0 ton capacity is found on the access road.
- 3) Construction of temporary jetty and demolition of existing bridge are necessary.

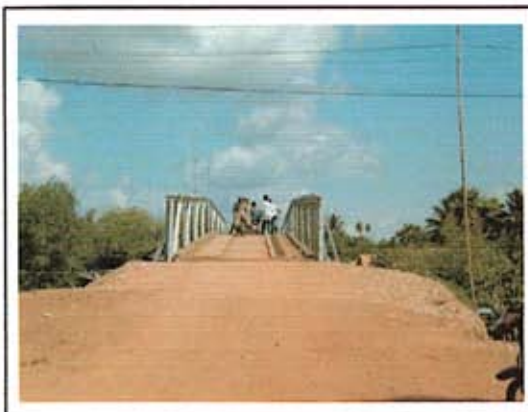
Picture 1 : ①

- 1) Existing bridge capacity 4t. Substructure reinforced in January 2000.
- 2) Planned load capacity 18t.
- 3) 48 hour closure to traffic during construction is permitted.
- 4) Proposed to retain the existing bridge, construct the new structure parallel to the existing.

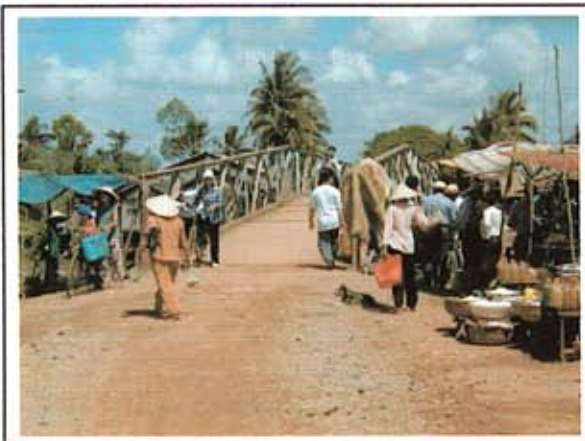
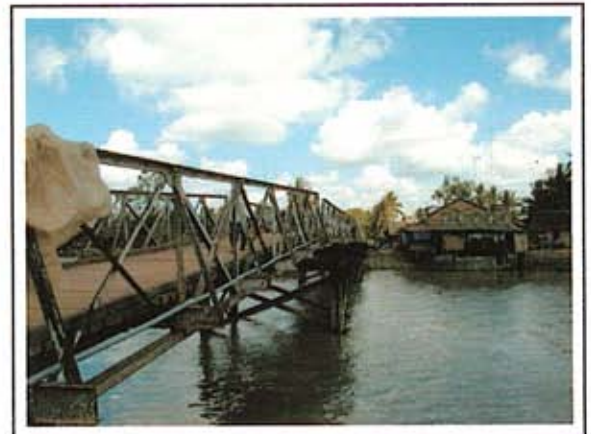
Picture 1 : ①

- 1) Piers added in 1999
- 2) Vertical clearance 3.5m required.
- 3) Towns on both banks are subject to flooding.
- 4) Bridge carries fresh water supply pipe
- 5) Optical fiber cables planned to be added in near future
- 6) Steel elements widely and seriously corroded.

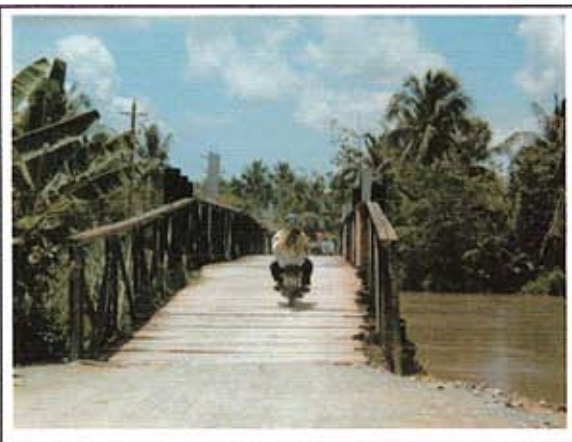
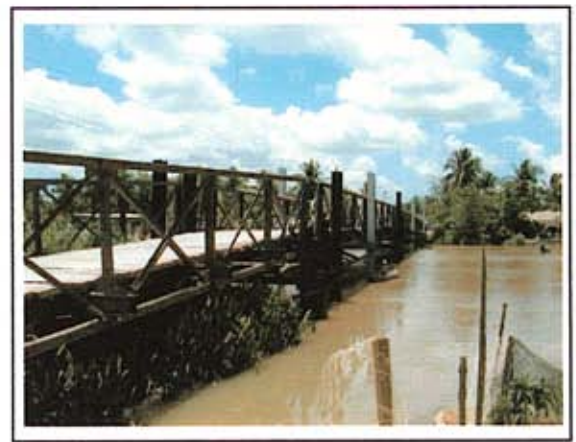
Picture 1 : ①

- 1) As reinforcement piers have been constructed between the original piers using steel H beams
- 2) Approach roads on both banks are being improved.
- 3) Vertical clearance of 3m is required according to Dept. of Transport
- 4) The existing bridge may be relocated and used as a temporary bridge.

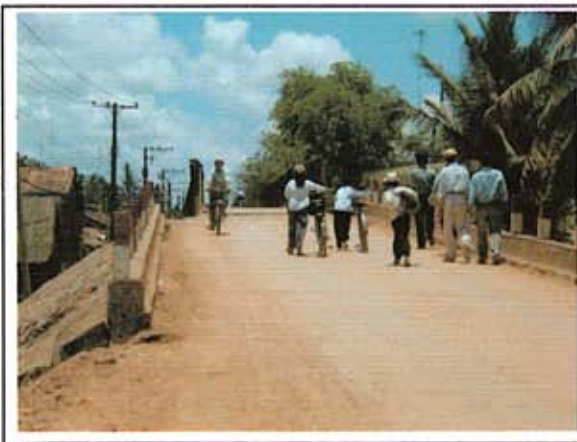
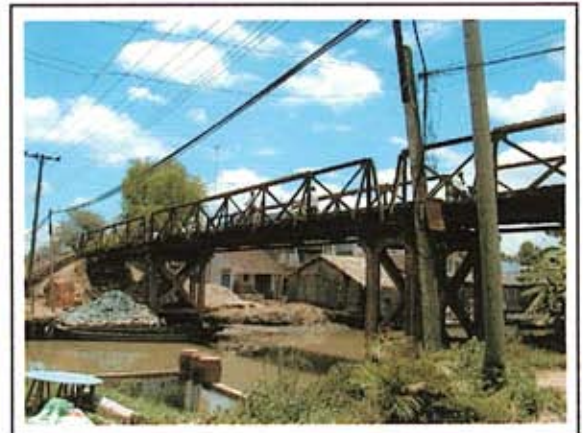
Picture 1 : ①

- 1) Steel elements widely and seriously corroded.
- 2) Approach road improved in 1986
- 3) No risk of flood damage as dams have been constructed upstream and downstream.
- 4) Consequently vertical clearance may be reduced by 2.5m below existing allowance
- 5) Necessary to construct a temporary jetty, and to demolish the existing bridge.
- 6) The next bridge Ranh Tong has a weight limit of 4t therefore imposition of an 8t limit on this bridge would not be worthwhile.

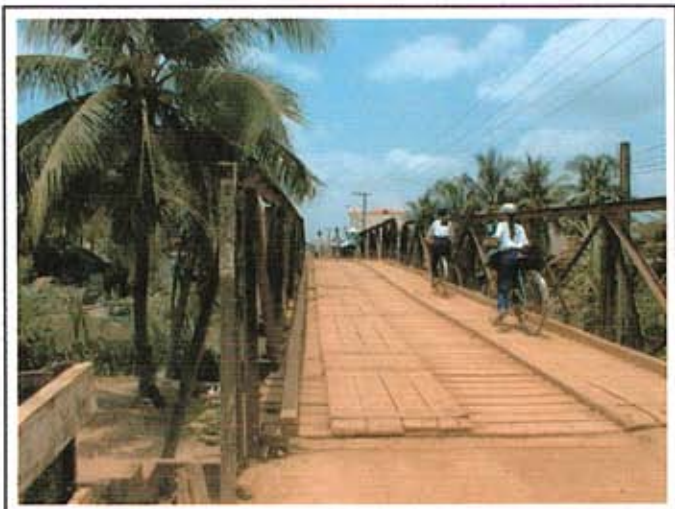
Picture 1 : Existing bridge

Other Information:
1) Necessary to cross the Vam Co River by ferry in order to reach the site
2) Many houses present around the bridge

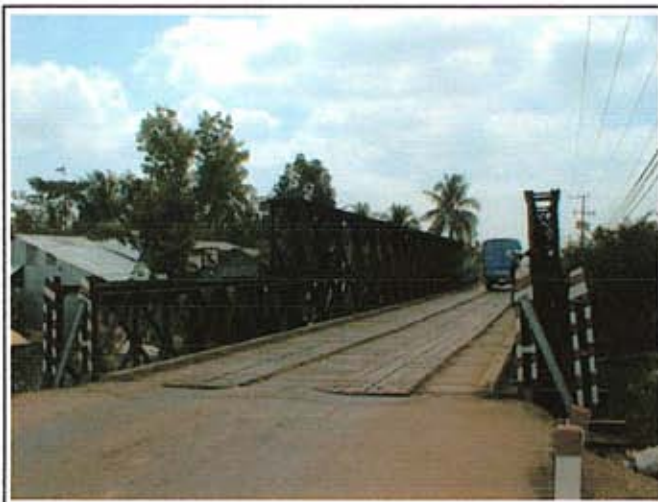
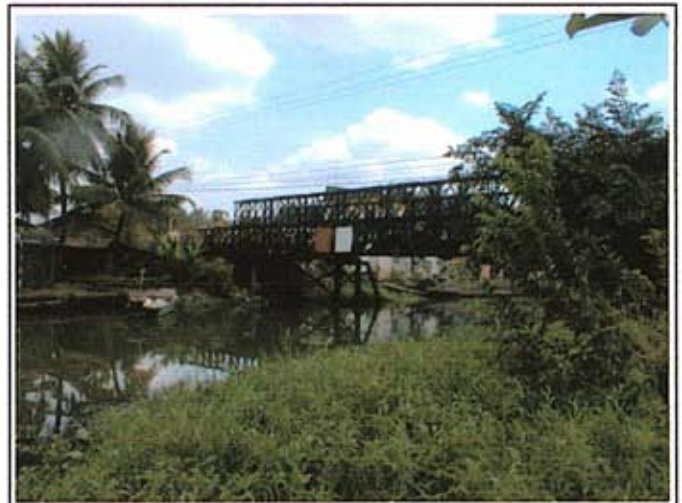
Picture 1 : Existing bridge

- 1) Existing Bailey-type truss bridge much deteriorated
- 2) Closed to cars/trucks due to dangerous condition. Access only for motorcycles/pedestrians
- 3) Difficulty transporting agricultural produce such as sugar cane to Binh Phuoc as no suitable route.
- 4) Deemed to be an important route in Tay Ninh Province
- 5) FS completed
- 6) Traffic controlled by army
- 7) No ferry service, only small fishing boat available
- 8) Connecting Tay Ninh and Binh Phuoc Provinces. Need to confirm responsibility for management and control.

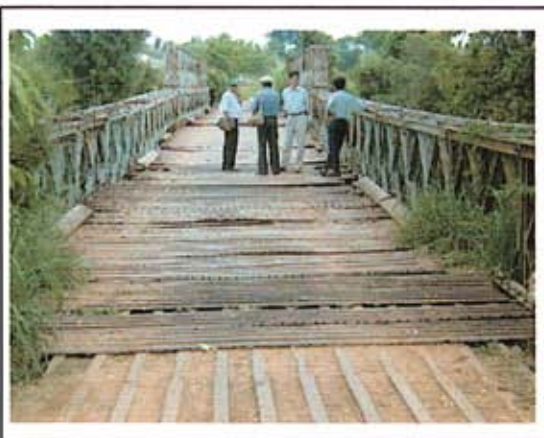
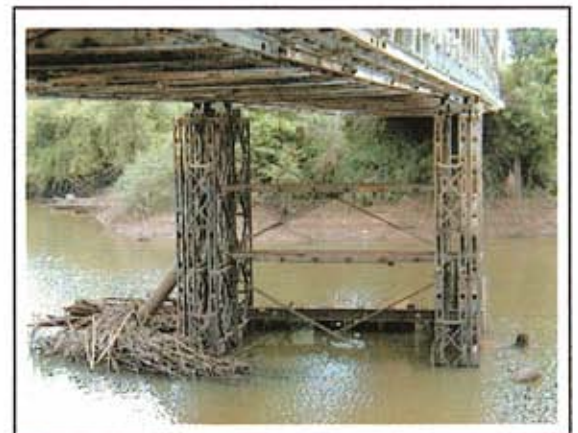
Picture 1 : ①

<b>Other Information:</b>
1) Minority tribes living nearby
2) Frequently trafficked by fully laden sugar cane trucks. Vibration and sway observed as the truck passes. Estimated loading 37t.
3) Flood water covered bridge deck in 1999.

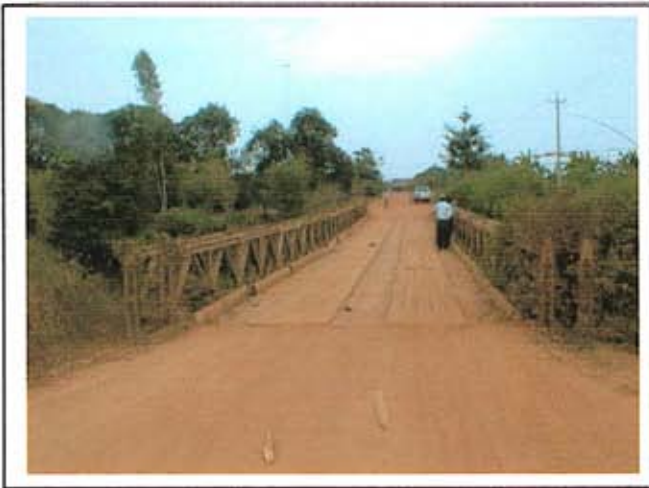
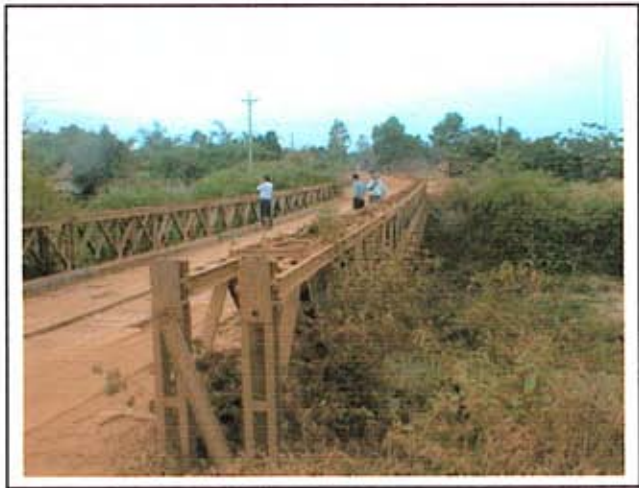
Picture 1 : Existing bridge

- 1) Minority tribes living nearby.
- 2) Collapsed in 1994, later recovered
- 3) Sign indicates load limit of 10t, but actually used by heavier vehicles
- 4) Difficult access due to serious rutting of approach road.
- 5) Approach road being improved and asphalt-paved by WB finance, to be completed in 2000.

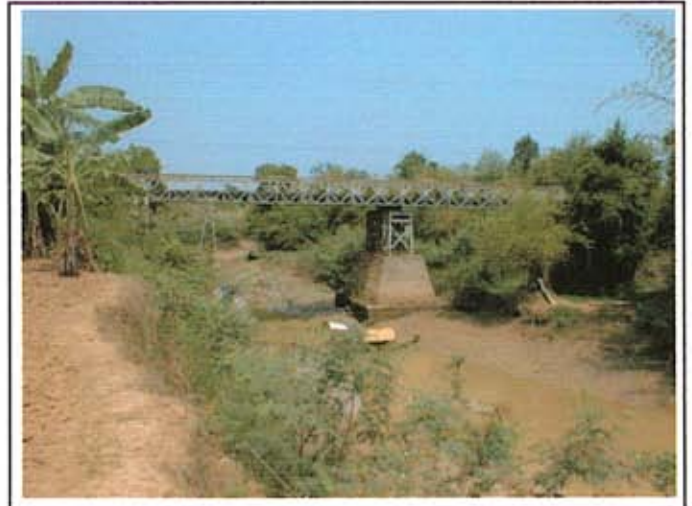
Picture 2: Existing bridge

- 1) As the three other bridges, this is also on Provincial Road No. 746. Difficult to prioritize any of the four bridges as conditions are the same on all of them, i.e. bridge type, degree of deterioration, although bridge lengths do vary.
- 2) The closest bridges to NH No. 13 are Chua, Rach Ro, Rach Goc and Vung Gam in that order
- 3) Attention to be paid to water level of Dong Nai River in deciding proposed height.

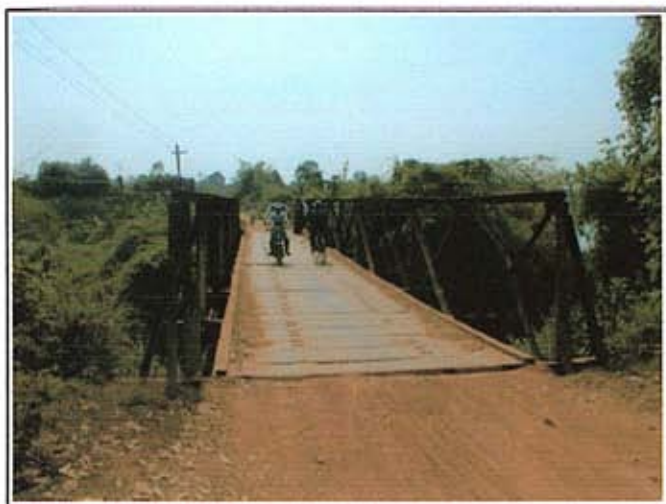
Picture 1 : Existing bridge

- 1) As the three other bridges, this is also on Provincial Road No. 746. Difficult to prioritize any of the four bridges as conditions are the same on all of them, i.e. bridge type, degree of deterioration, although bridge lengths do vary.
- 2) The closest bridges to NH No. 13 are Chua, Rach Ro, Rach Goc and Vung Gam in that order
- 3) Attention to be paid to water level of Dong Nai River in deciding proposed height.

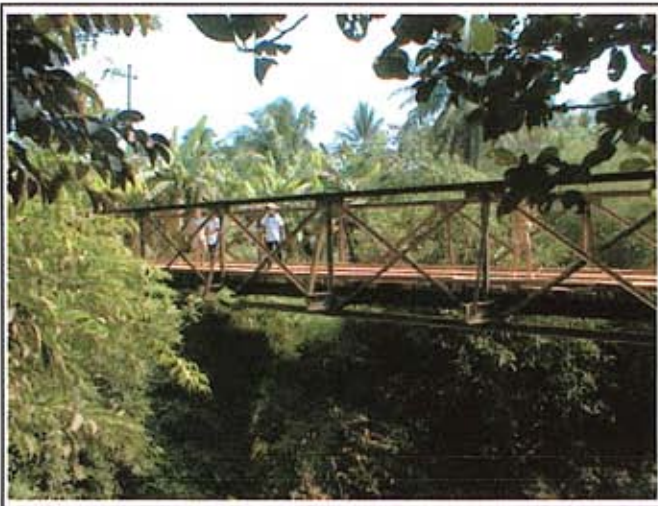
Picture 1 : Existing bridge

- 1) As the three other bridges, this is also on Provincial Road No. 746. Difficult to prioritize any of the four bridges as conditions are the same on all of them, i.e. bridge type, degree of deterioration, although bridge lengths do vary.
- 2) The closest bridges to NH No. 13 are Chua, Rach Ro, Rach Goc and Vung Gam in that order
- 3) Attention to be paid to water level of Dong Nai River in deciding proposed height.

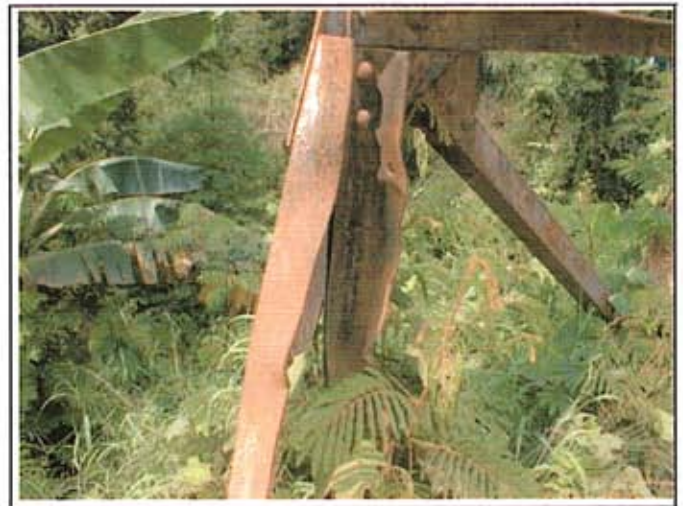
Picture 2 : Existing bridge

- 1) As the three other bridges, this is also on Provincial Road No. 746. Difficult to prioritize any of the four bridges as conditions are the same on all of them, i.e. bridge type, degree of deterioration, although bridge lengths do vary.
- 2) The closest bridges to NH No. 13 are Chua, Rach Ro, Rach Goc and Vung Gam in that order
- 3) Attention to be paid to water level of Dong Nai River in deciding proposed height.
- 4) Local people want a PC bridge that can be constructed using aggregate extracted from the nearby quarry

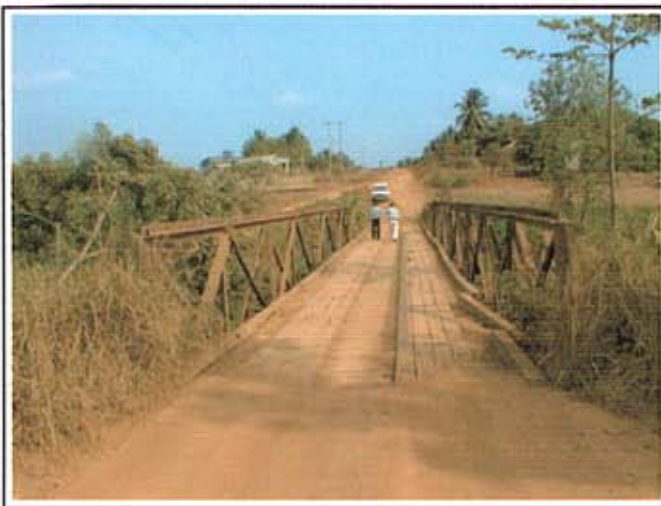
Picture 1 : Existing bridge

- 1) Inadequate capacity prevents passage of trucks. Possible to cross in the riverbed, but difficult in the rainy season.
- 2) Proposed elevation dependant on high water level
- 3) Girder supply type bridge not a problem for the local Dept. of Transport

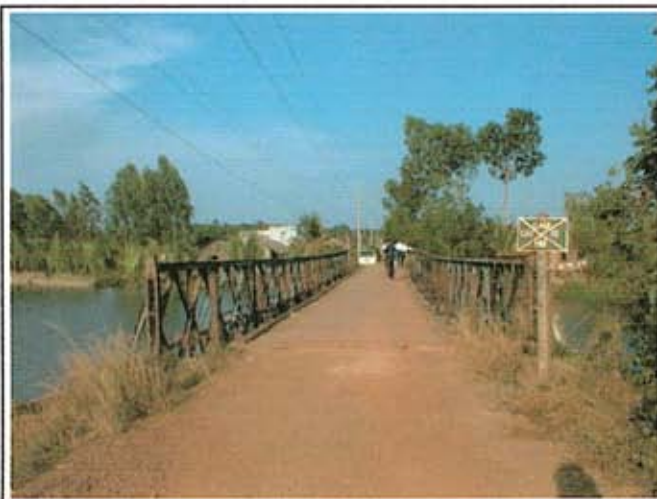
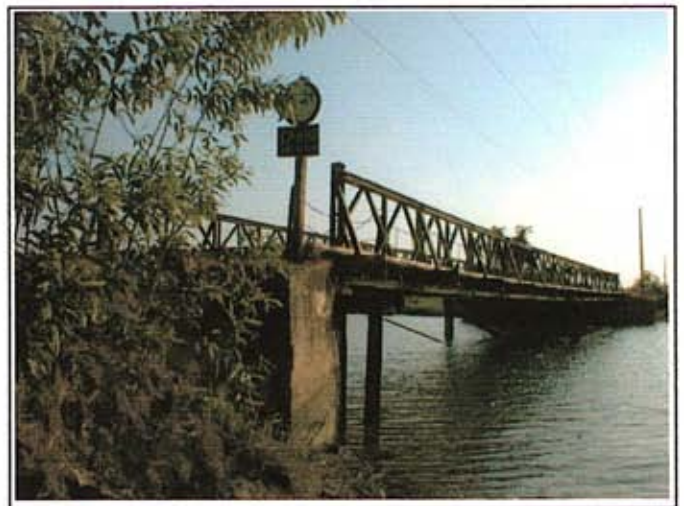
Picture 1 : Present bridge

- 1) Present bridge seriously understrength
- 2) No problem envisaged for bridge construction

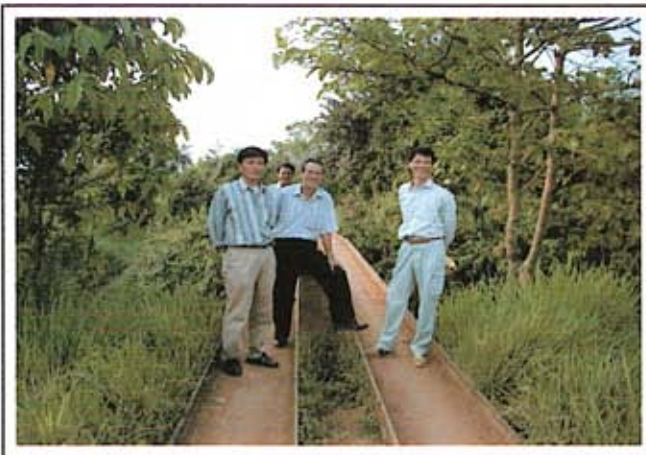
Picture 1 : Existing bridge

- 1) Need to construct temporary jetty and to demolish existing bridge

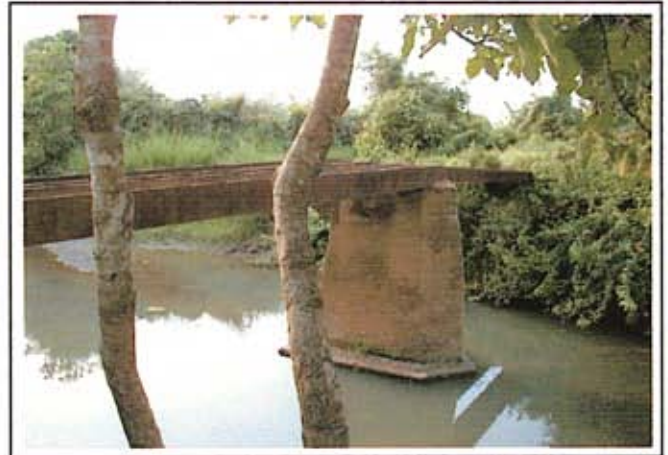
Picture 2 : Side view

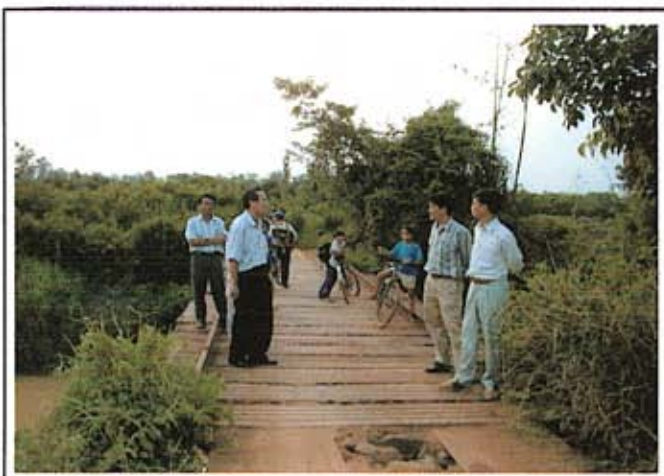
Picture 1 : ①

- 1) Road improvement planned to widen bridge to 6m width by the Government and the village with a target date of June 2000
- 2) Agricultural produce is loaded from larger vehicles to 2 ton trucks before the bridge.
- 3) No need to construct a temporary bridge. Center line for new bridge to be offset upstream.

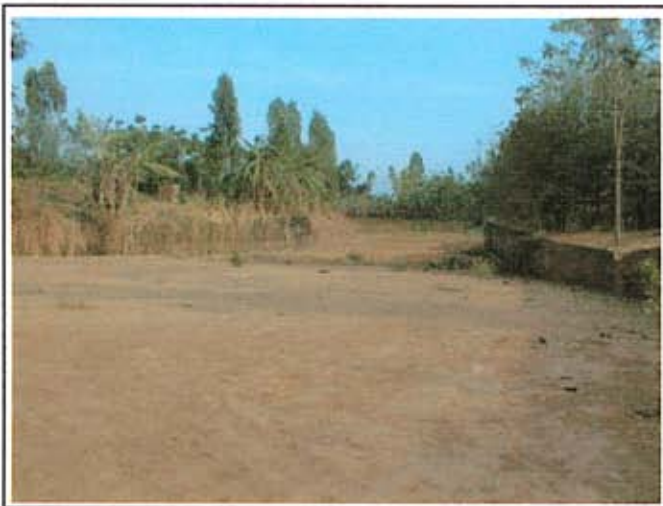
Picture 1 : Proposed location

1) To be constructed over spillway from irrigation dam. The spillway is protected against erosion. No water in dry season, hence easy construction conditions.

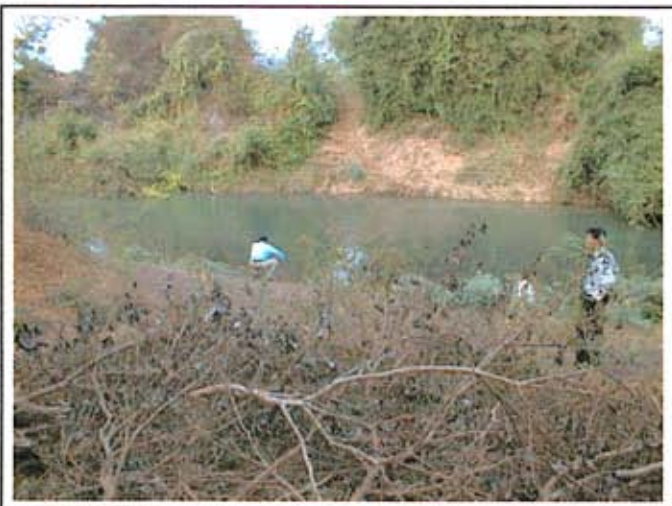
Picture 1 : Proposed location

Other Information:
1) Access road not yet constructed. Only access is a 5km walk from Xuan Son-Hoi Ba road, which is a narrow road in poor condition.
2) It is still too early to construct this bridge, and it is not recommended
3)

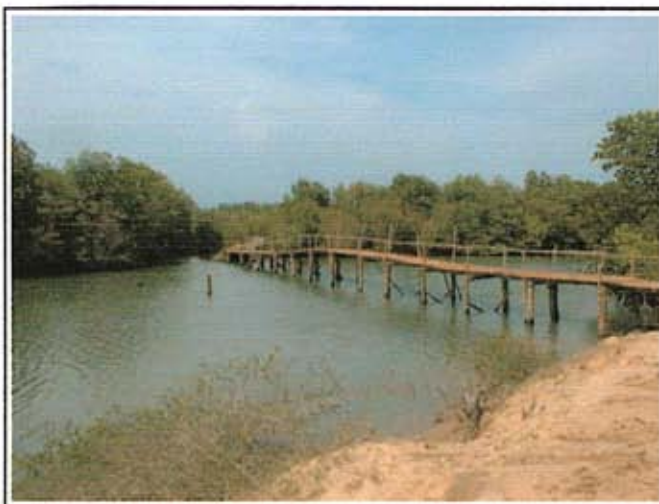
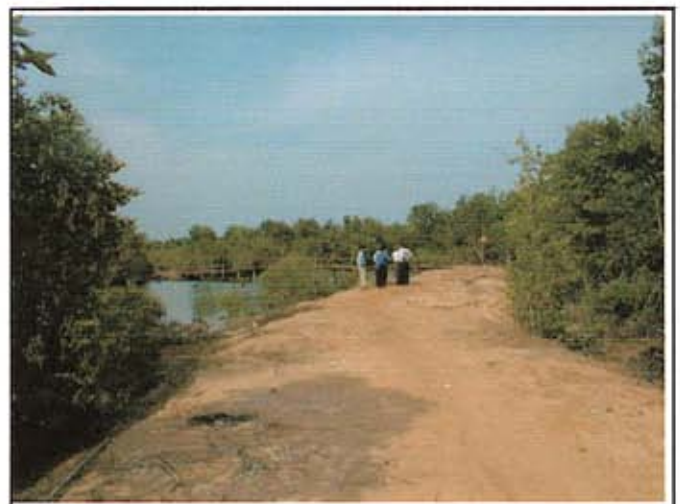
Picture 1 : Temporary bridge

- 1) Temporary timber bridge has access for pedestrians and motorcycles only.
- 2) Possibility of developing agricultural land of 200ha at the side of Provincial Road No. 44A
- 3) On completion, connected to NH No. 55, Provincial Road No. 44A, town road Loc An-Phuoc Long Tho and again to NH No. 55.

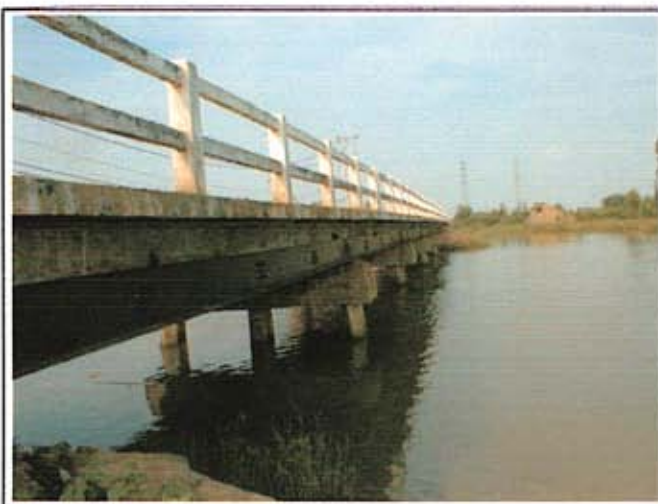
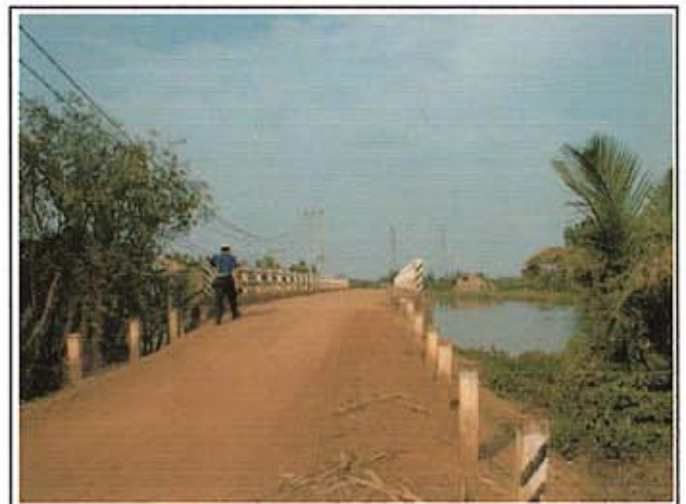
Picture 1 : Existing bridge

- 1) Access road is narrow and restricted by narrow bridges
- 2) The bridge condition has not deteriorated substantially. It was originally designed as a low capacity bridge.

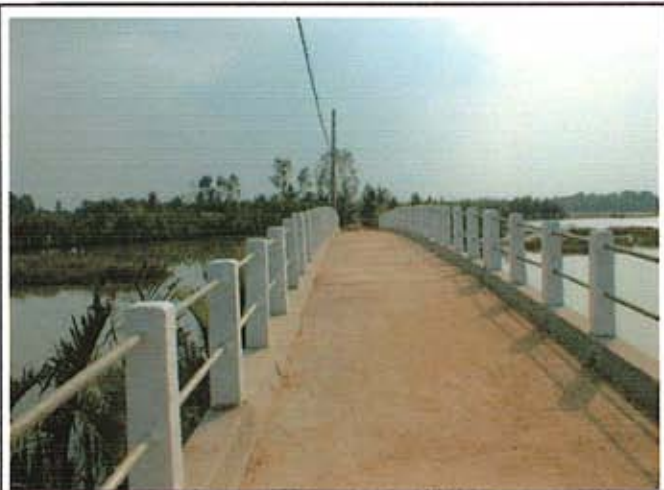
Picture 1 : Completed bridge

1) Bridge construction already completed.
