CLIENT	DESIGNER	DATE
NATIONAL WATER SUPPLY AND DRAINAGE BOARD THE PROJECT FOR THE REDUCTION OF NON-REVENUE WATER IN THE GREATER COLOMBO AREA	JICA

PROJECT TITLE	NO. OF SHEETS	SHEET NO.
TOWER - 1500m <sup>3</sup> CAPACITY GENERAL ARRANGEMENT

THE DETAILED DESIGN STUDY ON THE PROJECT FOR REDUCTION OF NON-REVENUE WATER IN THE GREATER COLOMBO AREA IN THE DEMOCRATIC SOCIALIST REPUBLIC OF SRI LANKA

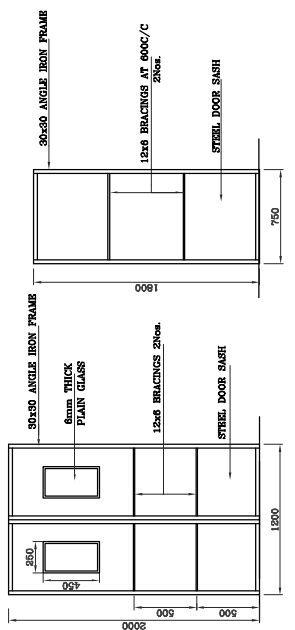
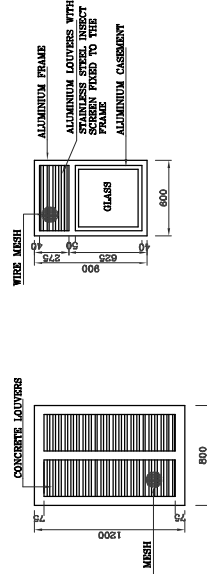
**DETAILS OF DOORS & WINDOWS**

**DA - No.**  
 ① - 1900x500 STEEL DOOR  
 3 Nos. STEEL HINGERS (TO BE FABRICATED AS REQUIRED)  
 1 No. MORTICE LOCK  
 2 Nos. TOWER BOLTS

**DB - No.**  
 ② - 750x500 STEEL DOOR  
 3 Nos. STEEL HINGERS (TO BE FABRICATED AS REQUIRED)  
 1 No. MORTICE LOCK  
 1 No. TOWER BOLTS

**YC - No.**  
 ③ - 800x1200  
 CONCRETE WINDOW WITH FIXED CONCRETE LOUVERS  
 WITH STAINLESS STEEL WIRE [8BY GAUGE 16]  
 12x12 MESH OUTER FACE.

**YD - No.**  
 ④ - 600x900  
 GLAZED ALUMINUM WINDOW WITH FIXED ALUMINUM  
 LOUVERS & STAINLESS STEEL WIRE [8BY GAUGE 16]  
 12x12 MESH ABOVE OUTER FACE OPERABLE GLASS  
 OPERABLE GLASS WINDOW AS SHOWN ON  
 TOWER DRG.

**YB - No.**  
 ⑤ - 1500x1500 STAINLESS STEEL  
 GAUGE 161 BEM MESH  
 FRAMED ON 100mm x 60mm  
 STAINLESS STEEL PLATS

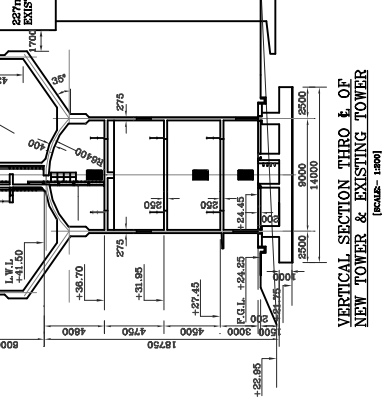
**VERTICAL SECTION THRO TH OF  
 NEW TOWER & EXISTING TOWER**

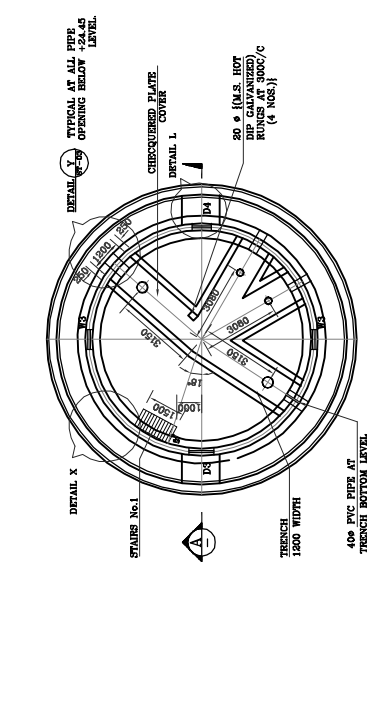
**SECTION C** [SCALE - 1/100]

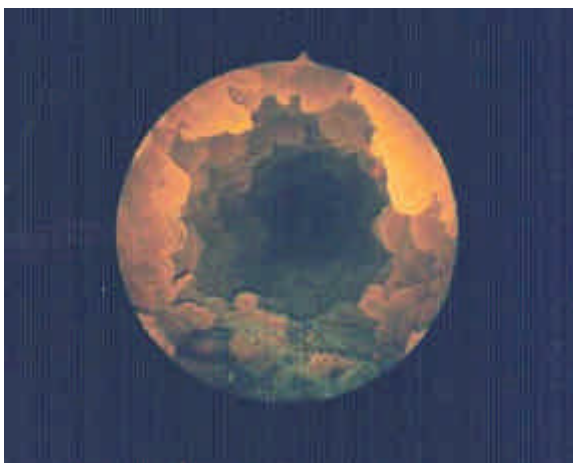
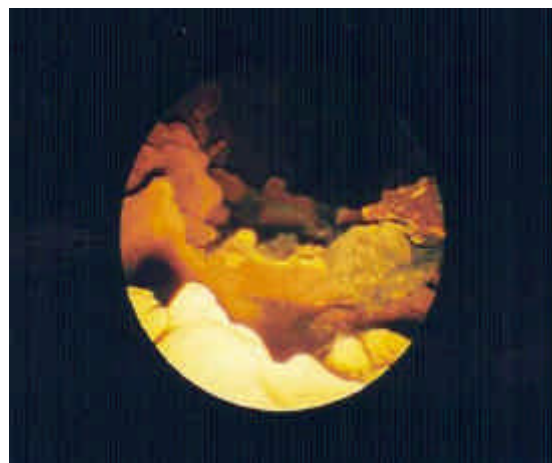
At various parts of the distribution system, the study team observed the internal conditions of existing cast iron mains using a rigidscope. The photographs below demonstrate typical internal conditions of existing cast iron pipes. Heavy encrustation has already developed inside the pipe leaving only a limited waterway space.

The use of the rigidscope allows the observation without disrupting service and minimizes the time required for the assessment.
