Figure 5.1 (1/2) Classification of section by slope soundness condition (existing Tribhuvan Highway)

5.4 Evaluation of the Existing Tribhuvan Highway

CHAPTER 6 ENGINEERING SURVEY AND ANALYSIS

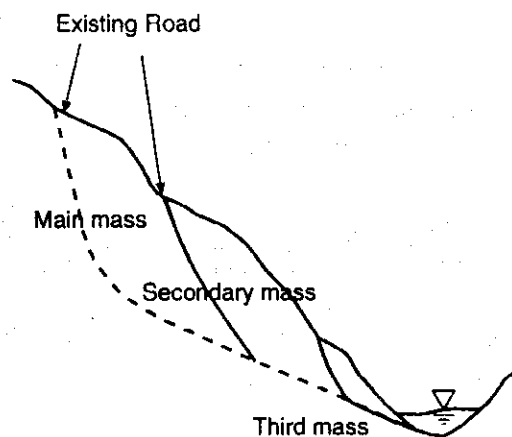
Figure 5.3 The conceptual profile of dormant landslide

On the other hand a dormant huge landslide is also identified near hairpin curve through aerial photo observation. This landslide magnitude reaches 300m in width and about 500m in length. This landslide can be divided into three slide mass. Main mass covers from stream to near ridge including the existing road. Top scarp of main mass can not be observed clearly although a landform feature of upper portion is so disturbed. The slip surface of secondary mass is estimated to cross near the low side existing road. Last mass is located on the lower portion of main mass. This landslide mass can be estimated slightly active (gradually moving). Scouring of toe of the mass due to the stream flow is considered to accelerate instability of the landslide. The conceptual profile can be shown in Figure 5.3. Although it can not be judged when this huge landslide may actually collapse, it must be judged that the existing road will be fatally damaged, if it happens.

- Furthermore one huge dormant landslide is identified in hairpin curve area. The landslide has a magnitude of 300m in width and 500m in length, and the scouring of toe of the landslide mass by stream flow is considered to accelerate instability of the landslide. Since the existing road is passing at top of the landslide and middle of the landslide, it must be considered that the existing road will be fatally damaged, if actual collapse of the landslide happens.

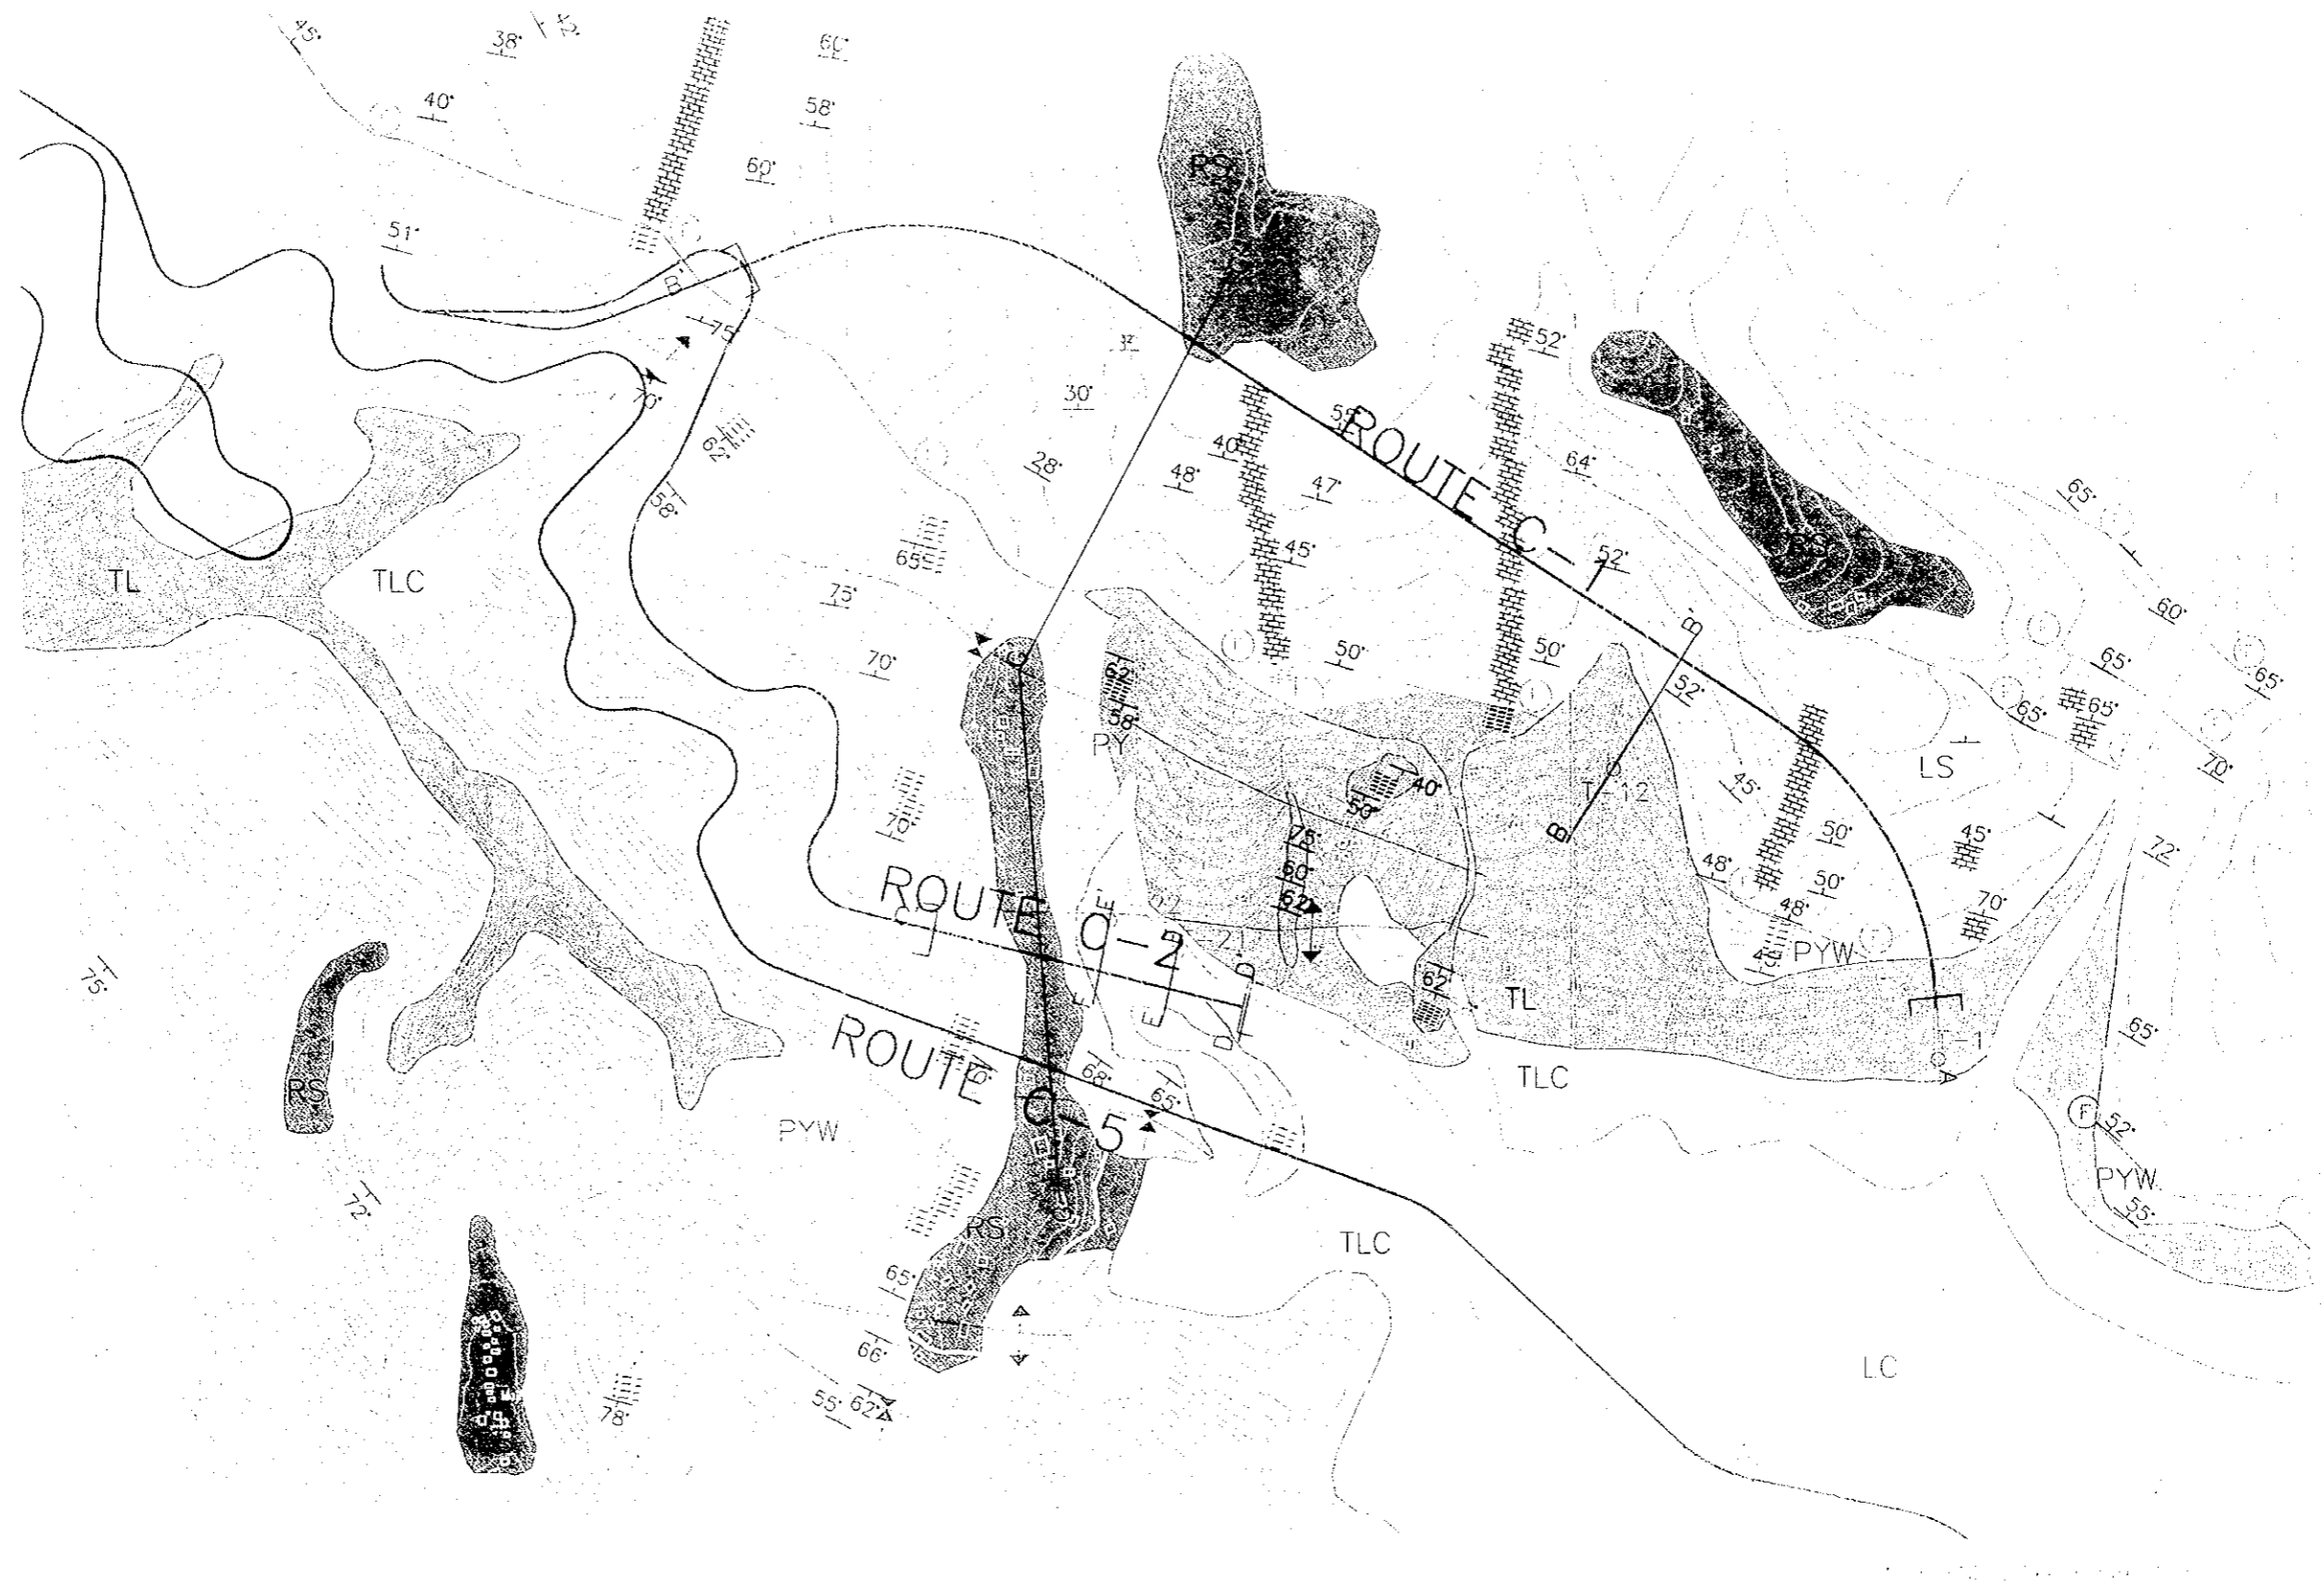
Figure 6.4 Geological Map of Bhimdhunga Pass Area

The summary of the completed quantity of above works is presented in Table 6.5, and the location of Boreholes is as shown in Figure 6.3. Geological map of the area in the vicinity of Bhindhunga Pass is prepared based on the surface geological survey and presented in Figure 6.4.
