Figures

The Study on Critical Land and Protection Forest Rehabilitation at Tondano Watershed in the Republic of Indonesia

Japan International Cooperation Agency

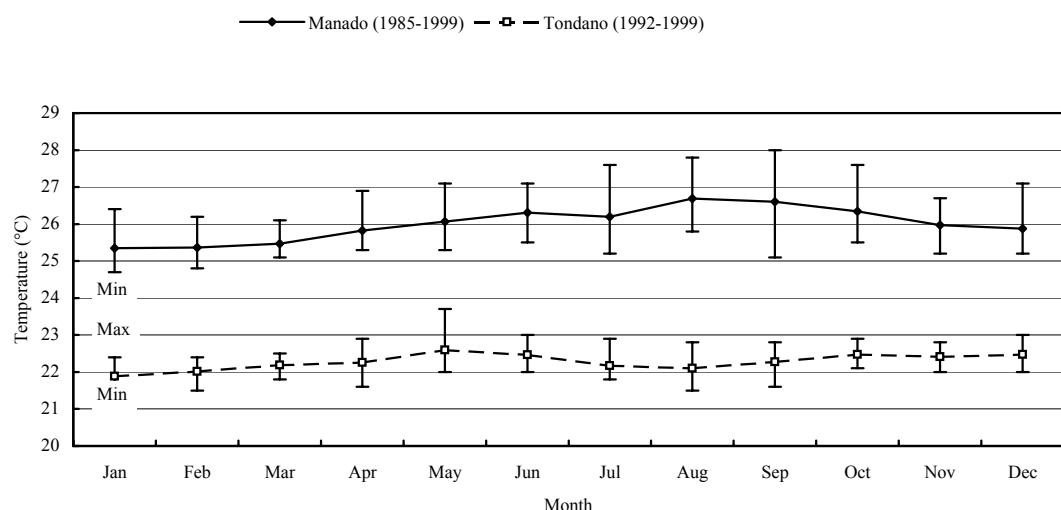
Figure C.2.2
Monthly Mean Temperature & Relative Humidity

(1) Monthly Mean Temperature

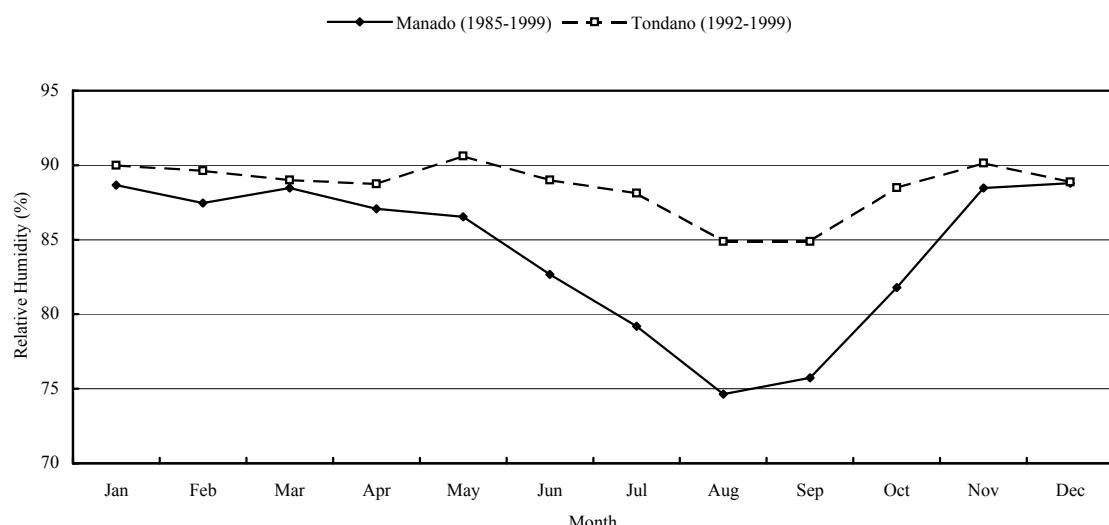
(2) Monthly Mean Relative Humidity
