*L'étude de Faisabilité Pour Le Développement des Ressources En Eau
Par Les Barrages Moyens Dans Le Milieu Rurale Au
Royaume Maroc
Rapport Final
Volume VII Livre de Donnees*

Livre de Donnees SO Études des Sols

Investigation du Terrain et Profiles du Sol dans la Zone Prioritaire du Projet

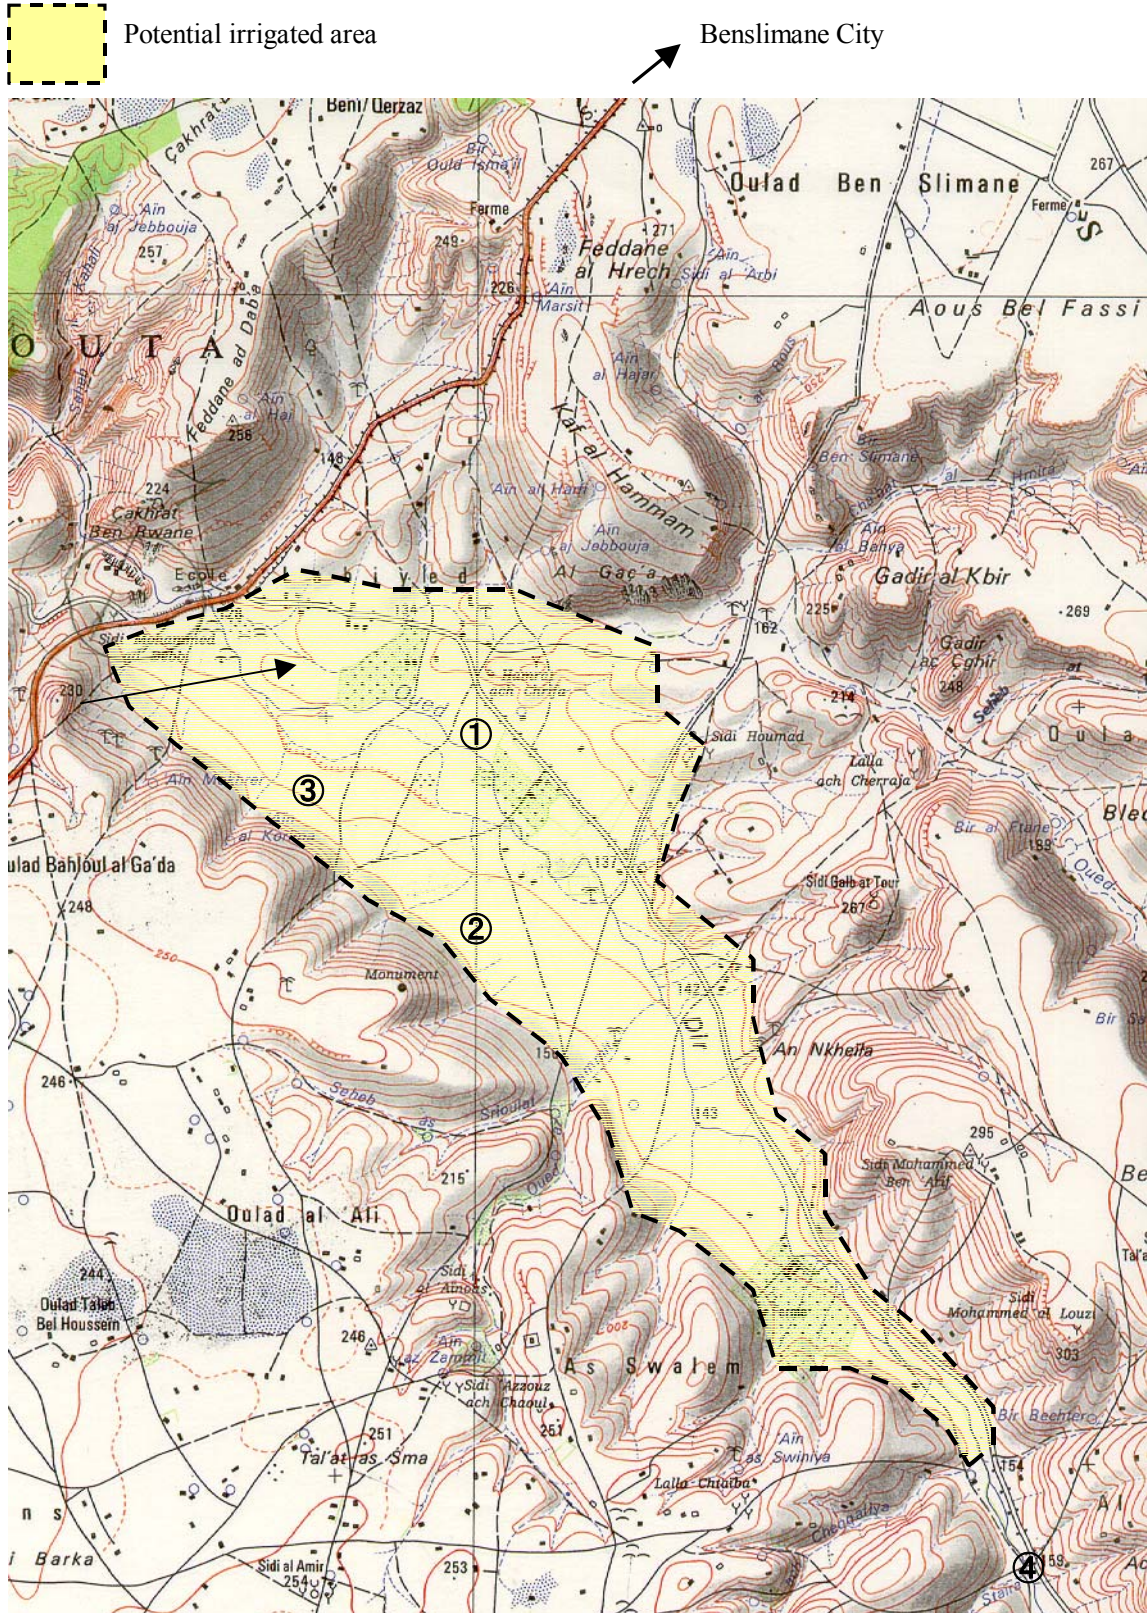
1) Area of Soil Survey

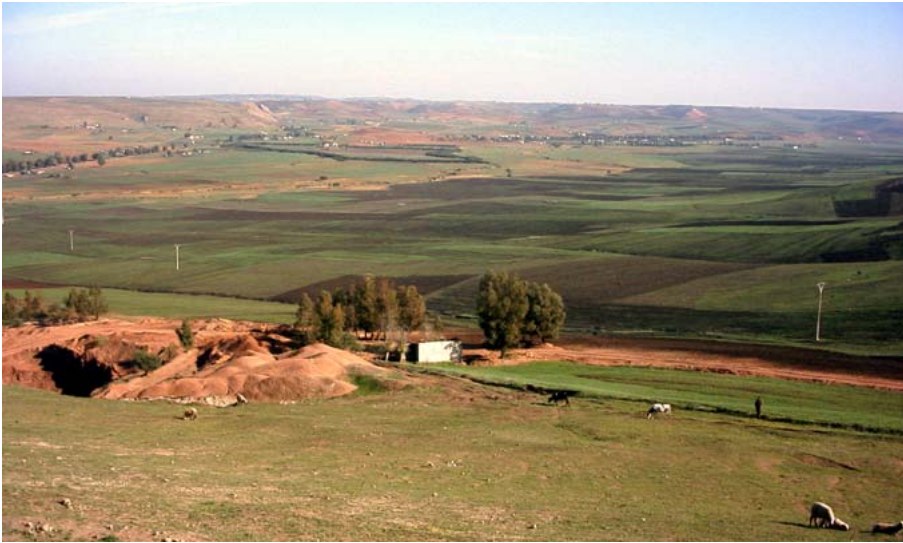
Photo No.1

View of Potential
Irrigable Area
(13th Dec. 2000)
View from the
direction of
allow on the Map

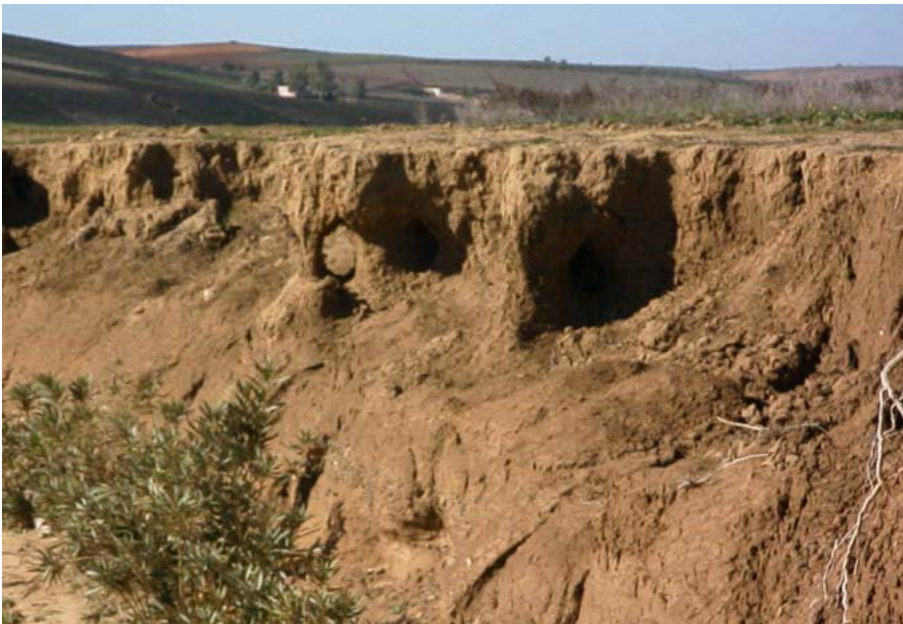
Photo No.2

Soil Erosion and
Profile along River
Bank
(Border of Survey
Area in Upstream
of N'Fifikh River)

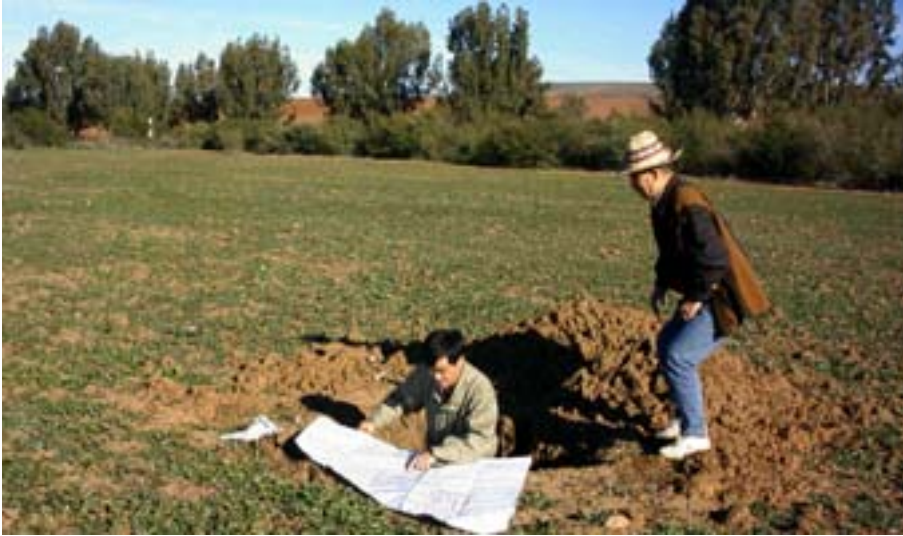
Photo No.3
Point ①
Soil Profile
Investigation
(Isohumic soil)

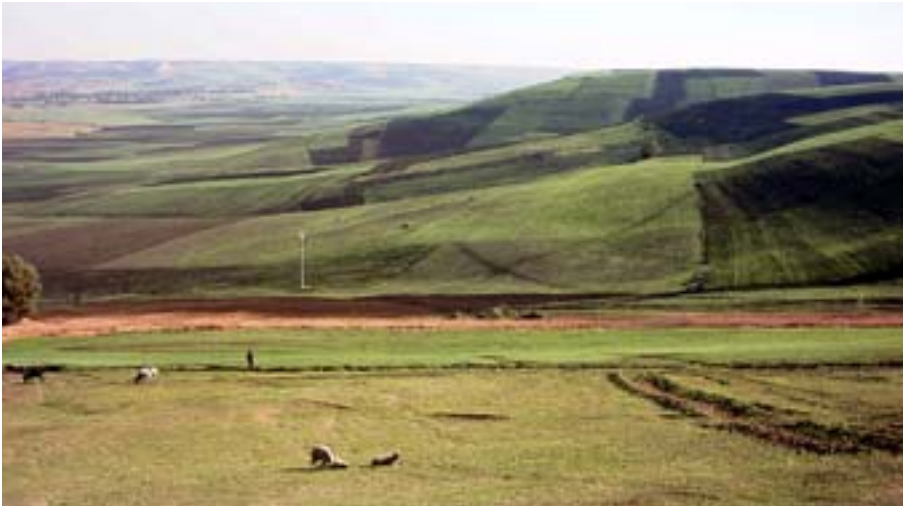
Photo No.4
Point③
Mountain Slope
(Vertisols)

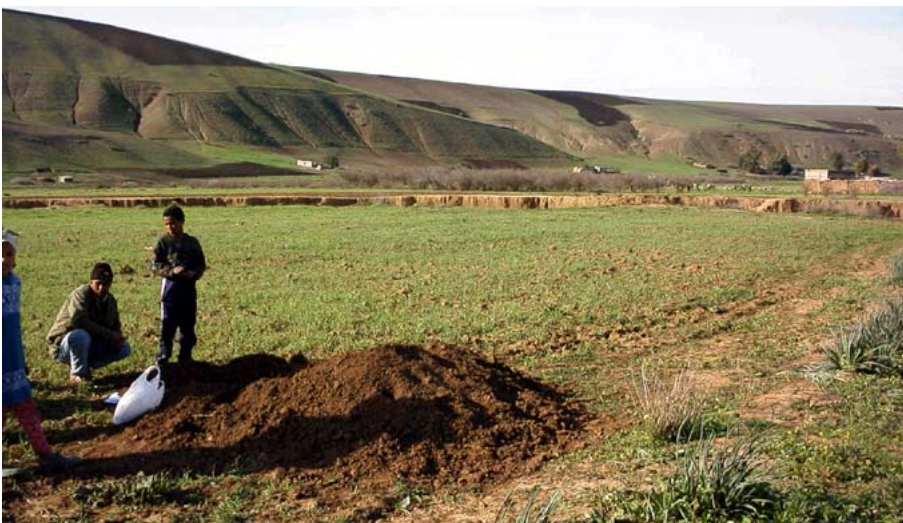
Photo No.5
Point④
Alluvial Deposit

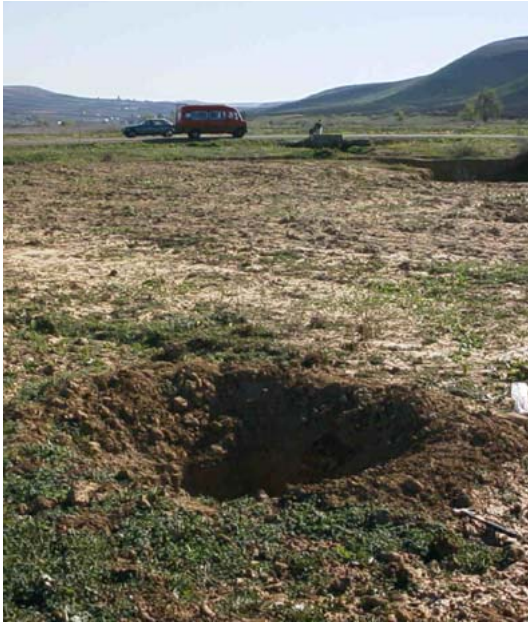
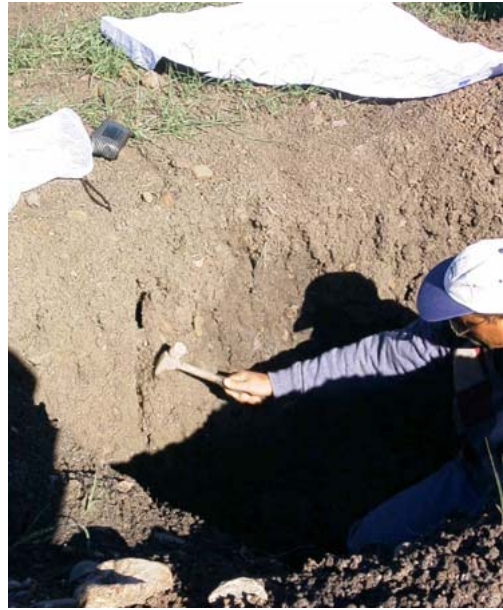
Photo No.6 (left) & No.7 (right)

Point④

Soil Profile of Vertisol

(Area of Left Bank on N'Fifikh River Basin)

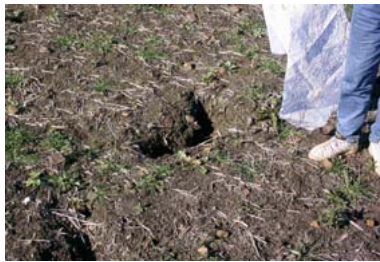
Photo No.8

Typical Natural Crack on Vertisols

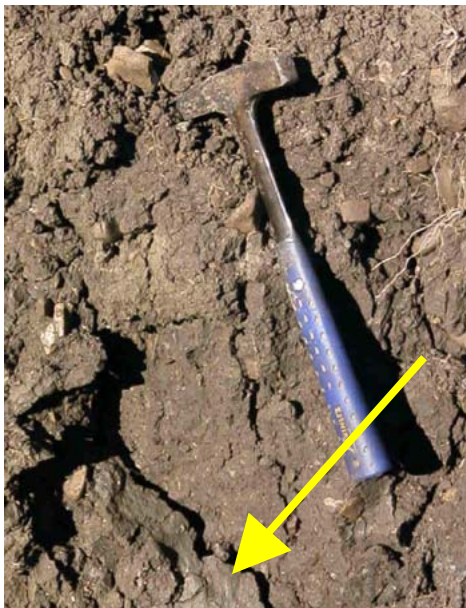
Photo No.9
Slickenside

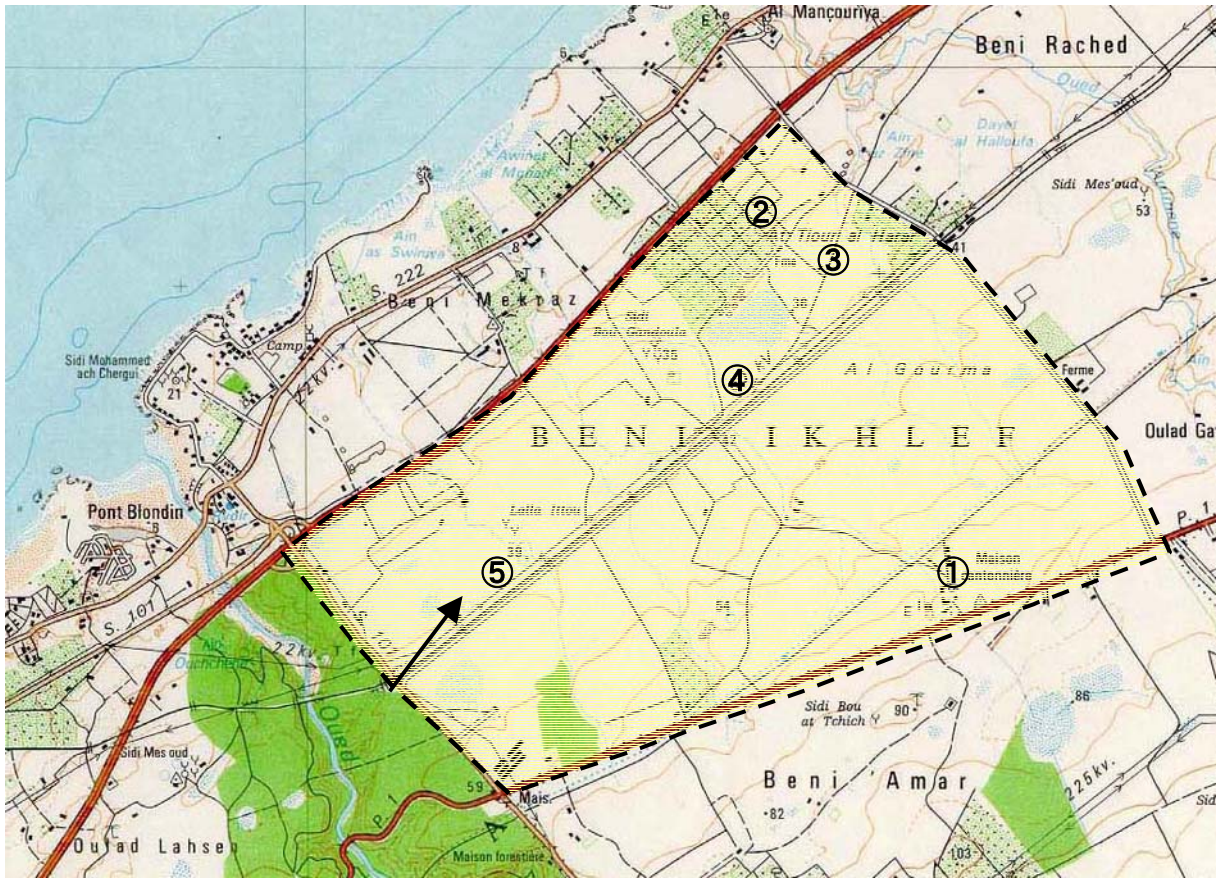
1) Area of Soil Survey

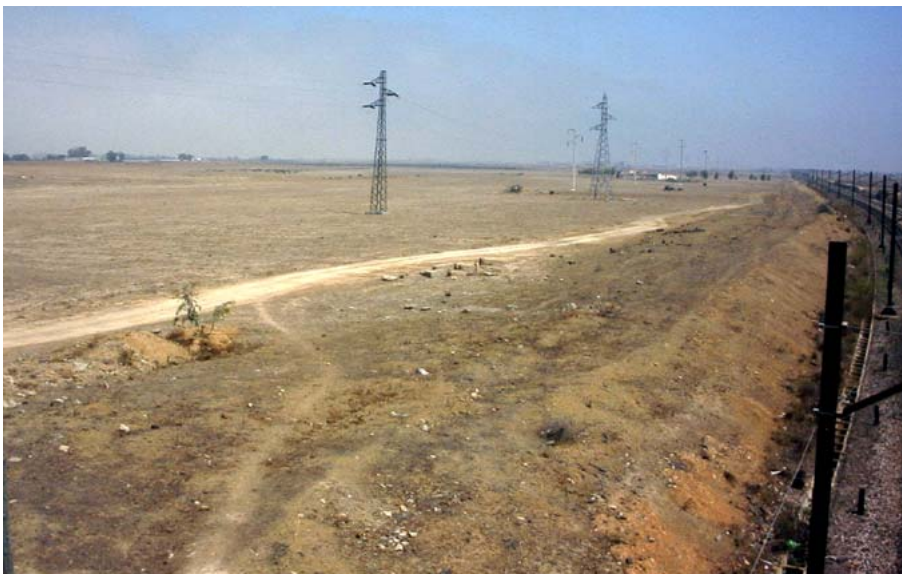
Photo No.11
From the bridge on
Rabat – Casablanca
railway's line
View from allow
side on the map

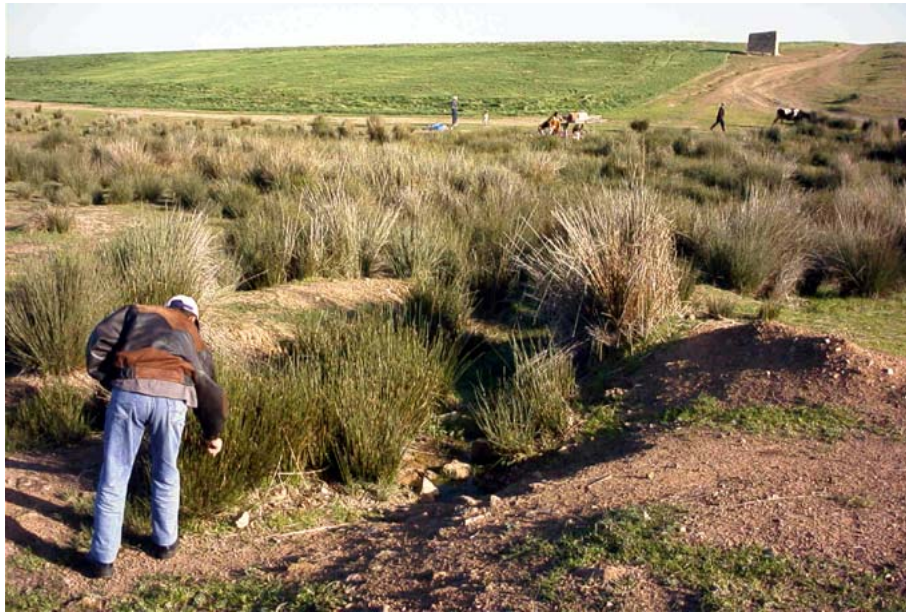
Photo No.12
Damp depression
Water level
(less than 1m)

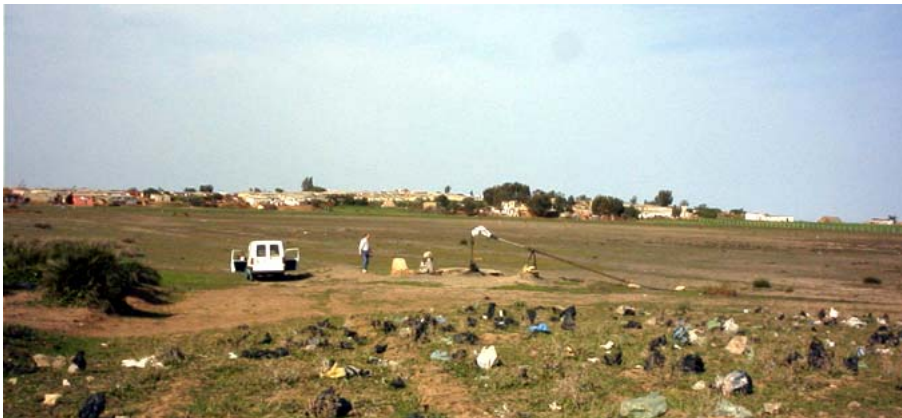
Photo No.13
Point ⑤
Depression Area
Seeping Water from
impermeable layer
During Rainy Season

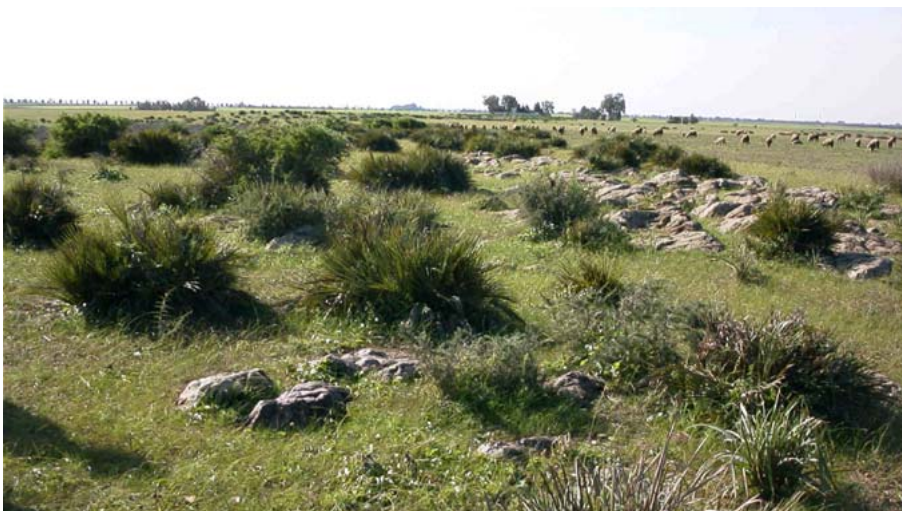
Photo No.14
Exposure Rock on the
Soil Surface
