CHAPTER 7 MONITORING AND ANALYSIS

7.3 Technical Evaluation of PV System

THE STUDY ON RURAL ELECTRIFICATION
 IMPLEMENTATION PLAN BY RENEWABLE ENERGY
 IN THE REPUBLIC OF BOLIVIA
 JAPAN INTERNATIONAL COOPERATION AGENCY

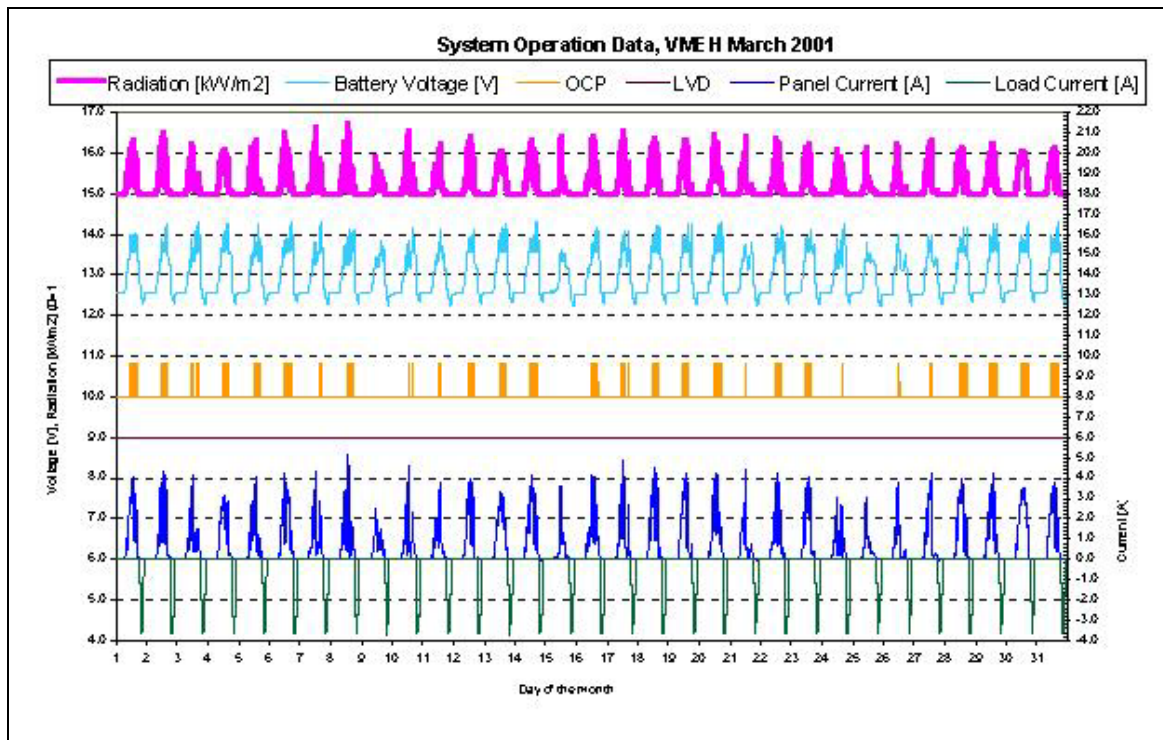
The graph below shows the system operation data as follows:

- Radiation [kWh/m²]
Daily radiation for the month are as presented in the first graph.
15.0 on the left scale indicates 0 of Radiation. 16.0 on the scale indicates 1kWh/m².
The daily average for the month was 5.12 kWh/m²

- **Battery Voltage[V]**
The voltage indicated lower in the days of 9th, 15th, 21st and 25th because of less radiation.
- **OCP: Over charge protection**
If the protection works, the positive line between 10 and 11 of the left scale is indicated. If there is no work of protection, the line is flat the whole day. As the consumption level was not so high, OCP worked in 28 days of 31 days.
- **LVD : Low voltage disconnection**
If the disconnection works, the positive line between 9 and 10 of the left scale is indicated. As the consumption was not so high, no LVD worked in the month.
- **Panel Current [A]:**
Generated power is indicated as Panel Current.
- **Load Current [A]:**
This is the power consumed by the loads. The level of the consumption is within the power generated, because the daily consumption was fixed at 8.75Ah.

The level of load consumption was fixed at 8.75Ah for one month. As the consumption level is within the generated electricity, the battery charge balance is very stable. This shows optimum use.

Total daily use of the PV system was regulated within 105Wh which is equivalent to 7 hours use of three 15W fluorescent lamps. With respect to the unit of Ampere hour (Ah), the daily limit is 8.75Ah which is taken as benchmark in the pilot project.

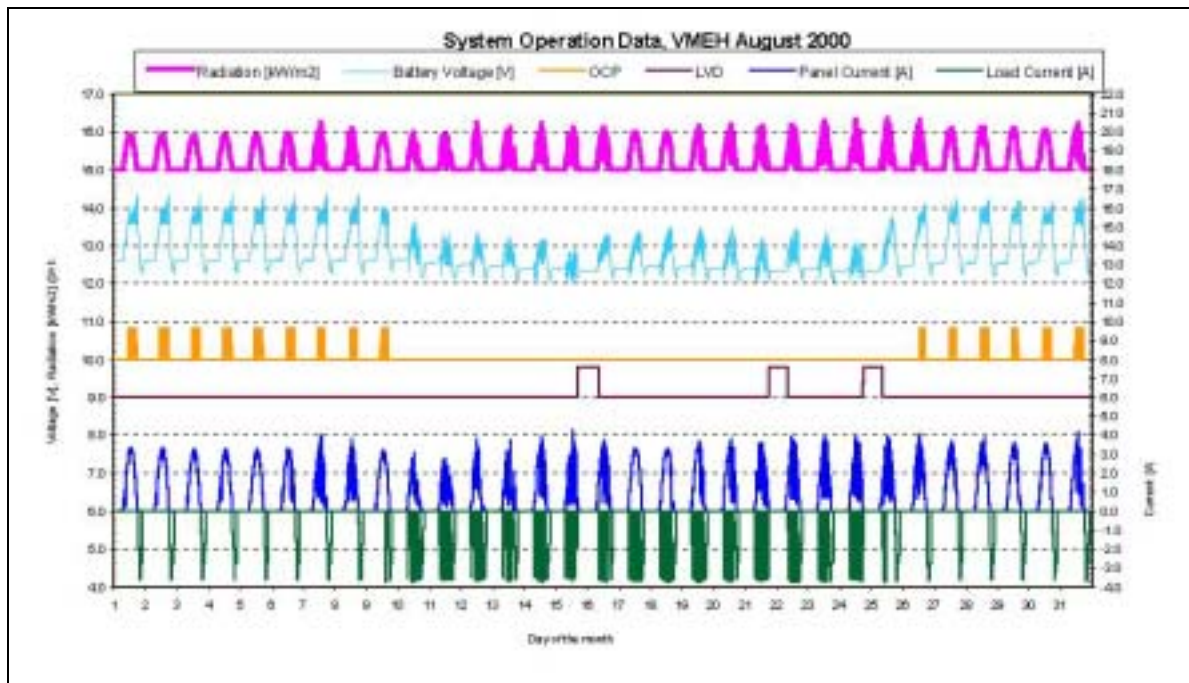
Data from VMEH (August 2000)

The graph below shows the system operation data as follows:

- Radiation [kWh/m²]
The daily average of the radiation for the month was 5.64kWh/m²
- Battery Voltage[V]
The voltage indicated lower during the days of the 9th to 25th because of high consumption.

- OCP: Over charge protection
As the consumption level was high for 17 days during 9th to 25th, the battery was in the condition of much discharged level. Therefore, OCP did not work on those days.
- LVD : Low voltage disconnection
As the consumption was very high during those 17 days, LVD worked three times on the days of 15th, 22nd and 24th in the month.
- Panel Current [A]:
Generated power is indicated as Panel Current.
- Load Current [A]:
This is the power consumed by the loads. The average of daily consumption was 13.27Ah for the month. However, the average consumption during the 17 days was 16.32Ah which was much higher than the generated electricity.

The heavy consumption may cause the lifetime of the battery to be shorter.

The daily average use was 10.69 hours. This is 152% of the benchmark level.
