5. Bidding and Installation

5.2 SHS Components Supply Survey

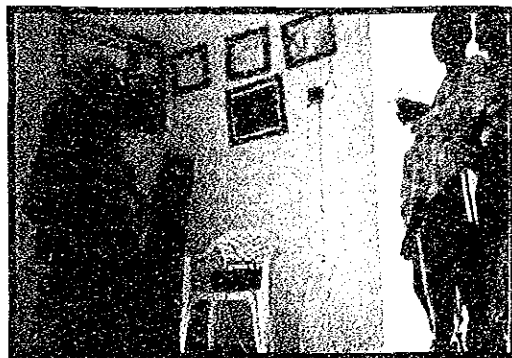
Figure 5.5 Interior Components (Outlets for Radio and LED Lamp)

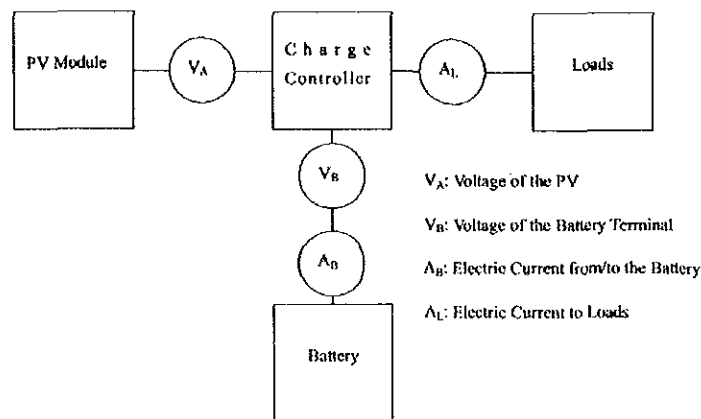
Figure 5.14 Data Capturing Point

Figure 5.14 shows the point of capturing basic data. The data shown in Table 5.6 and 5.7 was calculated with those basic data.

Watt-hours are calculated by multiplying the current and voltage and cumulating the result. V_B was applied on calculating watt-hours based on the assumption that there is no voltage drop between the capturing points. Current from PV is calculated with A_L and A_B (See Figure 5.14). When sign of A_B is positive, the current goes to the battery (charge). When it is negative, the current comes from battery (discharge).
