Quezon City

Individual Information Sheets for the Traffic Bottleneck Points

Small Scale Traffic Improvement Measures for Metro Manila

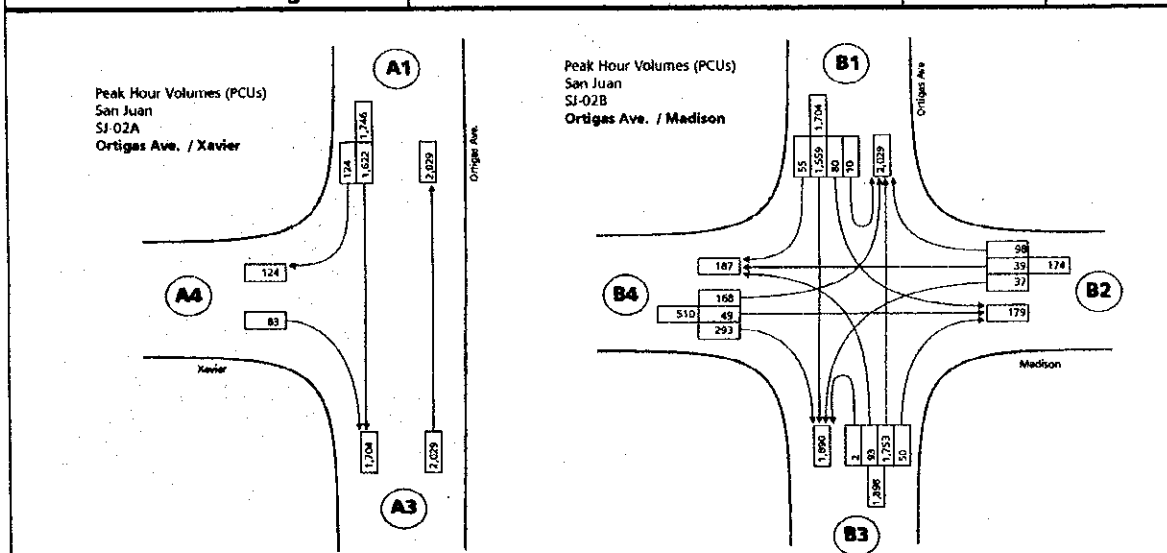
2) The intersection of Xavier St with Ortigas Avenue is basically a T-intersection since Ortigas Avenue is divided by a concrete barrier.						
	3) The North East approach of Madison St caters primarily to residents of North Greenhills Subdivision, which restricts entry into the subdivision. The South approach serves the nearby schools and access to vehicles from other parts of the city.						
Signalization	None	Pavement Markings	None	Peak	16:00-17:00		
Approach	Dimensions	Peak Hour Traffic Volumes (PCUs)				% Public Transport	Pedestrian Volume
		Left	Through	Right	Total		
A1: Ortigas (N)	21.0m	NA	1,622	124	1,746	4.10%	Medium
A2: None	None	None	None	None	None	None	None
A3: Ortigas (S)	21.0m	NA	2,029	NA	2,029		Medium
A4: Xavier (W)	9.9m	NA	NA	83	83	8.64%	Medium
	Total		3,650	207	3,857		
B1: Ortigas (N)	21.4m	90	1,559	55	1,704	17.57%	Medium
B2: Madison (E)	10.0m	37	39	98	174	2.22%	Medium
B3: Ortigas (S)	20.7m	95	1,753	50	1,898	19.98%	Medium

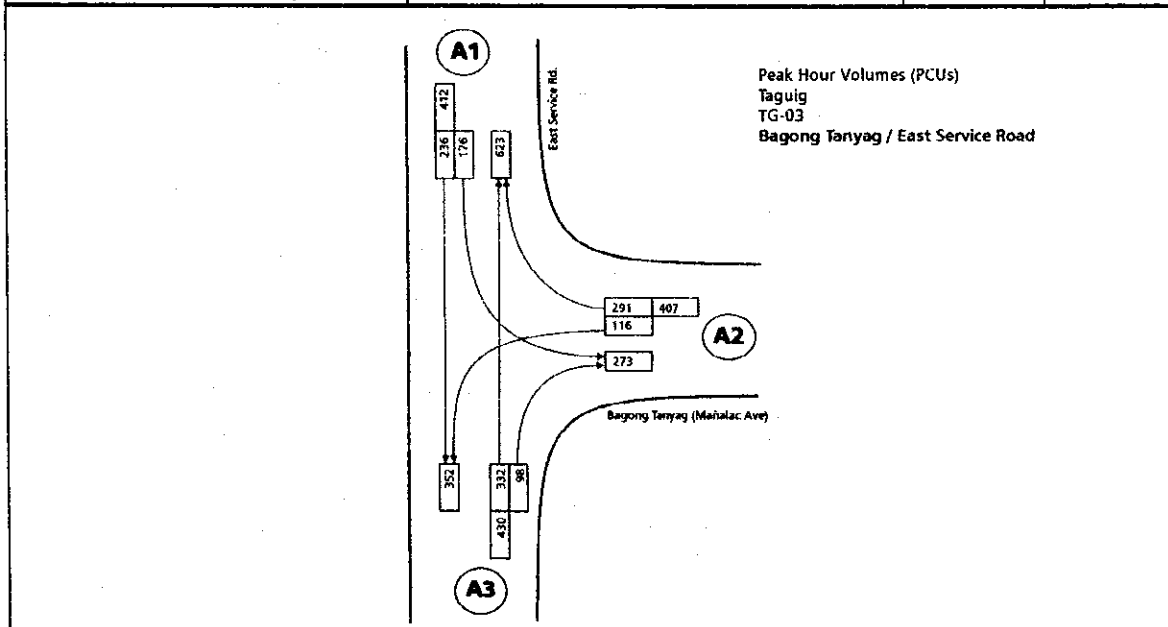
Name	Bagong Tanyag / East Service Road	Code	TG-03
Sheet	Analysis	LGU	Taguig

- 1) The East Service Road caters to local traffic along the South Luzon Expressway. It was already congested long before the columns of the Skyway temporary ramp were built, but later made it worse.
- 2) Sidewalks and pedestrian paths are occupied by vendors / eateries.
- 3) Queue propagation from Bicutan exit often reaches this intersection.
- 4) Left turning volume to/from Bagong Bayan Road is substantial.

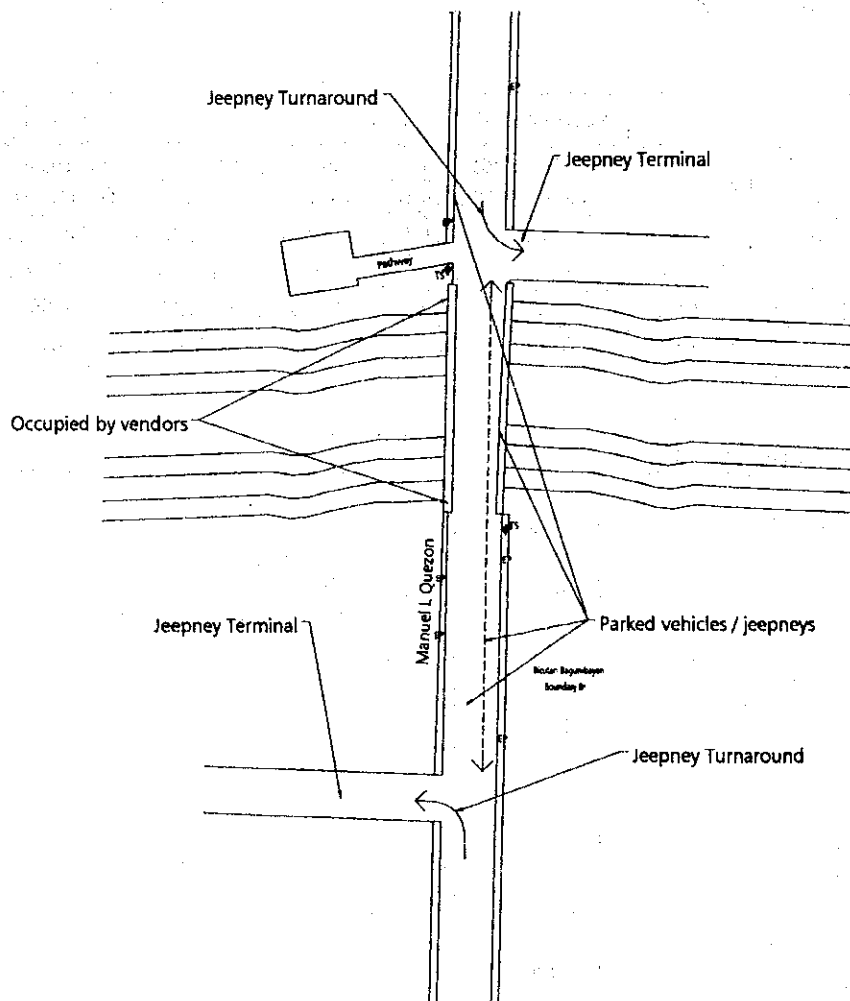
- 1) The high volume of jeepneys which terminate their routes at the boundary, and which have to turnaround, mainly causes the bottleneck. A number of off-street makeshift terminals have been accommodated in private lots, but there is not enough space to park all terminating jeepneys. Some of those in queue have to park on the street, which has no available space (no shoulders, not even sidewalks wide enough for pedestrians).

- 2) These jeepneys have to turn around by making a left turn to their terminal, or make a U-turn. With the narrow right of way width, jeepneys are not able to make the U-turn in one maneuver. Rather, most of them have to make a three-point turn.

- 3) Passengers getting off the jeepneys on either side of the bridge are forced to transfer to another jeepney on the opposite side. The bridge is just a two-lane bridge, and at times, vehicles are parked on the sides. The sidewalks are narrow and the approaches have been occupied by ambulant vendors.

Name	ML Quezon @ Bagumbayan-Sucacat Boundary	Code	TG-04
Sheet	Proposed Improvements	LGU	Taguig
Engineering	<ol style="list-style-type: none"> 1) Engineering improvements to the area are limited, given the available space. Engineering improvements may be limited to physical improvements of the terminal. 2) Paving the jeepney terminals would enhance turnaround and arrival/departure of vehicles, as well as benefit pedestrians 3) Extend the jeepney route either farther north or south of bridge where a suitable turnaround can be handled more conveniently. This would also minimize the number of passengers transferring, and would decrease opportunities for attracting ambulant vendors. 		
Enforcement	<ol style="list-style-type: none"> 1) Ban parking on the bridge, to facilitate vehicle and pedestrian flows. 2) Relocate ambulant vendors; clear sidewalks of obstructions.
