SUPPLEMENTAL INVESTIGATION
OF
THE STUDY ON INTEGRATED WATER RESOURCES DEVELOPMENT
IN THE CAÑETE RIVER BASIN IN THE REPUBLIC OF PERU
THE JAPAN INTERNATIONAL COOPERATION AGENCY

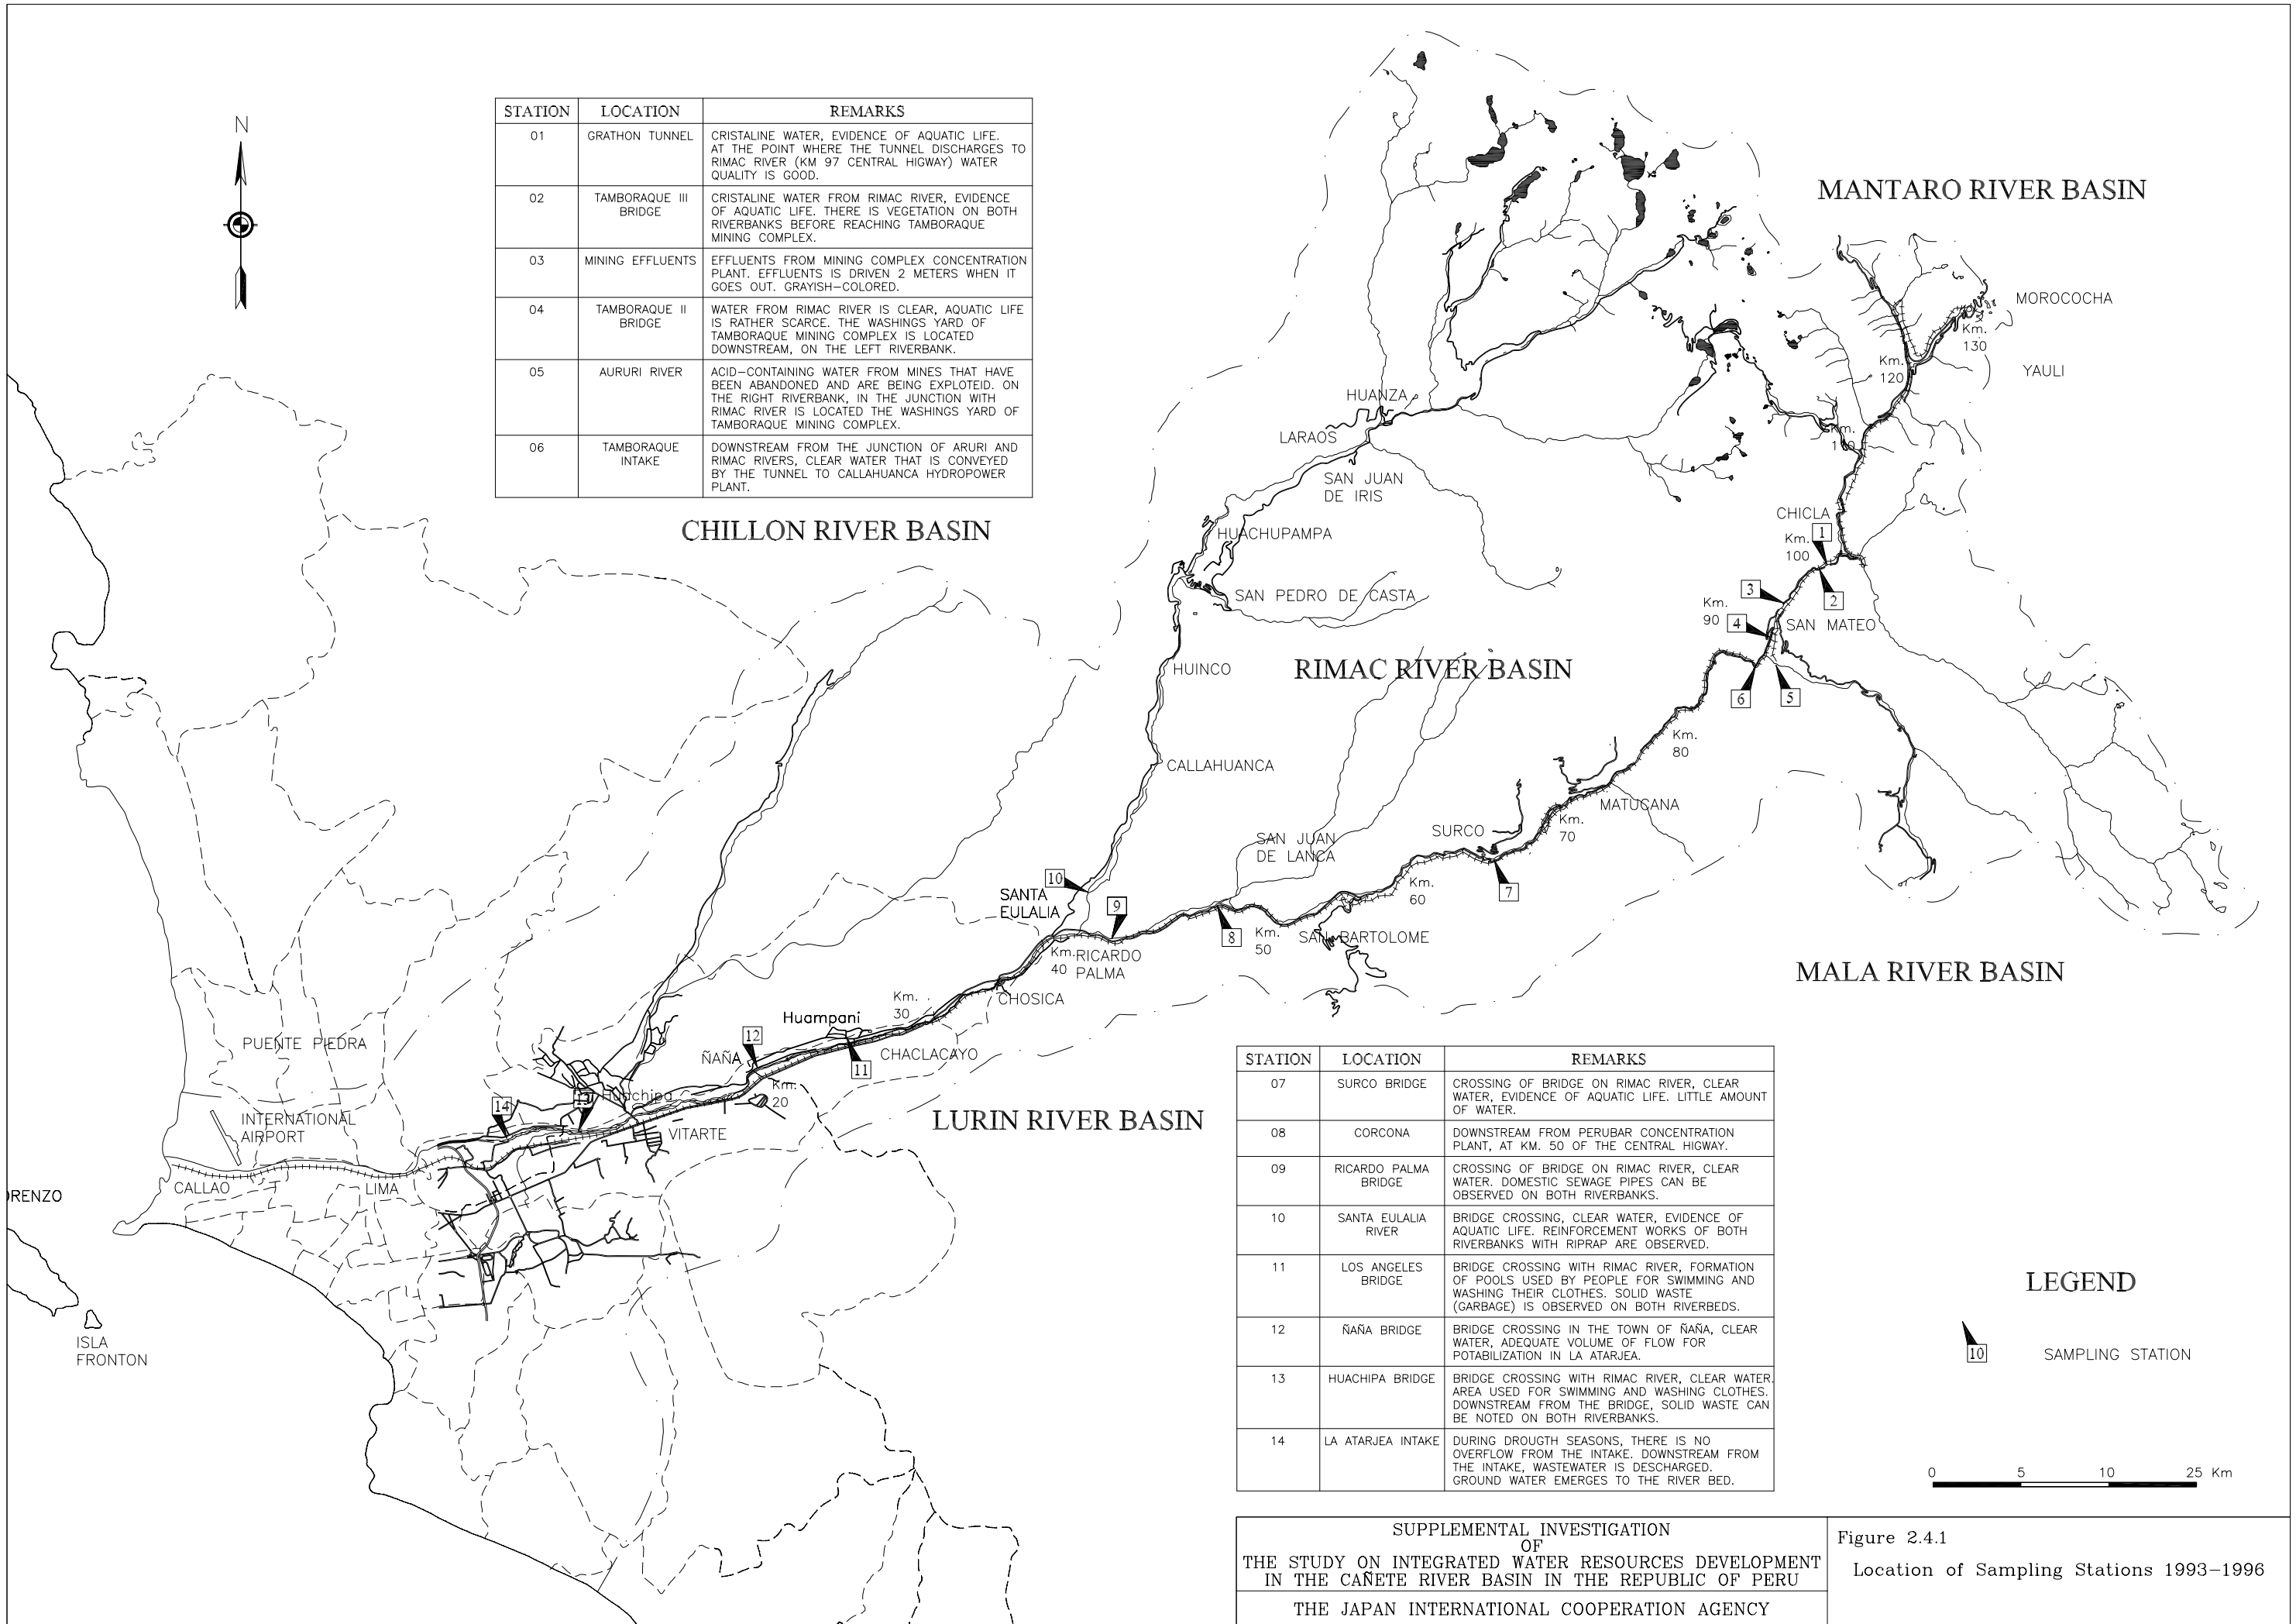
Figure 2.4.1
Location of Sampling Stations 1993-1996

STATION	LOCATION	REMARKS
01	GRATHON TUNNEL	CRISTALINE WATER, EVIDENCE OF AQUATIC LIFE. AT THE POINT WHERE THE TUNNEL DISCHARGES TO RIMAC RIVER (KM 97 CENTRAL HIGHWAY) WATER QUALITY IS GOOD.
02	TAMBORAQUE III BRIDGE	CRISTALINE WATER FROM RIMAC RIVER, EVIDENCE OF AQUATIC LIFE. THERE IS VEGETATION ON BOTH RIVERBANKS BEFORE REACHING TAMBORAQUE MINING COMPLEX.
03	MINING EFFLUENTS	EFFLUENTS FROM MINING COMPLEX CONCENTRATION PLANT. EFFLUENTS IS DRIVEN 2 METERS WHEN IT GOES OUT. GRAYISH-COLORED.
04	TAMBORAQUE II BRIDGE	WATER FROM RIMAC RIVER IS CLEAR, AQUATIC LIFE IS RATHER SCARCE. THE WASHINGS YARD OF TAMBORAQUE MINING COMPLEX IS LOCATED DOWNSTREAM, ON THE LEFT RIVERBANK.
05	AURURI RIVER	ACID-CONTAINING WATER FROM MINES THAT HAVE BEEN ABANDONED AND ARE BEING EXPLOITED. ON THE RIGHT RIVERBANK, IN THE JUNCTION WITH RIMAC RIVER IS LOCATED THE WASHINGS YARD OF TAMBORAQUE MINING COMPLEX.
06	TAMBORAQUE INTAKE	DOWNSTREAM FROM THE JUNCTION OF ARURI AND RIMAC RIVERS, CLEAR WATER THAT IS CONVEYED BY THE TUNNEL TO CALLAHUANCA HYDROPOWER PLANT.

STATION	LOCATION	REMARKS
07	SURCO BRIDGE	CROSSING OF BRIDGE ON RIMAC RIVER, CLEAR WATER, EVIDENCE OF AQUATIC LIFE. LITTLE AMOUNT OF WATER.
08	CORCONA	DOWNSTREAM FROM PERUBAR CONCENTRATION PLANT, AT KM. 50 OF THE CENTRAL HIGHWAY.
09	RICARDO PALMA BRIDGE	CROSSING OF BRIDGE ON RIMAC RIVER, CLEAR WATER. DOMESTIC SEWAGE PIPES CAN BE OBSERVED ON BOTH RIVERBANKS.
10	SANTA EULALIA RIVER	BRIDGE CROSSING, CLEAR WATER, EVIDENCE OF AQUATIC LIFE. REINFORCEMENT WORKS OF BOTH RIVERBANKS WITH RIPRAP ARE OBSERVED.
11	LOS ANGELES BRIDGE	BRIDGE CROSSING WITH RIMAC RIVER, FORMATION OF POOLS USED BY PEOPLE FOR SWIMMING AND WASHING THEIR CLOTHES. SOLID WASTE (GARBAGE) IS OBSERVED ON BOTH RIVERBEDS.
12	ÑAÑA BRIDGE	BRIDGE CROSSING IN THE TOWN OF ÑAÑA, CLEAR WATER, ADEQUATE VOLUME OF FLOW FOR POTABILIZATION IN LA ATARJEJA.
13	HUACHIPA BRIDGE	BRIDGE CROSSING WITH RIMAC RIVER, CLEAR WATER AREA USED FOR SWIMMING AND WASHING CLOTHES. DOWNSTREAM FROM THE BRIDGE, SOLID WASTE CAN BE NOTED ON BOTH RIVERBANKS.

14	LA ATARJEJA INTAKE	DURING DROUGHT SEASONS, THERE IS NO OVERFLOW FROM THE INTAKE. DOWNSTREAM FROM THE INTAKE, WASTEWATER IS DISCHARGED. GROUND WATER EMERGES TO THE RIVER BED.
