No. 49 Ka Don

(Lam Dong Province)

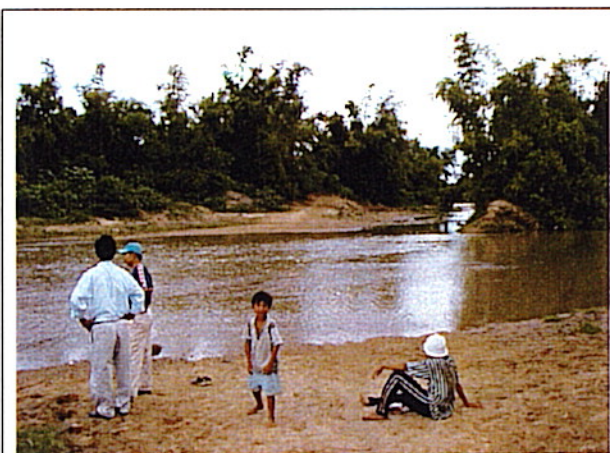
Photo 1: Proposed Location

Other Information
1) There has been no bridge there. People in the vicinity communes cross the river in dry season.
2) There is little traffic on the access road to this crossing point due to the narrow earth road. People in the vicinity communes cross the river to access to NRI.
3) Whereas the water level in dry season is 0.5m in depth, it reaches to 5.5m in rainy season. In rainy season, as the flow become fast, some people have been drown when crossing the river.

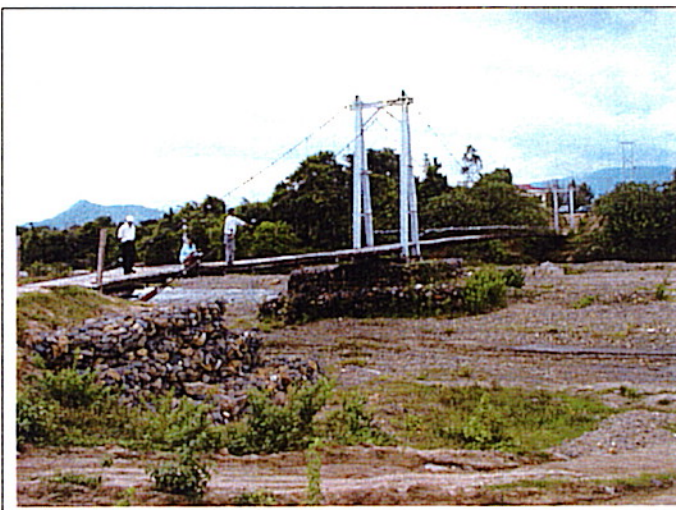
Photo 1: Existing Bridge

- 2) The bridge is a suspension bridge type for pedestrian and bikes constructed in 1999. All components of the bridge still looks stable. Although A2 abutment has seriously damaged by flooding in 2000, it was repaired by gabion mattresses.
