Case Study Summary of Enterprise Diagnosis and Guidance

Case No.	1st category	Division / Process	
MW-14	Production management	Galvanizing workshop	
2nd category		Industry	Sector / Product
Work management		Metalworking	Galvanizing

Improvement of the jigging method

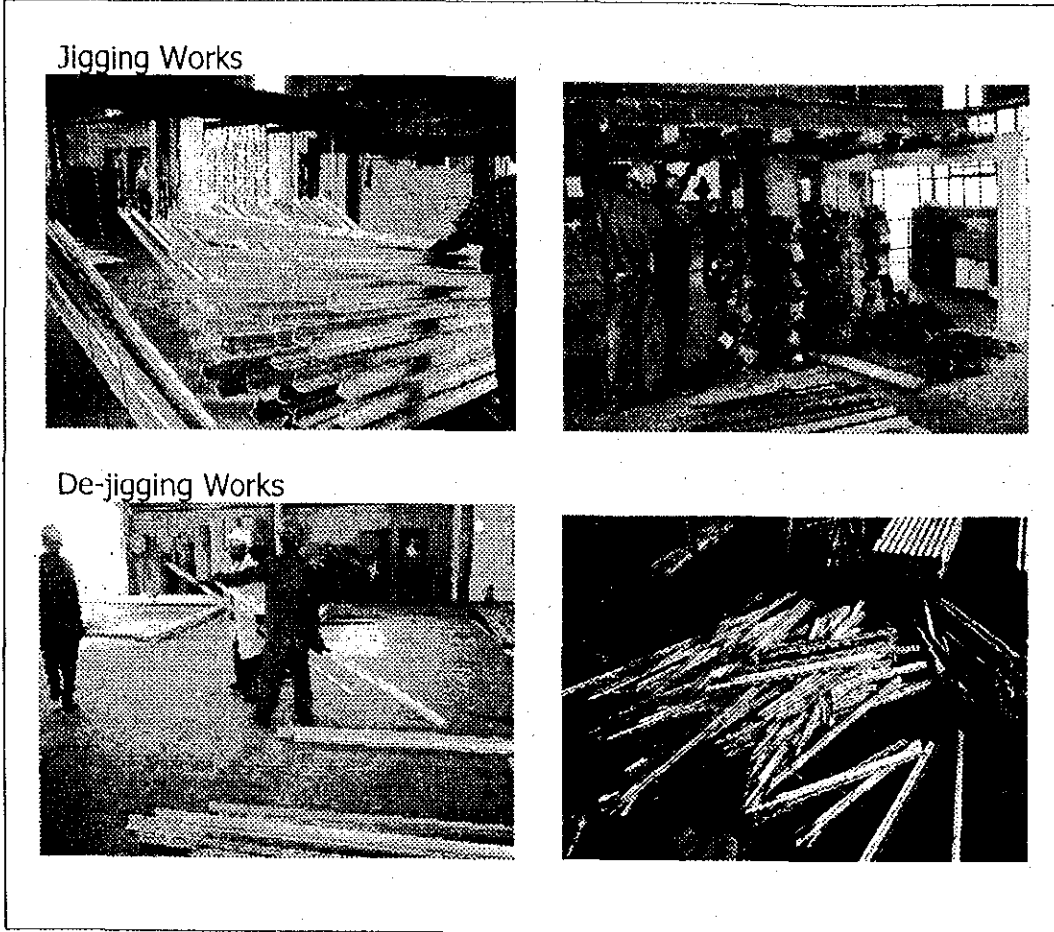
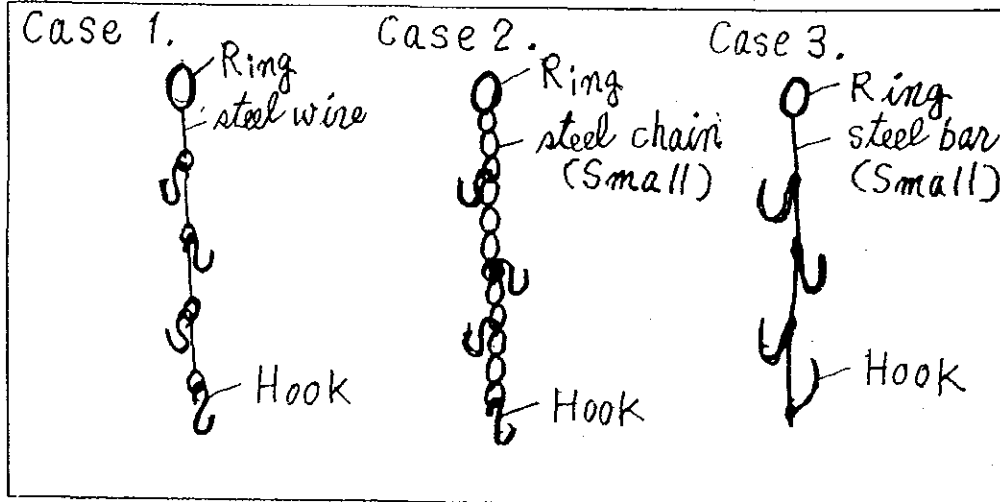
Photograph 1 Improvement of the jiggging & de-jiggging works

Many workers are involved in jiggling the work to a lifting beam prior to being galvanized and de-jigging of work after galvanizing. This process is time consuming and unproductive.

This method of jiggling and de-jigging is also costly as the wire is used only once in this process and is thereafter thrown away. There have also been incidents where the galvanized works have sometimes fallen into the tanks and onto the floor due to the wires cutting. This results in damage to the products and is also dangerous as products can fall and injure workers.

Hangers that can be used repeatedly should be utilised for the purpose of jiggling. The hangers reduce the jiggling and de-jigging time and the manufacturing cost, as it is not necessary to dispose of the hangers each time after use. The hangers can be made beforehand, provided that their lengths are standardized (See Photograph 1).

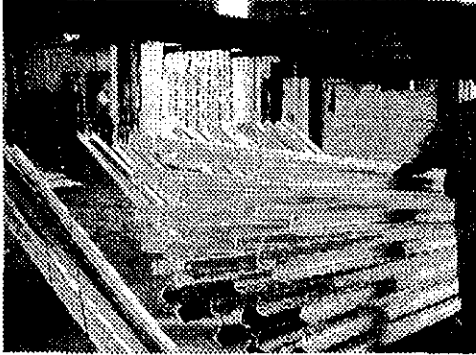
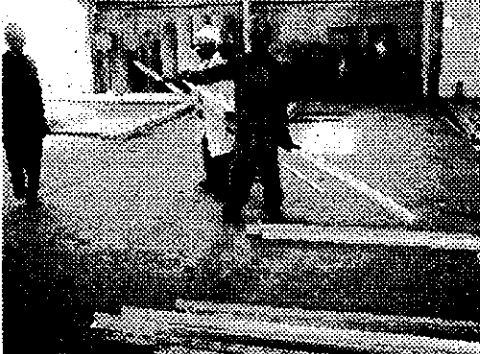
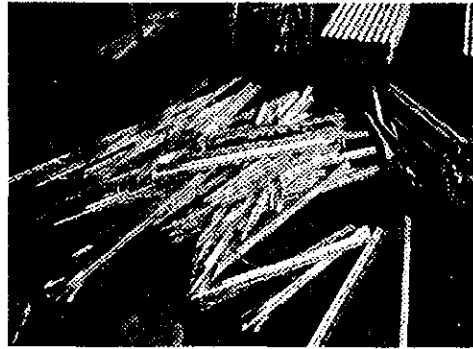
Photograph 1 Improvement of the jiggging & de-jiggging works

Jiggging Works

De-jiggging Works

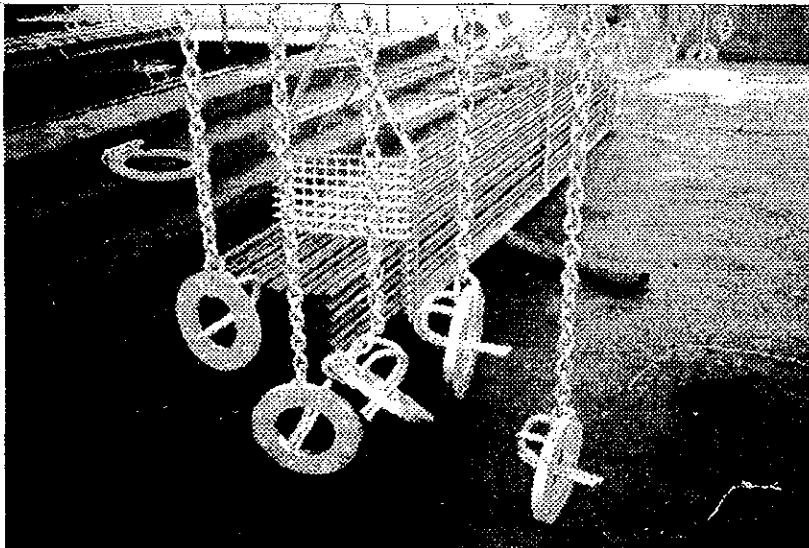
Introduced hanging jigs for steel pipes

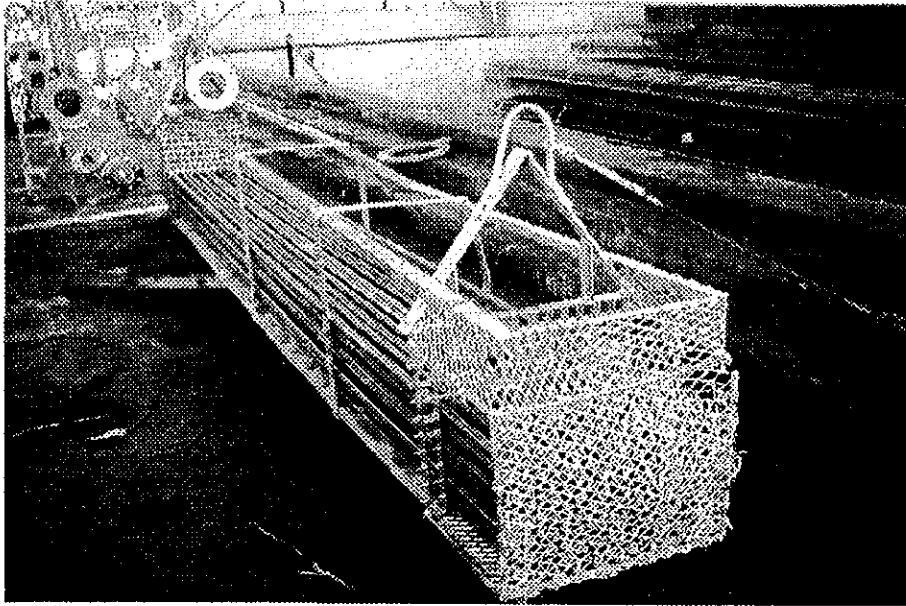
Introduced hanging jigs for steel pipes with small diameters

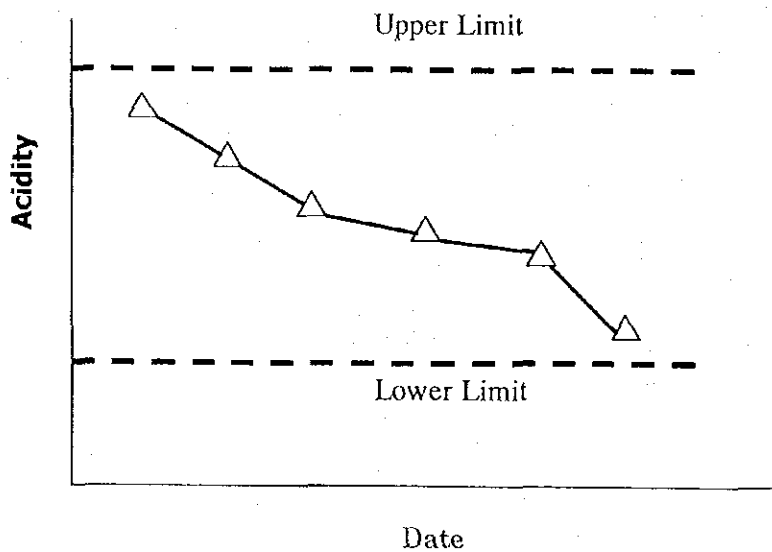
Sketch 1 Applying quality control chart in galvanizing process

The concentration of acid in pickling tanks is measured and recorded once a week by the acid suppliers in conjunction with the production manager. These records are only kept by the production manager, and not displayed on site.

A quality control graph should be put up on the wall located close to the relevant tanks or on the sidewall of the tanks in order to inform people of the condition of the chemicals. The upper control limit, the lower control limit and the measured value should be written down on the control graph.

This method of displaying information motivates all employees to show interest in quality control, and improves the morale of workers. As a result, quality control can be carried out easily at the factory.

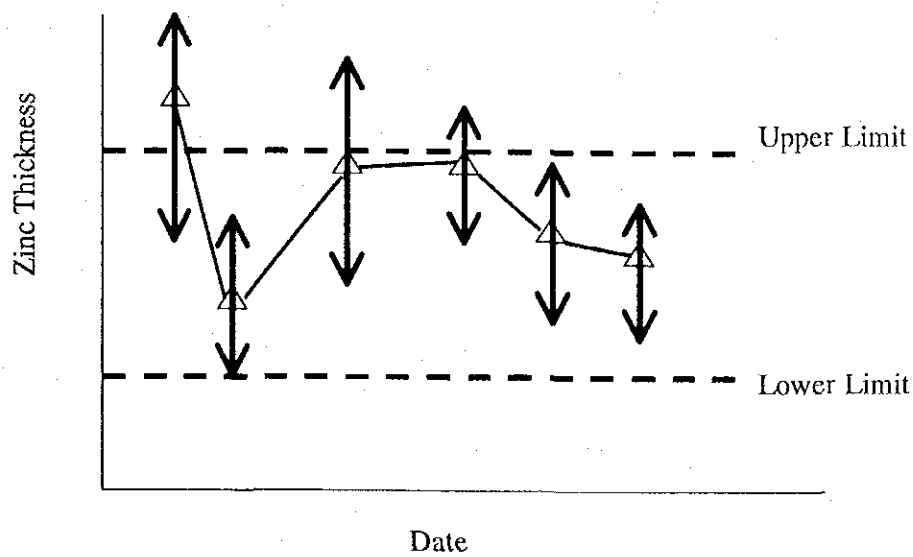
Sketch 2 Applying quality control chart to galvanized thickness

The thickness of the galvanizing on the products are measured by random inspection and recorded by quality inspectors. It was however observed that the thickness of the galvanizing was generally above the customers' requirements and this factor therefore contributes to increasing the cost of production.

The galvanized thickness should be controlled using a quality control chart. It is a useful tool to reduce the dispersion of thickness, and to keep constant thickness.

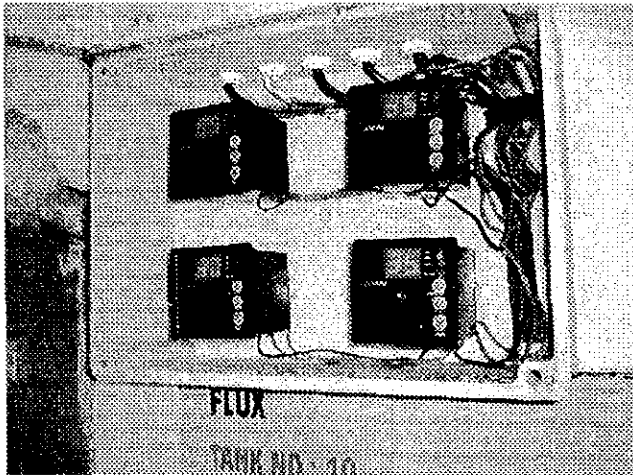
Timer for dipping (newly – installed)

A timer and indication lamp should be installed on each tank to inform operators of the lapse time for dipping. This method of operating would improve quality and efficiency in the factory.

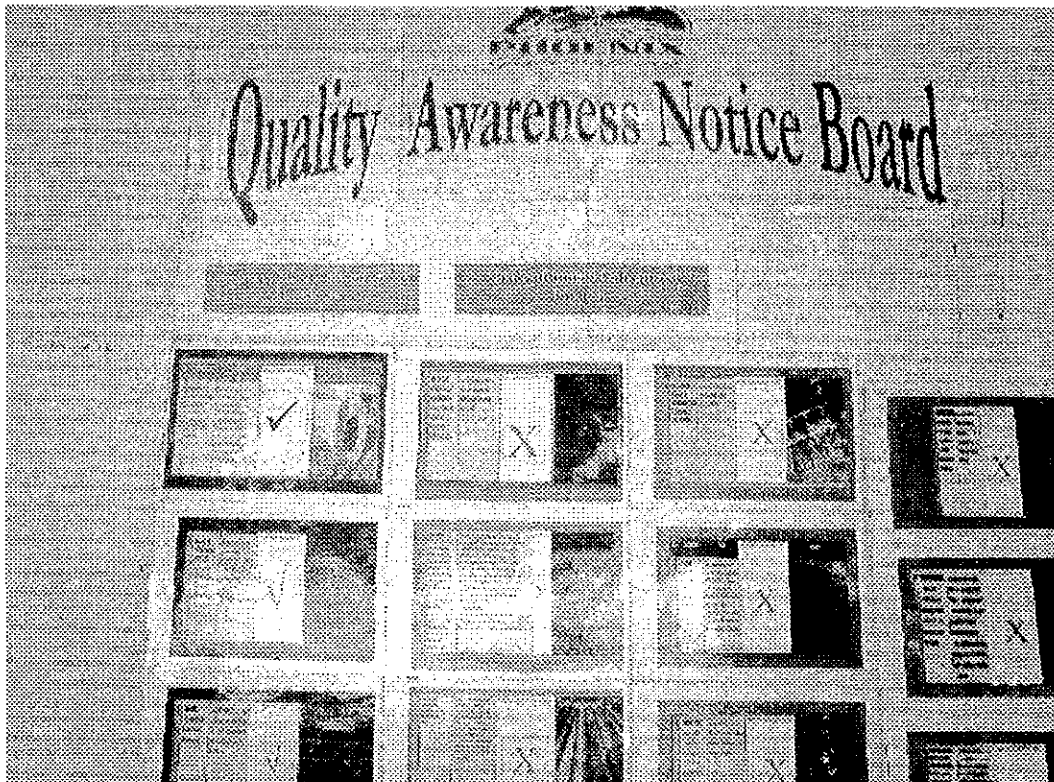
Notice board for products including rejects (newly – installed)

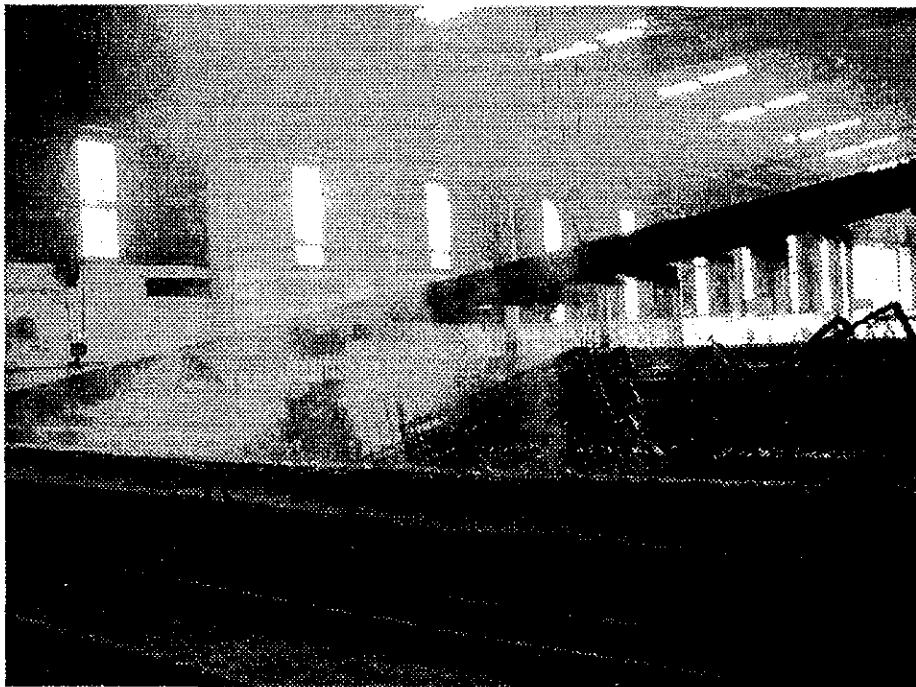
- 1) Fume is generated partly due to insufficient drying of work pieces in the preceding process. It is recommended to provide a drying furnace or provide long drying time.
- 2) A ventilation hood should be provided above the molten zinc tank to prevent fume from spreading into the factory.

A lot of fumes are generated and molten zinc is dispersed from the zinc-galvanizing tank when products are dipped into the tank. This contributes negatively towards the working environment.

One of the causes is that the products are dipped while still containing moisture as a result of the previous processes. It is therefore recommended that the products are preheated over the zinc tank for a longer period so as to remove the moisture or drying equipment should be installed. Furthermore, a hood and a ventilator should be installed on the roof located above the zinc-galvanizing tank in order that the generated fume does not diffuse in the workshop (See Photograph).

It is therefore recommended that the products are preheated over the zinc tank for a longer period so as to remove the moisture or drying equipment should be installed.

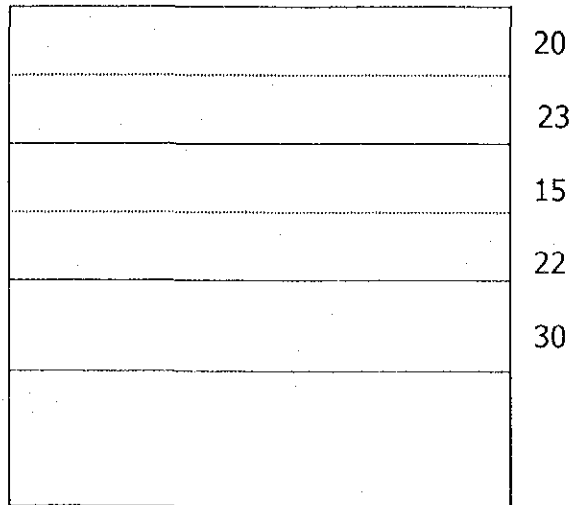
A dimensional diagram stuck on the wall of workshop

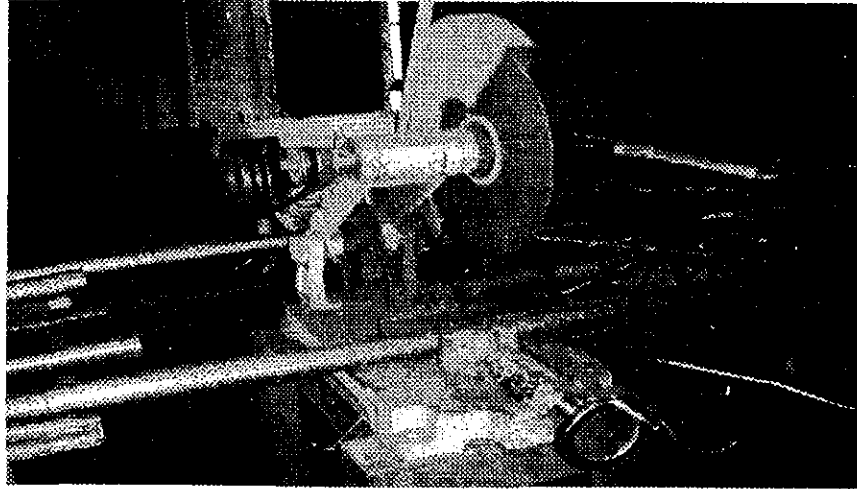
Photograph 1 The cutting work of pipes

1. Although a scale is installed on the guide, operator is required to adjust the length of pipe each time because there is no stopper for length adjustment.
2. The cutting grinder is dangerous due to the safety cover being too small.

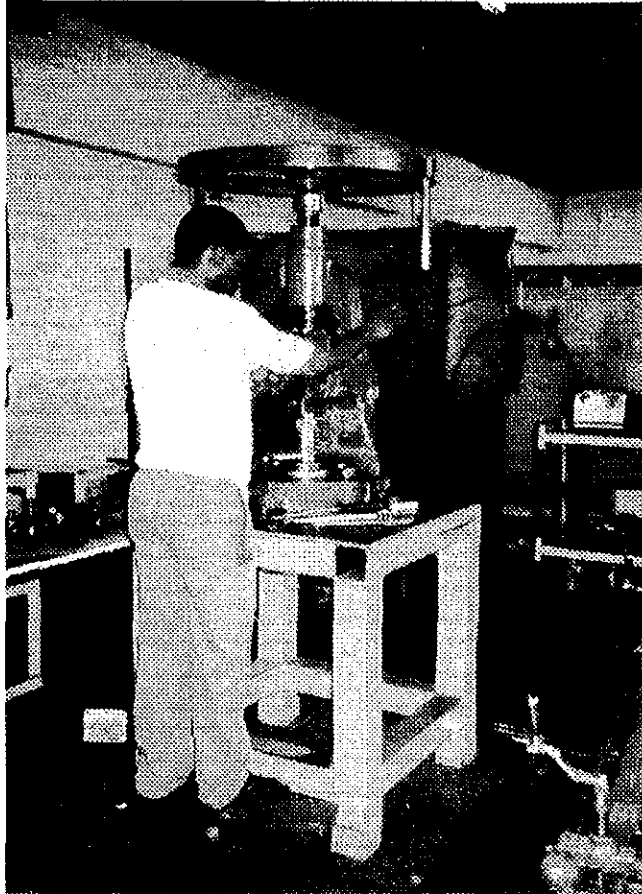
Photograph 2 The pressing work for flange

The operator of one of the machine presses has to step on a make shift platform due to the unsuitable height of the machine press. This method of operating is not only dangerous but also unproductive.

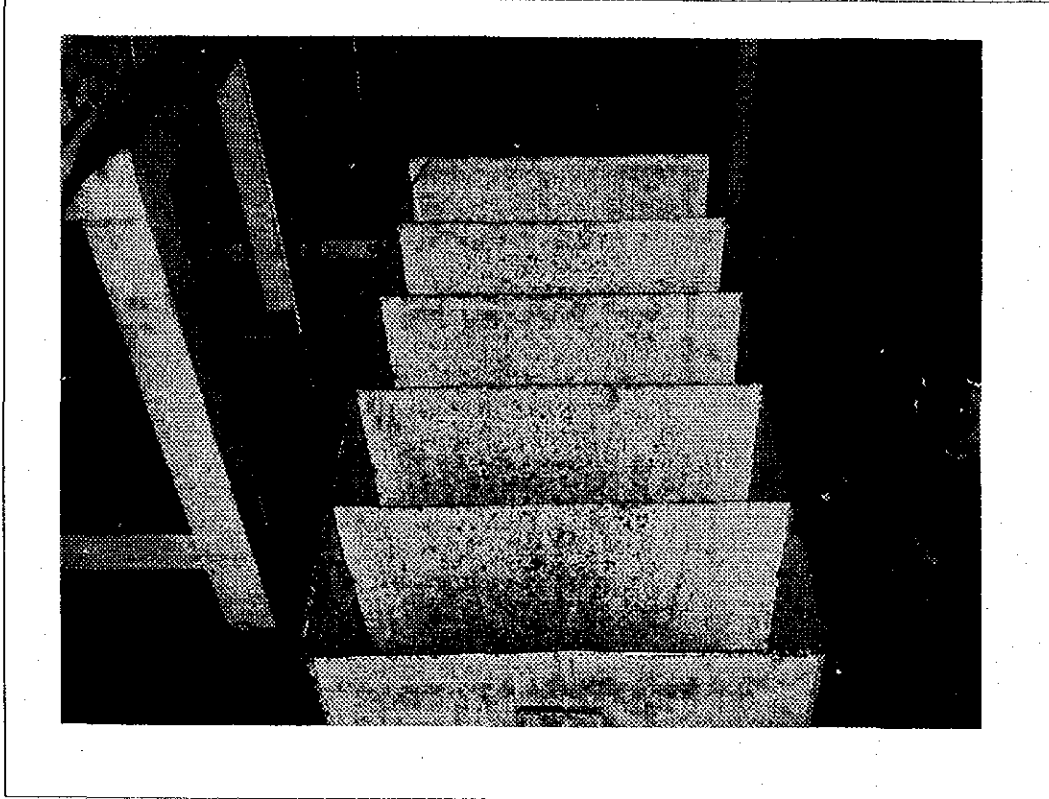
Photograph 1 The steel box for pipes store

- 1) A steel box in which pipes are stored prior to welding is situated between two welding worktables. It is difficult to pick up the pipes located in the far end of the box due to the narrow space.
- 2) Steel plates sheared by shearing machine are put on the floor beside a bender. The plates are prone to damage when they are bent by the bender with dust adhered. Productivity becomes poor firstly because the steel plates are put on the floor, then the operator of the bender picks them up. There is loss of time due to this method of operating resulting in low productivity.

A vertical steel box should be made and installed in front of the wire fence.
It makes the accessibility of pipes easy and results in increased productivity.
