***Chapter 7 Maintenance Dredging of Coastal Channels
of CDC II***

7. Maintenance Dredging of Coastal Channels of CDC II

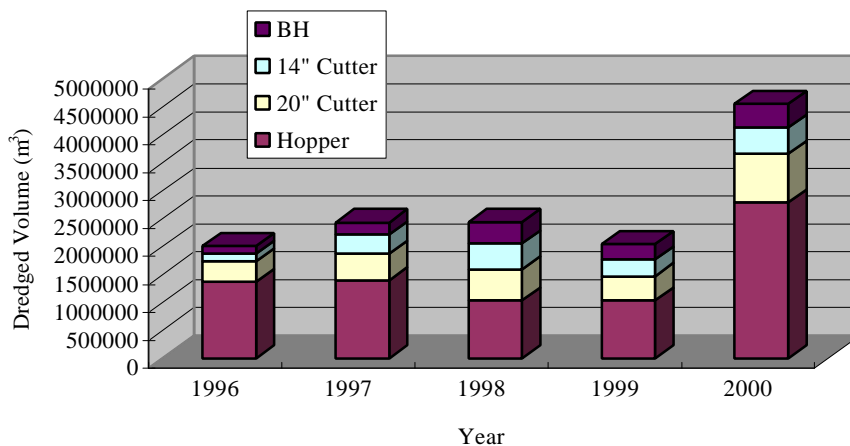
Figure 7.2.2-1 Dredged Volume by Kinds of Dredger, 1996 to 2000

Based on this data, the following Figure 7.2.2-1 shows that the dredged volume doubled in 2000 primarily due to an increase in the number of Hoppers.

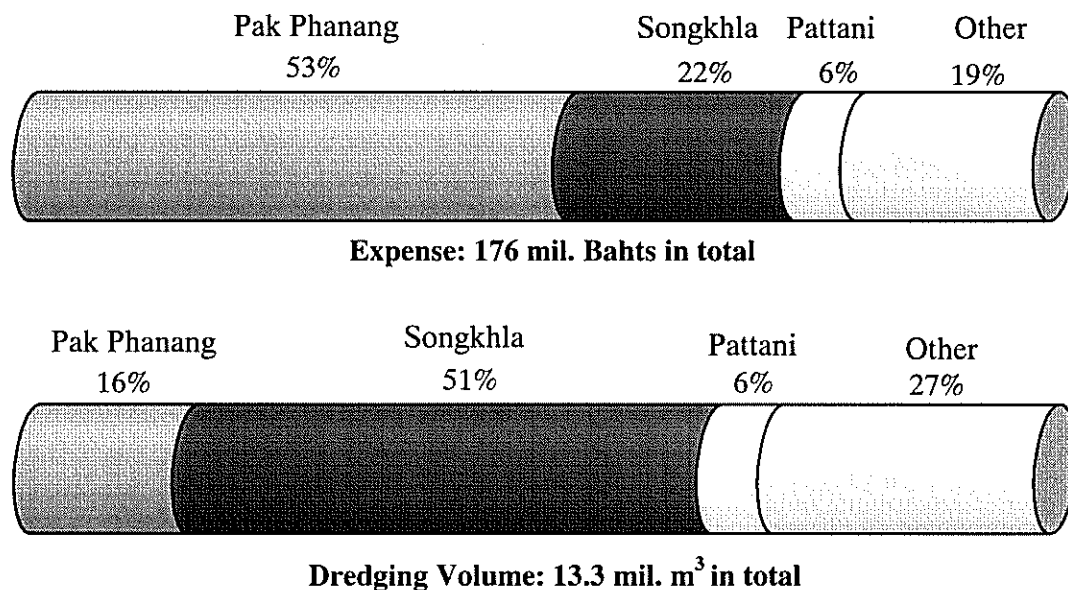
Figure 7.2.2-2 Share of Expenses & Volume for Maintenance

Name of Channels	Expenses		Volume	
	(Baht)	(%)	(m ³)	(%)
Pak Phanang	93,944,802	53%	2,073,898	16%
Songkhla	39,359,525	22%	6,856,000	51%
Pattani	9,659,110	6%	796,217	6%
Other channels	4,097,495	19%	3,595,176	27%
Total	175,851,564	100%	13,321,291	100%

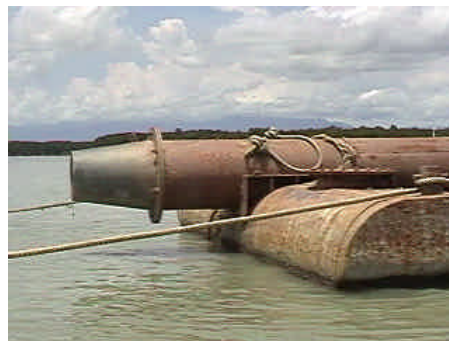
Figure 7.2.2-10 Diffuser at the End of Discharge Pipe

The vacuum of suction pipe should be set 150-160 mmHg for water only before starting excavation, in order to dredge a high concentration material and achieve high dredging output. The design discharge pipe length of C-25 and C-37 is more than 1,000m, but actual discharge takes place at 200m. It is therefore impossible to control the velocity to get an adequate vacuum. For operation of these dredgers, a diffuser should be put at the end of the pipe to reduce its diameter to 50%-70% or to about 14". When dredging pump engine starts, the rpm should be increased gradually so the vacuum gauge can be maintained at 150-160 mmHg. In case the engine cannot be stabilized, the size of the diffuser nozzle needs to be reduced. This process needs to be repeated until the engine becomes stable and a vacuum can be maintained 150-160 mmHg. Thereafter dredging work should continue at this rpm level. When the dredging pump starts with only water, the vacuum should be kept 150-160 mmHg, which in terms of water velocity will be 5.5 m/sec (see Figure 7.2.2 -10).

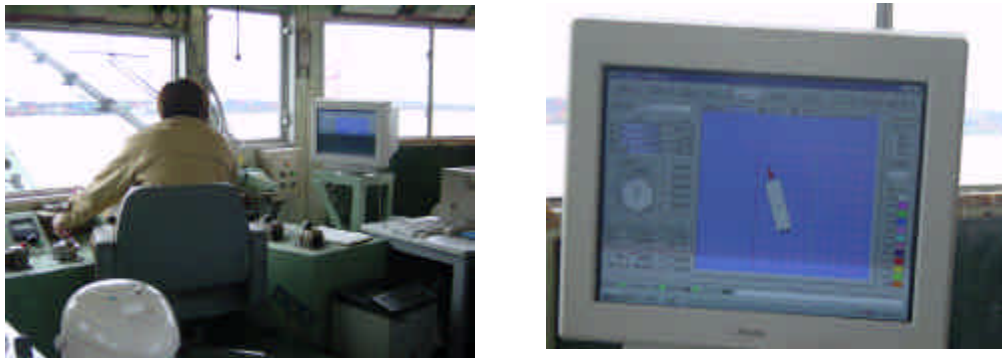
Figure 7.2.2-14 GPS for Cutter Suction Dredger

It is recommended that Global Positioning System (GPS) be used to monitor the Cutter Suction Dredges C-25 and C-37 in Pak Phanang to confirm their work positions (see Figure 7.2.2 -14). A control reading should be taken to establish GPS accuracy. Software should be used for recording daily positions. GPS is also recommended for the Hopper Dredger in Songkhla to increase the accuracy of the path of the dredger (see Figure 7.2.2 -15).
