## **1.8 Damage to Buildings**

1.8.2 Preparation of Fragility Curves

### 1.8.3 Damage Estimation

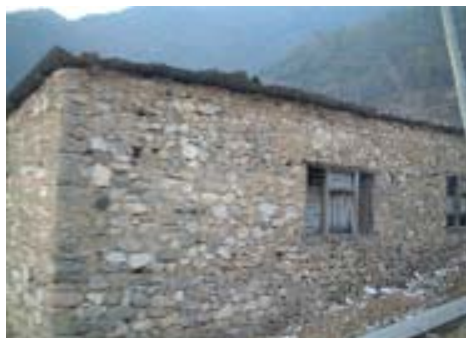
**Photo 1.8.1 Stone with mud mortar (ST)**

- Stone with mud mortar (ST)  
Buildings in rural areas are mainly of stone, as shown in these photos. Two shapes of stone are used; round riverbed rocks and squared dressed stones.
- Adobe (AD)  
This is an old type of building composed of sun-dried bricks with mud mortar. There are many adobe houses in rural areas. Adobe houses also exist in the old urban or sub-urban areas, mainly on elevated ground.

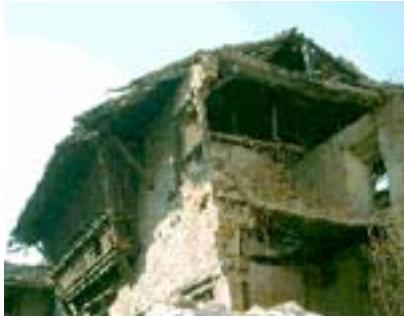
**Photo 1.8.3**

- Brick with mud mortar (BM)  
It can be seen that floors and roofs are timber structures. There is also a certain number of examples using sun-dried brick inside covered by fired brick on the exterior.
- Brick with cement mortar(BC)  
A distinctive feature is the lack of or insufficient number of RC columns. The

**Brick with mud mortar (BM)**

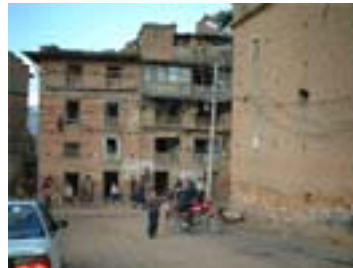
**Photo 1.8.4**

use of CS (cement sand) was adopted only 30 years ago, so its history here is short. A destructive earthquake has not yet been experienced, except for the 1988 earthquake, and evaluation of the strength of these buildings is needed.

**Brick with cement mortar (BC)**

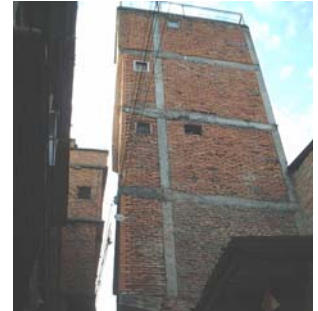
**Photo 1.8.5**

- Reinforced Concrete frame with masonry (RC)  
 enerally, 50% of the households are cement-bonded types. Over 90% of new RC frame buildings are typical RC frame with masonry structures.

**Reinforced concrete frame with masonry (RC)**

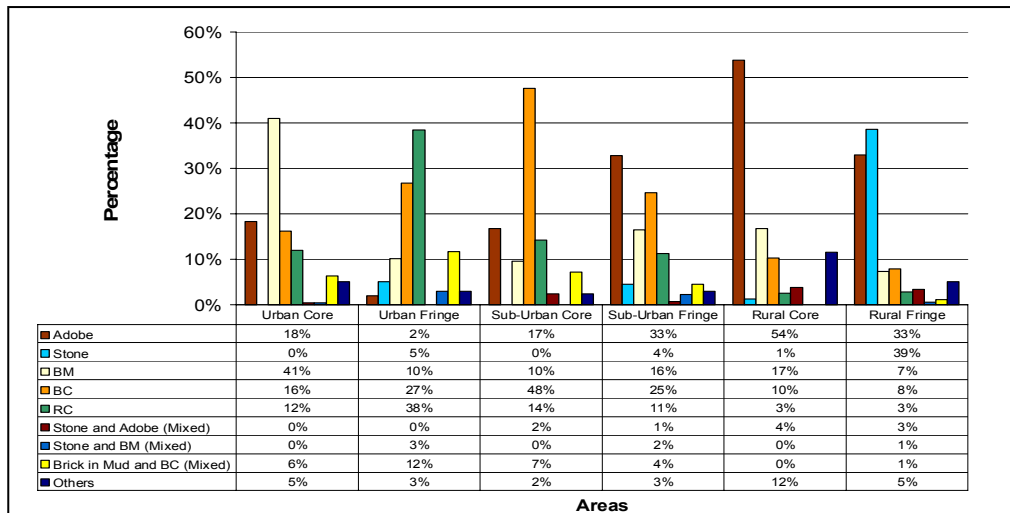
- In the rapidly growing suburban areas, brick masonry with cement mortar is dominant in the core, as well as the fringe areas. Brick masonry with mud and adobe building types are common in the suburban area. The proportion of reinforced concrete buildings is relatively low, 14% in the suburban core and 11 % in the suburban fringe.

- In the rural areas, the major types are adobe and stone/brick masonry in mud mortar, while brick masonry with cement or reinforced cement structures are significantly low in proportion.

Figure 1.8.2 Frequency of Building Types in Each Locality

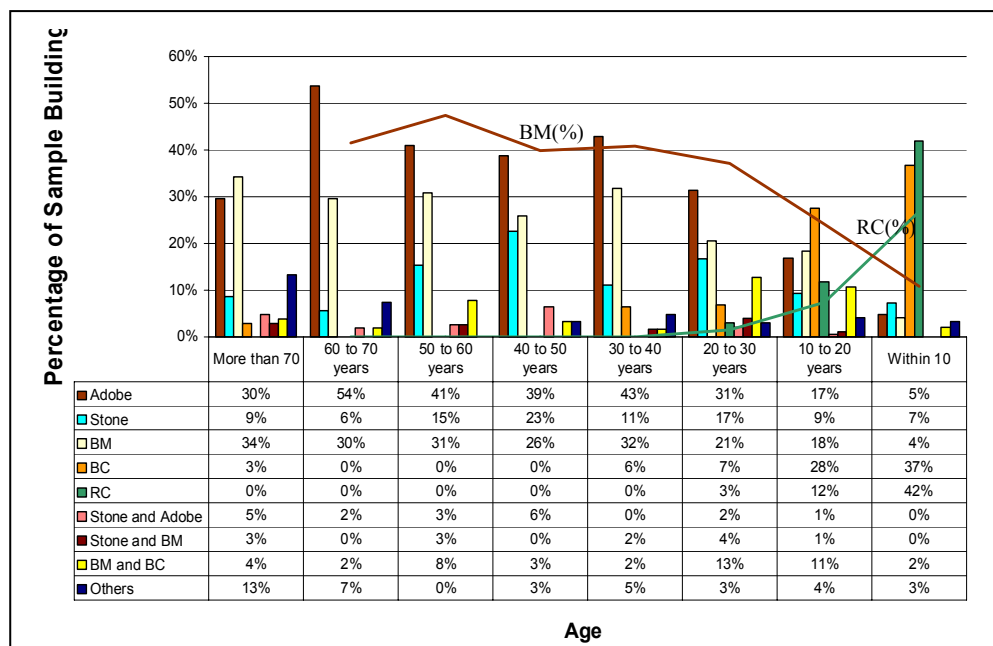
The proportion of building types by age of 10-year age intervals is shown in Figure 1.8.3.

- Adobe and BM were main types of building until 30 years ago.
- Construction of RC started 20 to 30 years ago, and increased since 10 to 20 years ago.
- In recent 10 years, BC and RC are the dominant types of buildings.
- About 23% of the total buildings are more than 50 years old, indicating high vulnerability.

Figure 1.8.3 Building Type by Age

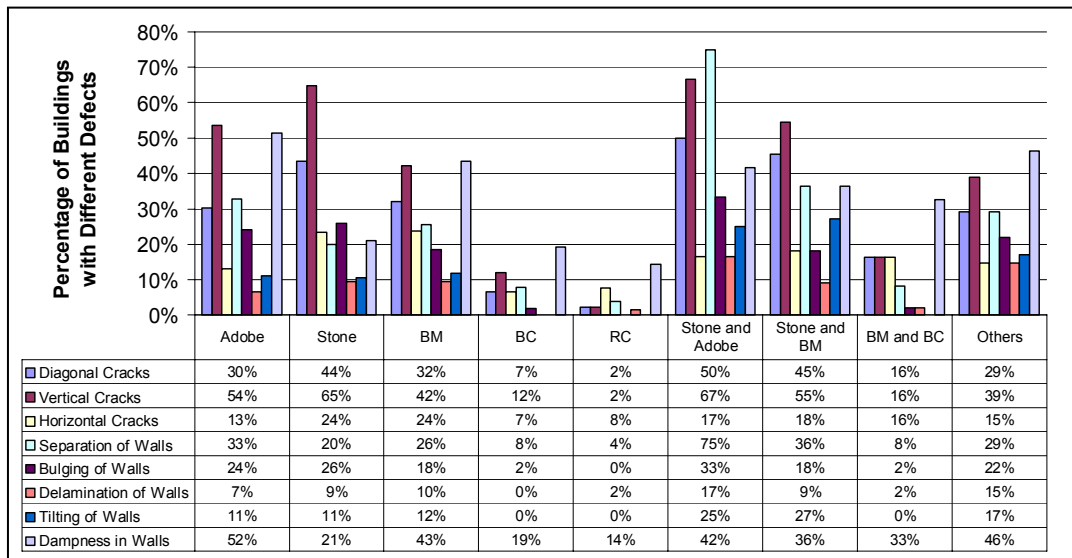
The survey result for damage to walls in each type of building is shown in Figure 1.8.4.

- Many visible defects such as cracks, wall separation, bulging, and tilting of walls were observed in mud-based buildings (adobe, and brick or stone masonry in mud mortar).
- On the contrary, much fewer visible defects were seen in cement-based constructions such as brick-in-cement and RC frames.
- Vertical cracks had developed in about 12% of the surveyed brick masonry buildings with cement mortar, diagonal and horizontal cracks were seen in 7% of the buildings, and separation of walls in about 8%.
- The major problem seen in RC construction (in about 8% of the buildings) was the development of horizontal cracks, mostly along the wall-beam contacts.
- Dampness is a serious problem in all buildings.

Figure 1.8.4 Damage to Wall in Each Type of Building

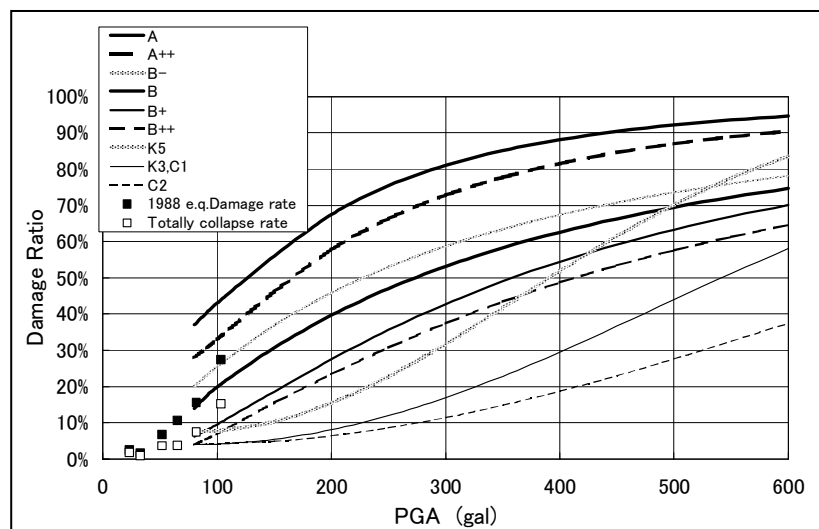
The analytical result in Table 1.8.3 was plotted on the existing fragility curves in Figure 1.8.5.

**Figure 1.8.5 Existing Fragility Curves for Building Damage**

Based on Figure 1.8.5, a fragility curve for each type of building in the Kathmandu Valley was determined as follows:

- Most of buildings damaged by the 1988 earthquake were adobe type (AD) and the envelope of the plotted points of the damage rate by the 1988 earthquake appear to be an extension of the curve A++. Therefore, the fragility curve for the damage rate for AD in the Valley can be a curve connecting the curve A++ and the envelope.

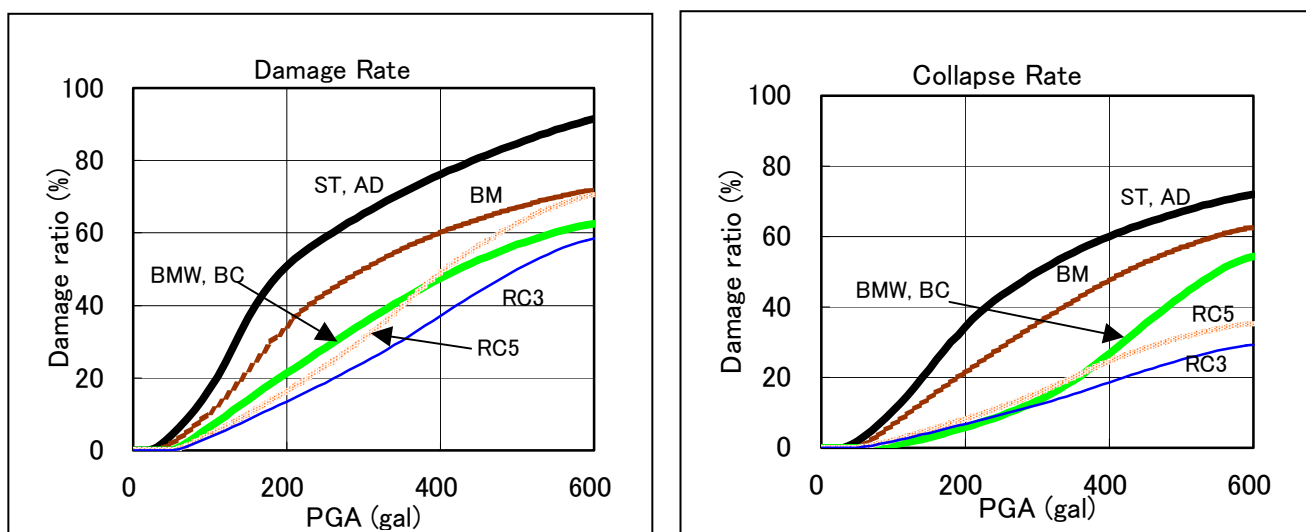
Figure 1.8.6 Fragility Curves Used in the Study

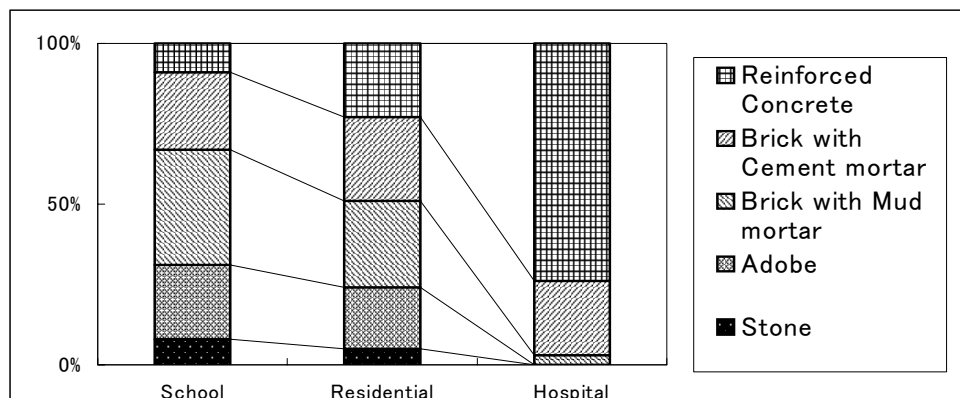
The damage ratio for schools is worse than that for residential buildings. The structure type ratios for schools and residential buildings are shown in Figure 1.9.2. The percentage of comparatively weak structure types of schools is higher

than that of residential buildings. That is why the damage ratio of schools is high. This result would indicate that school buildings could not be used for shelters after an earthquake. Furthermore, it should be kept in mind that many children in the school would suffer if the earthquake would occur in daytime on a weekday.

Figure 1.9.2 Structure Type ratio of School, Residential Building and Hospital

The damage ratio for hospitals is lower than that for residential buildings due to the type of buildings. As shown in Figure 1.9.2 of the previous section, the main type of hospital is relatively strong RC.

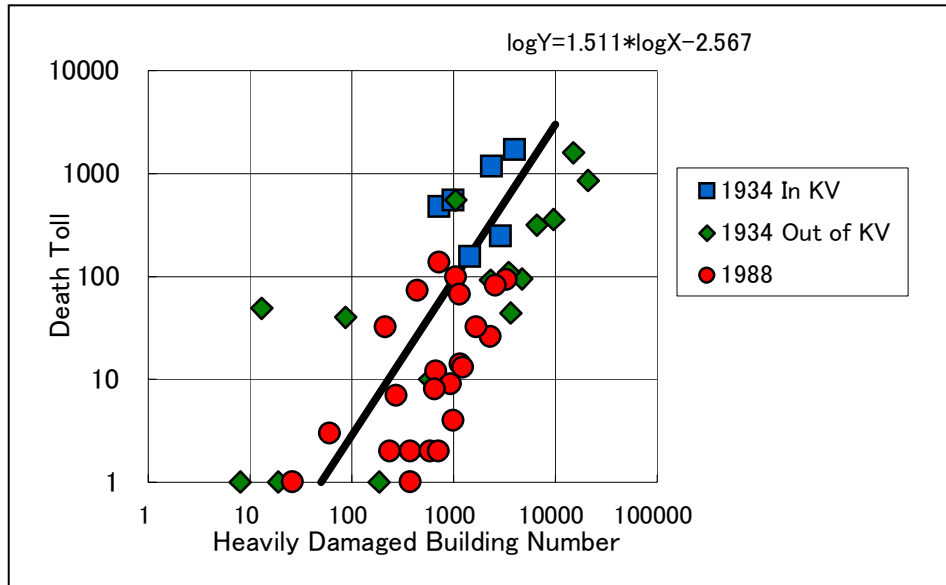
To estimate the death toll, the empirical relation between the number of heavily damaged buildings and death toll was used. This empirical relation is strongly affected by the number of residents in one building and the ratio of fatalities to the number of residents. This condition is different by country or area, so the data in Nepal were used in this study. Figure 1.10.1 shows the relation between heavily damaged or collapsed building number and death toll from the 1934 Bihar-Nepal earthquake and the 1988 Udayapur earthquake.

**Figure 1.10.1 Empirical Relation of Building Damage and Death Toll in Nepal**

These data of building damage and death toll were from Niranjana Thapa (1988) and Pandey et al. (1988). The death toll in the Kathmandu Valley in the 1934 earthquake is rather larger than the others. The concentrated building distribution in the Valley may be the reason for this difference. The black line defined by least square method in Figure 1.10.1 is the empirical relation that was used to calculate the death toll in this study.

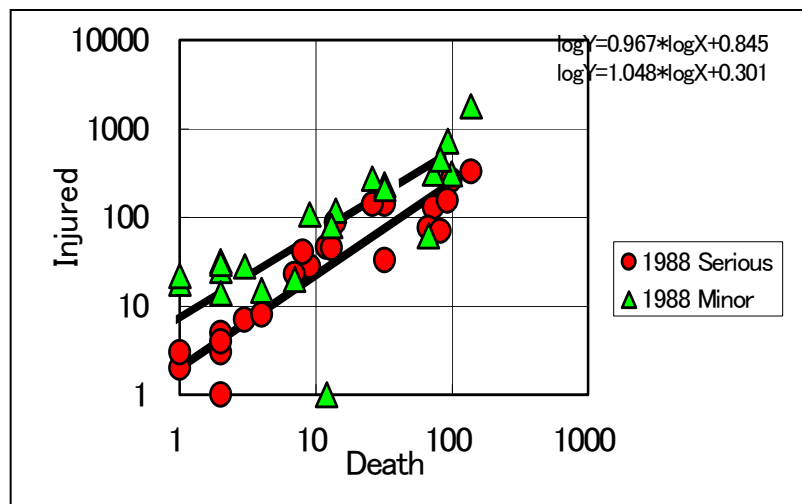
To estimate the number of injured people, the empirical relation between death toll and number injured is adopted. Figure 1.10.2 shows the relation of the seriously injured or moderately injured and the death toll from the 1988 Udayapur earthquake.

**Figure 1.10.2 Empirical relation between Death Toll and Injured in Nepal**

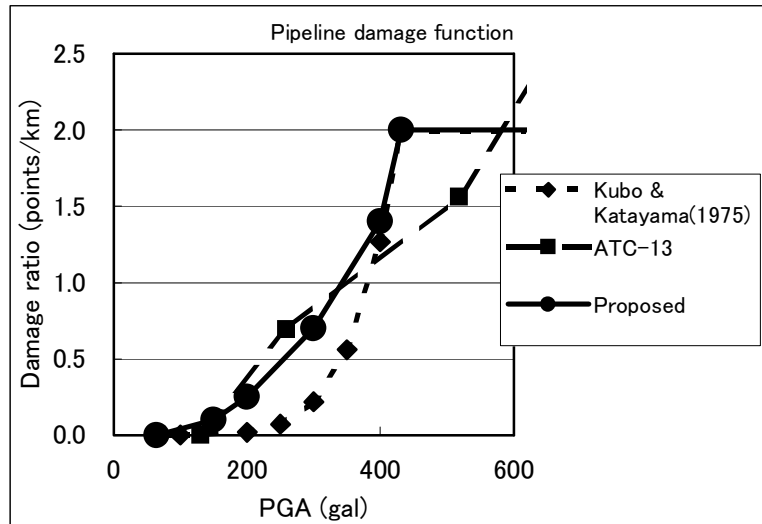
Kubo and Katayama (1975) proposed a relationship between peak ground acceleration and the damage ratio of water supply pipelines from experience in Japan, USA and Nicaragua, as shown in Figure 1.12.2. This figure also shows the damage function for distribution pipelines from ATC-13 that was originally compiled to estimate seismic damage in California, USA, using historical earthquake damage records.

Figure 1.12.2 Damage Function of Water Supply Pipelines by PGA

In this study, a new damage function was used, as shown in Figure 1.12.2. This damage function estimates a higher damage ratio than that of Kubo and Katayama (1975) because the construction quality in Nepal is poorer than in Japan, according to our field reconnaissance. But this new damage function is almost the same as that of ATC-13.

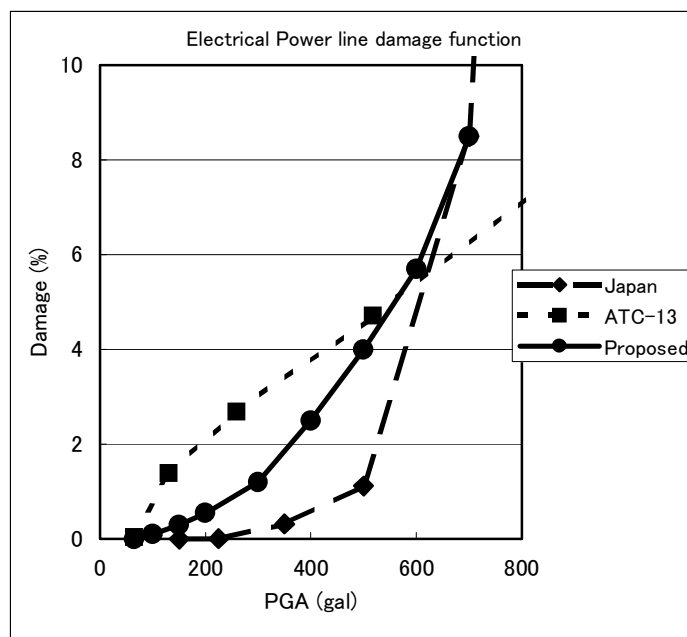
Based on this experience, the damage function for electric power supply line was made by Saitama Prefecture (1998). This damage function is shown in Figure 1.12.7. The damage function of power supply lines from ATC-13 is also shown in this figure.

Figure 1.12.7 Damage Function of Power Supply Lines by PGA

In this study, the newly proposed damage function, shown in Figure 1.12.7, was used for analysis. This function was based on the damage from the 1988 Udayapur earthquake. Dikshit (1991) reported that several electric pylons were damaged in the area of MMI VI (approximately 65 gal after Trifunac & Brady, 1975) in the 1988 Udayapur earthquake. From this damage, the smallest PGA that may cause damage to electrical power lines was estimated to be 65 gal.
