Part III Detailed Description of Exploration on Phase II

Chapter 1 Geological Investigation

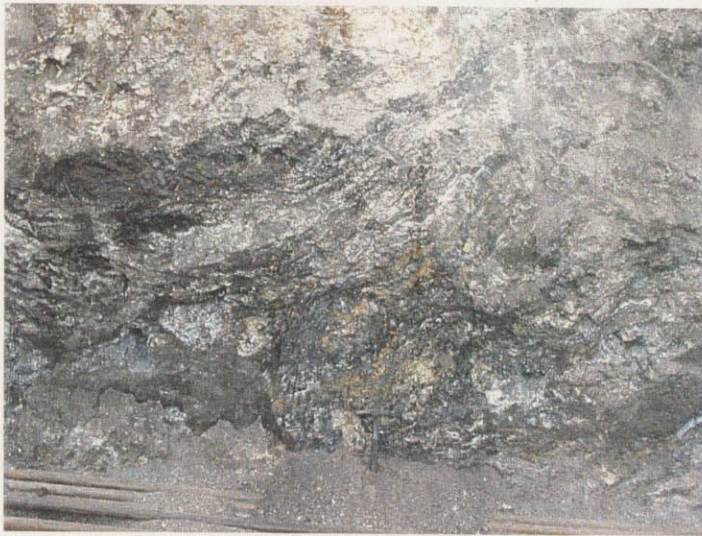
Outcrop of banded ore
near MJVD-17 boring site

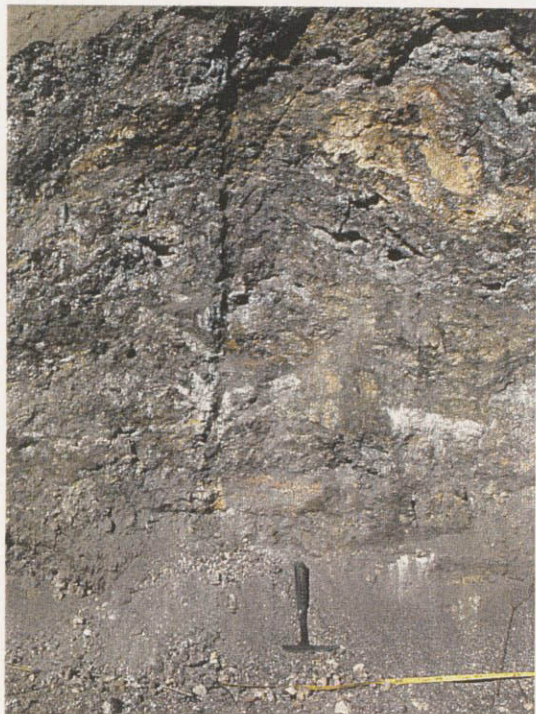
Outcrop of ore near
MJVD-17 boring site

Figure III -1-5 Photograph of the outcrop near the MJVD-17 drill hole

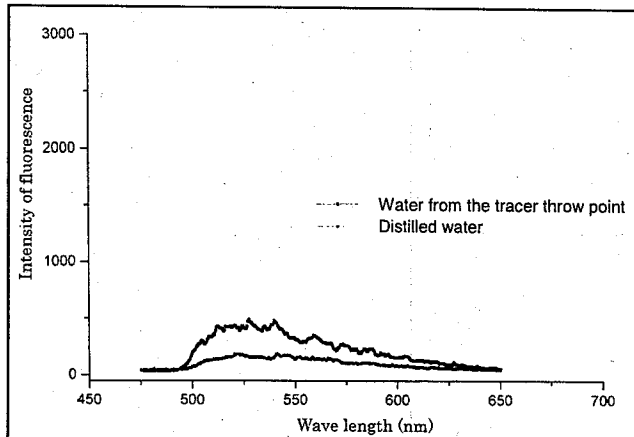
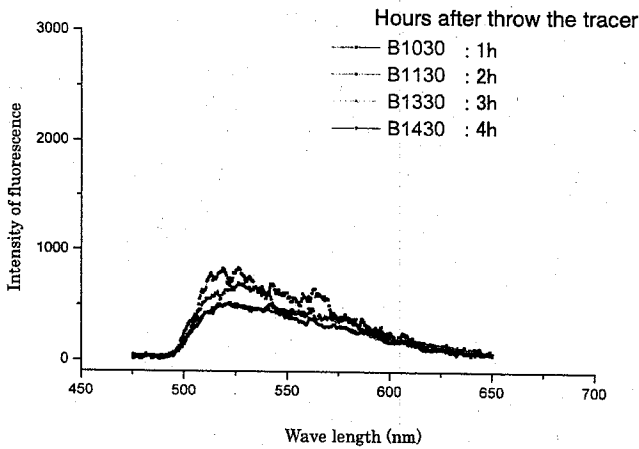
Figure III-2-3 Results of the fluorescence photo analysis (S1)

Without the Uranie (tracer)

Spectrum of a pure Uranine sample

The results of the fluorescence photometer analysis for the charcoal samples of the S-1 and S-2 stations are shown in Figures III-2-3 and III-2-4. Figure III-2-4 includes the fluorescence of the input tracer and that of the river water at the input station, DW-10. The ordinate indicates strength of fluorescence against its wave length on the abscissa in the graph. The tracer, fluorescent sodium, has its peak strength in the wave length range between 510 and 520nm.

The tracer was first detected in the water sample collected at the S-1 station 12 hours after the tracer input and continued to be detected to the sample collected 60 hours after the tracer input. The strongest fluorescence was recorded in the sample collected 18 hours after the tracer input. According to the test result, it is apparent that infiltrated water of the Dong Pao River flows through underground caves and outlets to the headwater of the Nam Hon River. It is also witnessed by the local residents that when the Dong Pao River is turbid, the Nam Hon River will become muddy some hours later.
