# GEOLOGICAL LOG OF CORE DRILL

**Project:** JICA Study Team: Landslide Protection    **Page:** 2 / 4  
**Core Drill #:** O-4    **Site Location:** Upper terrace near El Porvenir    **Ref. #:** B-2  
**Elevation:** 975.60    **Inclination (Angle with respect to Horizontal):** Vertical (90°)  
**Log Elaborated by:** Ing. Raul Flores Peñalba    **Date:** November 05, 2001

**Project:** JICA Study Team: Landslide Protection Page: 1 / 3  
**Core Drill #:** O-3 Site Location: Lower middle terrace facing gym Ref. #: B-3  
**Elevation:** 942.40 Inclinacion (Angle with respect to Horizontal): Vertical (90°)  
**Log Elaborated by:** Ing. Raul Flores Peñalba Date: October 27, 2001

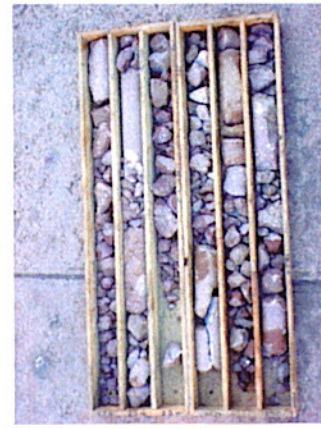
26.15 ~ m  
 F. Rio Chiquito  
 27.70 ~ 28.40m  
 shear zone

WATER CONTENT END OF DRILLING	ELEVATION (M)	DRILL DEPTH (M)	GRAPHIC LOG	CLASSIFICATION AND PHYSICAL CONDITION (COLOR)
NOV 8 16.20	960.60	15.00	[Graphic Log: Soil with small clasts]	Deiftus; area of rhyolite boulders with small lenses of clay

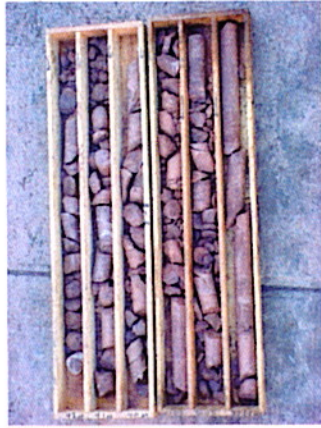
34.58~ m shear zone

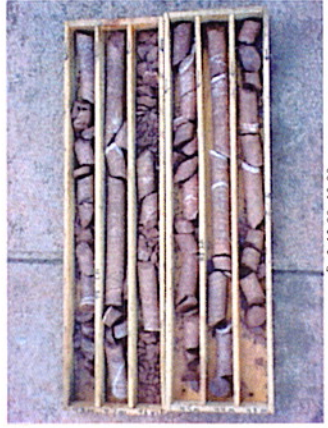
38.00~38.50m shear zone

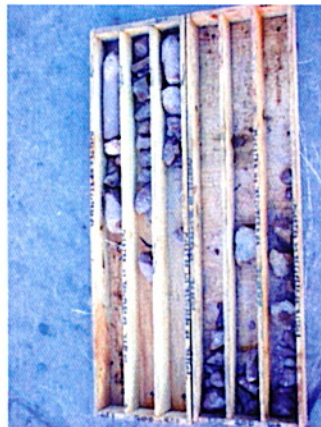
B-3 0 00-6 00m

0.00~20.25m  
Detritus

WATER CONTENT END OF DRILLING	ELEVATION (M)	DRILL DEPTH (M)	GRAPHIC LOG	CLASSIFICATION AND PHYSICAL CONDITION (COLOR)
	942.40	0.00	[Graphic Log]	Detritus; area of rhyolite boulders with small lenses of clay
	941.40	1.00	[Graphic Log]	
	940.40	2.00	[Graphic Log]	
	939.40	3.00	[Graphic Log]	
	938.40	4.00	[Graphic Log]	
	937.40	5.00	[Graphic Log]	
OCT. 11	936.40	6.00	[Graphic Log]	
5.70	935.40	7.00	[Graphic Log]	
	934.40	8.00	[Graphic Log]	
	933.40	9.00	[Graphic Log]	
	932.40	10.00	[Graphic Log]	
	931.40	11.00	[Graphic Log]	
	930.40	12.00	[Graphic Log]	
	929.40	13.00	[Graphic Log]	
	928.40	14.00	[Graphic Log]	
	927.40	15.00	[Graphic Log]	Clay lens with detritus material of sands, gravels and pebbles
