GEOLOGICAL LOG OF CORE DRILL

Project: JICA Study Team: Landslide Protection Page: 1 / 2
Core Drill #: Y-5 Site Location: Landslide lower Terrace front of gym Ref. #: B-5
Elevation: 928.10 Inclination (Angle with respect to Horizontal): Vertical (90°)
Log Elaborated by: Ing. Raul Flores Peñalba Date: October 25, 2001

Project: JICA Study Team: Landslide Protection Page: 1 / 4
 Core Drill #: Y-8 Site Location: Upper terrace near Mountainside Ref. #: B-6
 Elevation: 965.10 Inclination (Angle with respect to Horizontal): Vertical (90°)
 Log Elaborated by: Ing. Raul Flores Peñaiba Date: November 10, 2001

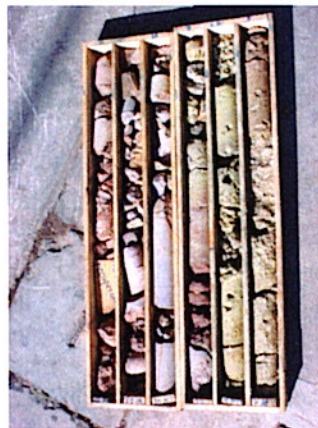
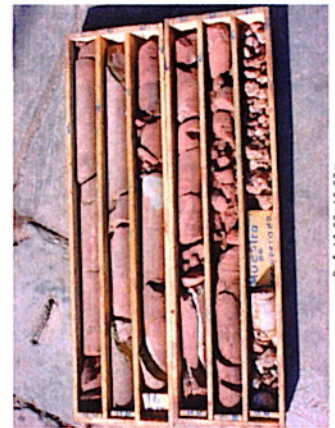
0.00~13.00m
Detritus

13.00~ m
F. Rio Chiquito

WATER CONTENT END OF DRILLING	ELEVATION (M)	DRILL DEPTH (M)	GRAPHIC LOG	CLASSIFICATION AND PHYSICAL CONDITION (COLOR)
	928.10	0.00		
	927.10	1.00		Topsoil, with organic contamination, brown color
	926.10	2.00		
	925.10	3.00		
OCT 23 3.40	924.10	4.00		Detritus; area of rhyolite boulders interbedded within lenses of clay
	923.10	5.00		
	922.10	6.00		
	921.10	7.00		Lens of clayey sand, brownish to greenish color
	920.10	8.00		
	919.10	9.00		
	918.10	10.00		
	917.10	11.00		Detritus; area of rhyolite boulders interbedded within lenses of clay
	916.10	12.00		
OCT 24 13.00	915.10	13.00		
	914.10	14.00		Rock contact composed of lutite (shale) or sandstone due to small particles of quartz present on core, red color with white bands of gypsum
	913.10	15.00

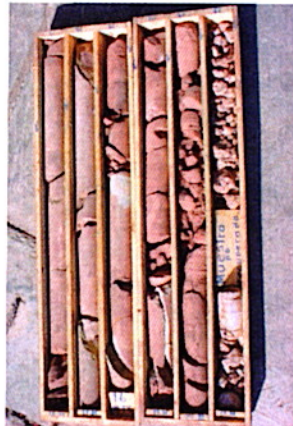
WATER CONTENT END OF DRILLING	ELEVATION (M)	DRILL DEPTH (M)	GRAPHIC LOG	CLASSIFICATION AND PHYSICAL CONDITION (COLOR)
	913.10	15.00		
	897.10	16.00		
	896.10	17.00		
	895.10	18.00		
	894.10	19.00		
	893.10	20.00		
	892.10	21.00		
	891.10	22.00		
	890.10	23.00		
	889.10	24.00		
	888.10	25.00		
				Bottom of Borehole

sound rock Formation Rio Chiquito

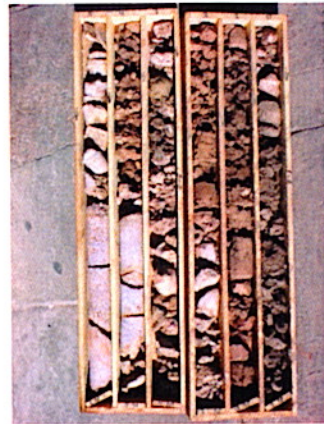
WATER CONTENT END OF DRILLING	ELEVATION (m)	DRILL DEPTH (m)	GRAPHIC LOG	CLASSIFICATION AND PHYSICAL CONDITION (COLOR)
	965.10	0.00		
	964.10	1.00		Topsoil with organic contamination, clayey matrix
	963.10	2.00		
	962.10	2.60		
	961.10	4.00		
	960.10	5.00		
	959.10	6.00		
	958.10	7.00		
	957.10	8.00		Detritus; area of rhyolite boulders with small lenses of clay
	956.10	9.00		
	955.10	10.00		
	954.10	11.00		
	953.10	12.00		
	952.10	13.00		
	951.10	14.00		Red clay layer with fragments of boulders or gravels, possibly redeposited soils
	950.10	14.85		
		15.00

2.60~43.40m
 Detritus (Boulder, Red clay, Gravels, Alternated)

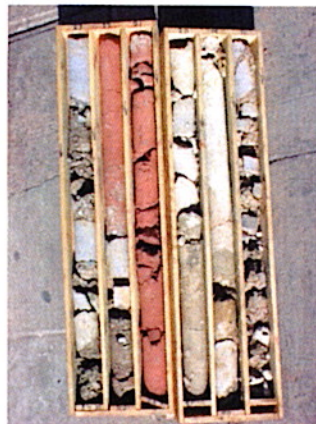
WATER CONTENT END OF DRILLING	ELEVATION (M)	DRILL DEPTH (M)	GRAPHIC LOG	CLASSIFICATION AND PHYSICAL CONDITION (COLOR)
	950.10	15.00		Detritus: area of rhyolite boulders with small lenses of clay
	934.10	16.00		
	933.10	17.00		
	932.10	18.00		
	931.10	19.00		
	930.10	20.00		
	929.10	21.00		
	928.10	22.00		
	927.10	23.00		
	927.10	23.75		
NOV.9	926.10	24.00		Red clay lens with gravels or boulder fragments of rhyolite rocks, redeposited soils
24.0	925.10	25.00		
	924.10	26.00		Detritus: area of rhyolite boulders with small lenses of clay
	923.10	27.00		
	922.10	28.00		
	921.10	29.00		
	920.10	30.00		Red sandy clay layer with small pebbles of detritus
