# **The Pilot Study on** *Improvement of Al-Bassa Disposal Site*

## **Weekly Report**

# Week 3

*June 23<sup>rd</sup> – 29<sup>th</sup>, 2001*

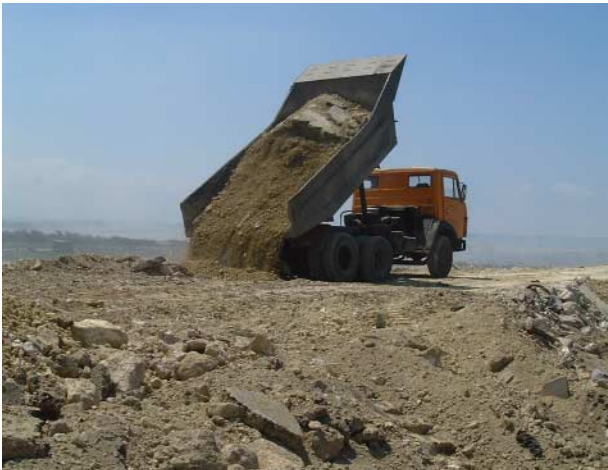
At the beginning of this week, dump truck continued to discharge the construction debris to be used to cover the top of the embankment as already described in weekly report 2 (figure 3.2).

*(Figure 3.2)* Dump truck is discharging the construction debris on embankment 1

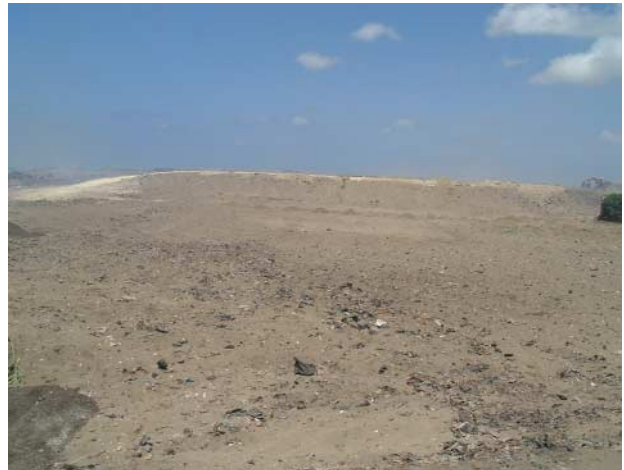
At the end of this week, embankment 1 is 100 % completed and covered with construction debris (figure 3.3).

*(Figure 3.3)* Completed embankment 1, as seen near the control house

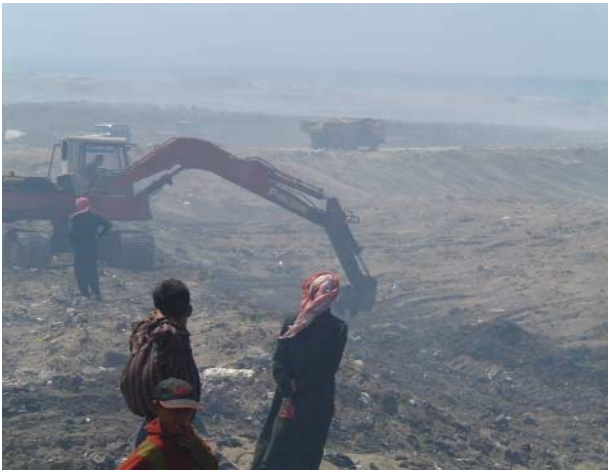
As mentioned in item 1 of this report, at the beginning of this week, the re-arranged waste is used for the core of the embankment (figure 3.4).

*(Figure 3.4)* Re-arranging the accumulated waste as core of embankment 2

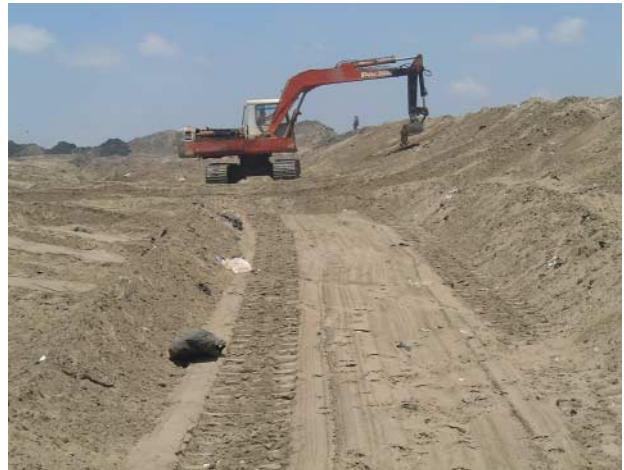
Later, the core is completed and cover-soil started to be applied to the embankment (figure 3.5).

*(Figure 3.5)* Applying the cover-soil to embankment 2

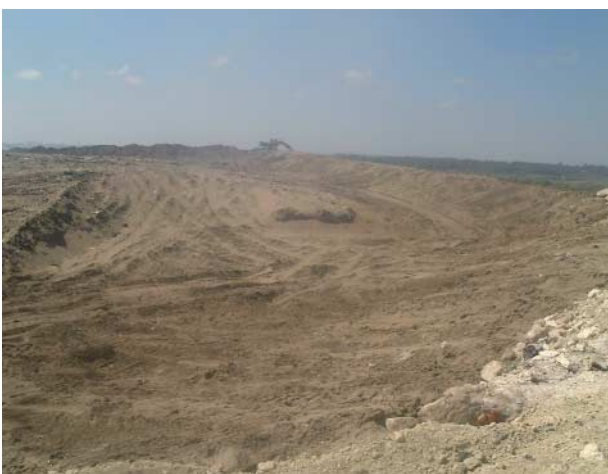
Finally, almost 80 % embankment was covered with the sand, but still the construction debris is not applied (figure 3.6).

*(Figure 3.6)* Embankment 2 at the end of week 3

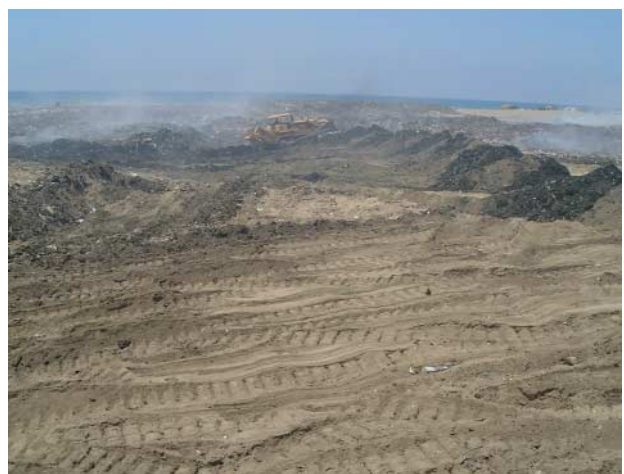
When the embankment 2 has been finished, bulldozer started to re-arrange the accumulated waste to be use as core of embankment 3 (figure 3.7)

*(Figure 3.7)* Start of the cored re-arranged waste of embankment 3

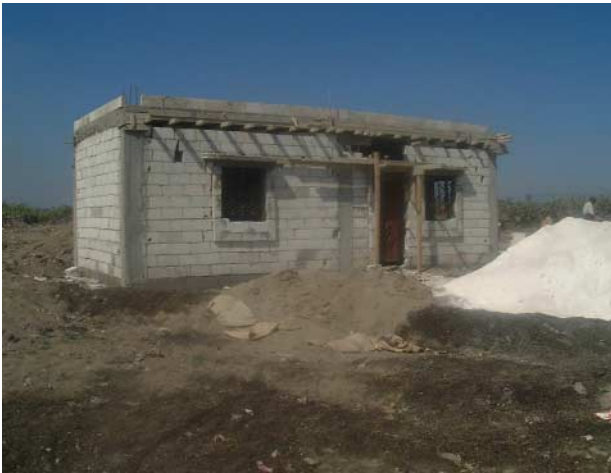
Still the wooden shuttering of the roof is not removed (figure 3.8), it takes for the reinforced concrete approximately 10 days to dry up; therefore, the shuttering would be removed next week.

*(Figure 3.8)* Control house during week 3

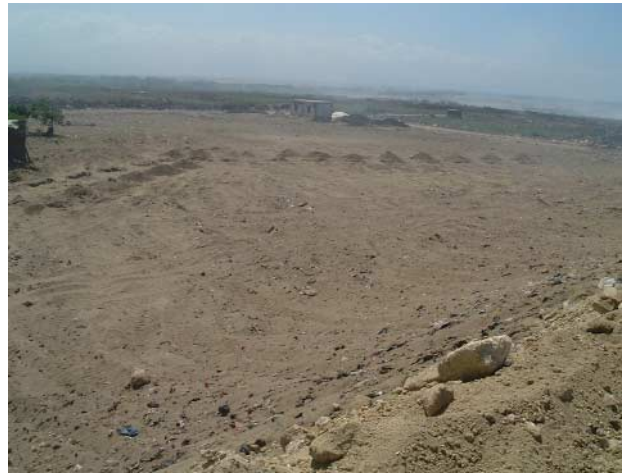
At the start of this week, excavations are made to install the iron-supports for the two parts of the fence (figures 3.1 & 3.9), and later the supports of the first part are installed (figures 3.10 & 3.1).

*(Figure 3.9)* Preparation excavations for the fence

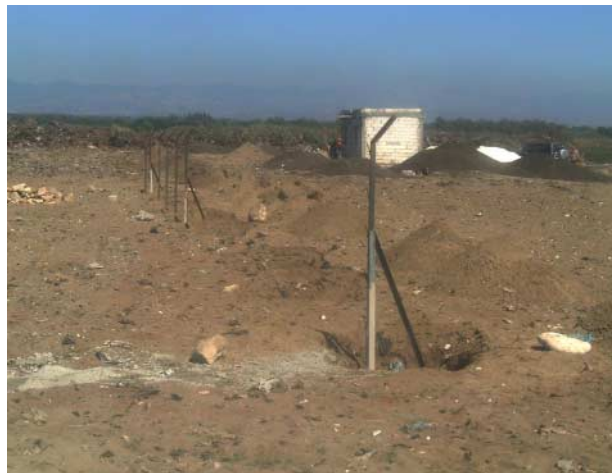
*(Figure 3.10)* Installation of the iron-supports of the fence

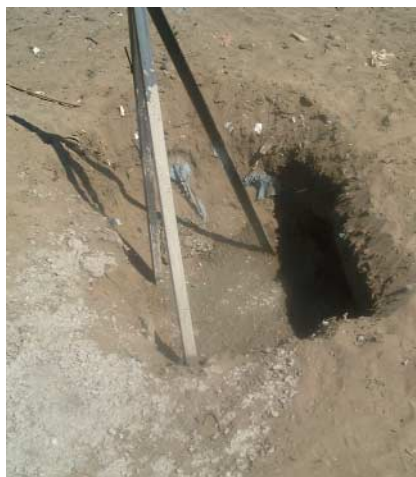
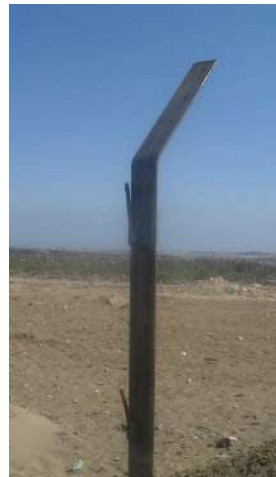
*(Figure 3.11)* Iron-support of the fence

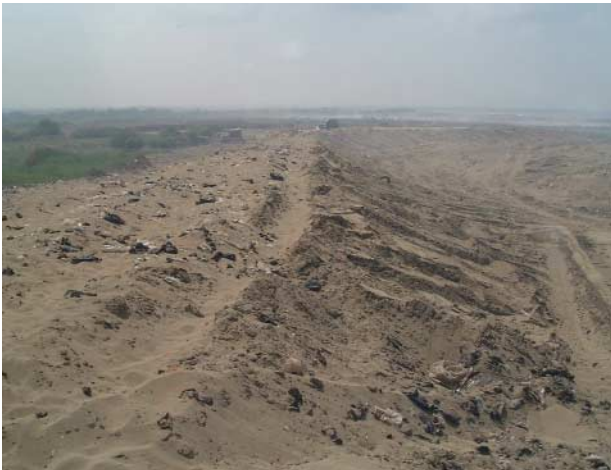
During this week, cover-soil applying for embankment 2 has been completed (figure 4.2)

*(Figure 4.2)* Cover-soil is applied to the entire of embankment 2

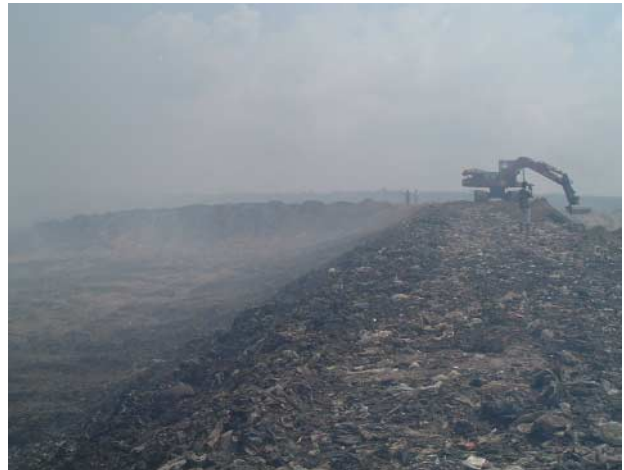
The core of this embankment has been 90% completed using the re-arranged waste, (figure 4.3), and cover-soil is applied to about 40 % of the embankment (figures 4.4 & 4.5)

*(Figure 4.3)* Completing the core of embankment 3

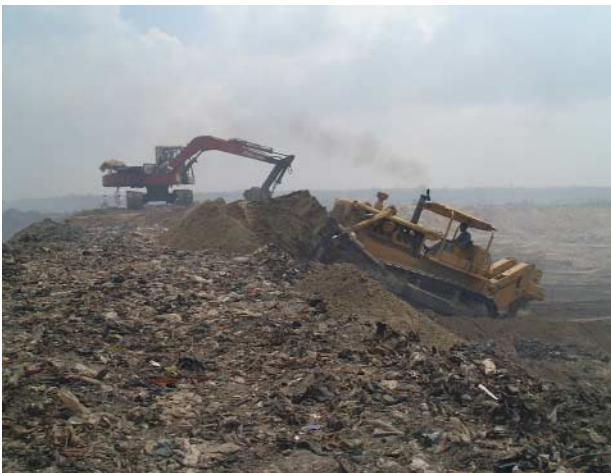
*(Figure 4.4)* Applying cover-soil to the cored waste of embankment 3

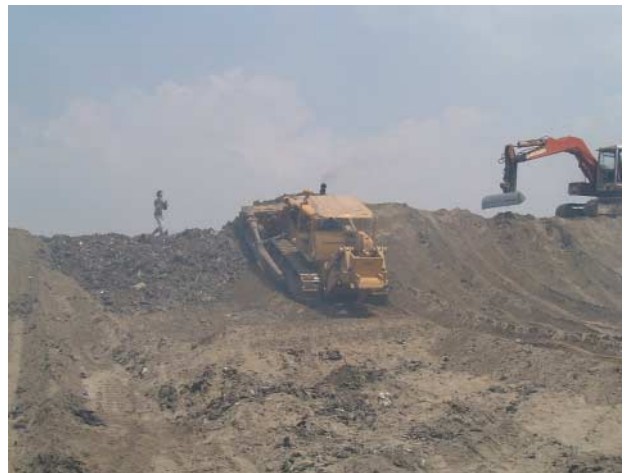
*(Figure 4.5)* Pushing the cover-soil from bottom to up leads the good compaction of the cored waste, as well as leveling by the backhoe

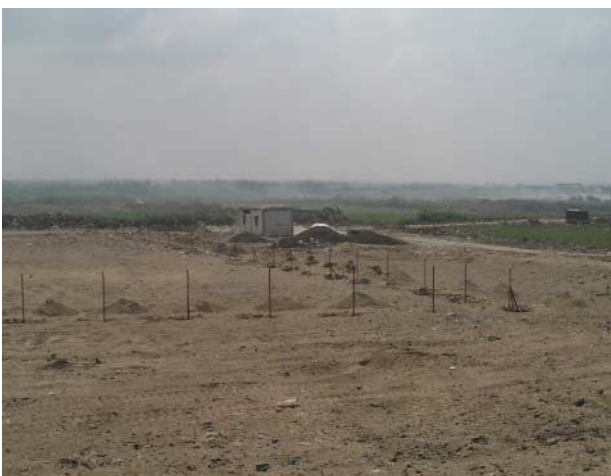
Installation of the iron-support of the second part of the fence is also completed this week, but still the steel-net is not installed yet (figure 4.6).

*(Figure 4.6)* Installation of the iron-support on both parts of the fence is completed.

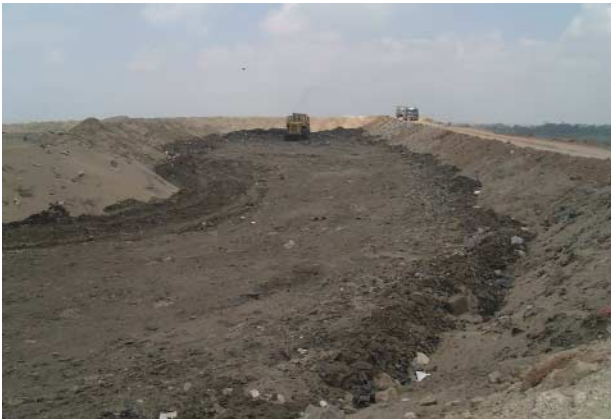
Construction debris is applied to the entire of this embankment (figure 5.2)

Construction of operation road near the embankments 1 & 2 is completed this week. For this purpose, re-arranged accumulated waste is used as it is quite dry and can bear the collection vehicles that are proposed to start discharging the waste as from next week (figure 5.2).

*(Figure 5.2)* Construction debris covering the top of the entire embankment 2.  
Construction of operation road

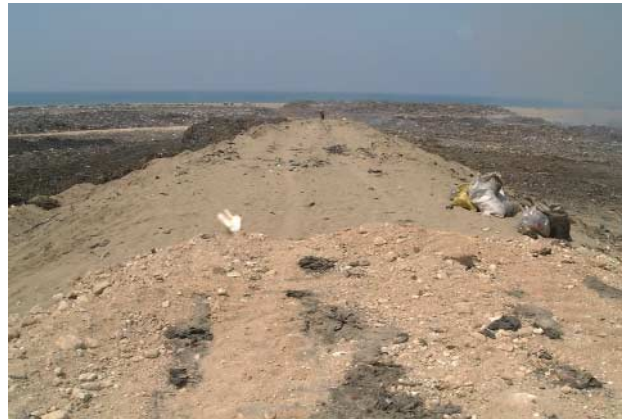
Cover-soil is applied to the entire of this embankment, but still the construction debris is covering approximately 10 % of it (figure 5.3).

*(Figure 5.3)* Cover-soil applied to the entire embankment 3, and construction debris on 10 % of it

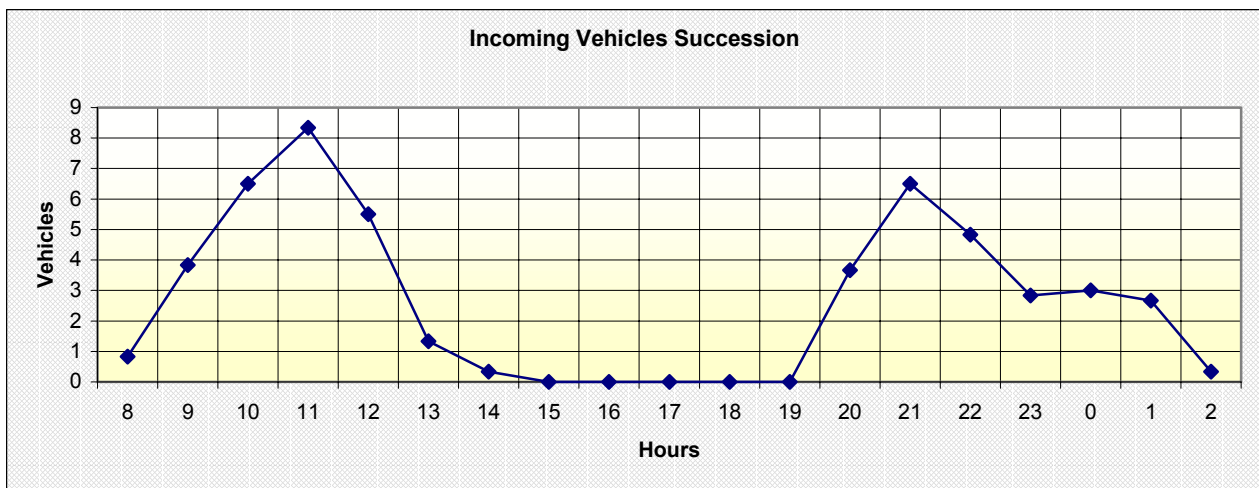
*Peak-hour for the incoming vehicle for the day-shift is between 10:00 to 12:00 (figure 6.1.)*

*Peak-hour for the incoming vehicles for the night-shift is between 20:00 to 22:00 (figure 6.1).*

(Figure 6.1) Average of the daily incoming vehicles during Week 6

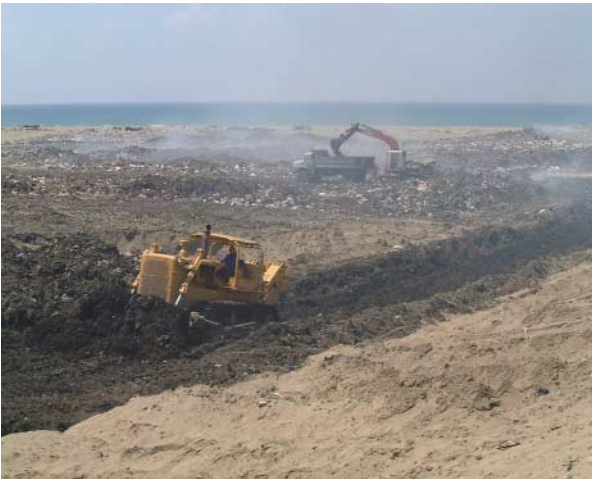
At the start of this week, the bulldozer was still re-arranging the existing accumulated waste in the working-phase 2 (figure 6.3), while the incoming vehicles started to discharge the waste in the working-phase 1 (figures 6.5 & 6.6).

*(Figure 6.3)* Re-arrangement of existing accumulated waste by bulldozer (Working-phase 2)

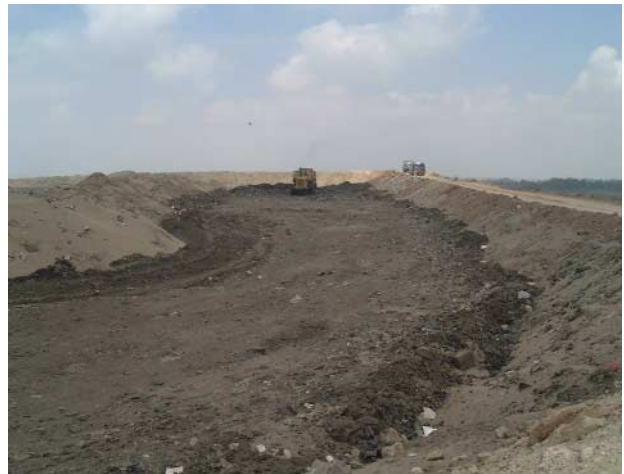
*(Figure 6.4)* Working-phase 1 before receiving the daily incoming waste

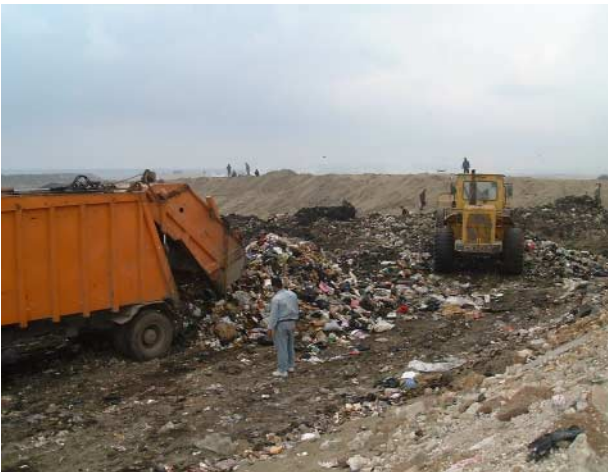
Discharging of the new incoming waste started in the **working-phase 1** (figures 6.2, 6.5 & 6.6). The vehicles are coming from the cities of Lattakia, Al-Qurdaha, Baniyas, and some of the villages surrounding Lattakia city.

*(Figure 6.5)* Start of discharging the new incoming waste in the working-phase 1

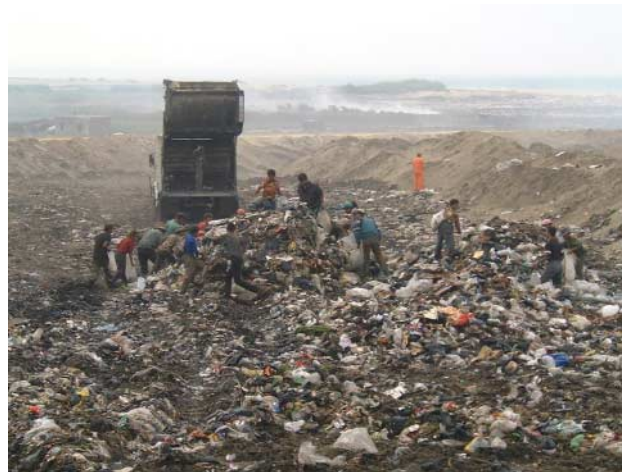
The waste-pickers were picking the recyclable materials from the waste when just being discharged from the incoming vehicle (figure 6.6), or when pushed by the bulldozer. They never worked far from the landfill equipments; therefore, endangering themselves and possibly cause various accidents.

*(Figure 6.6)* Discharging of new incoming waste in working-phase 1, as well as scavenging activities

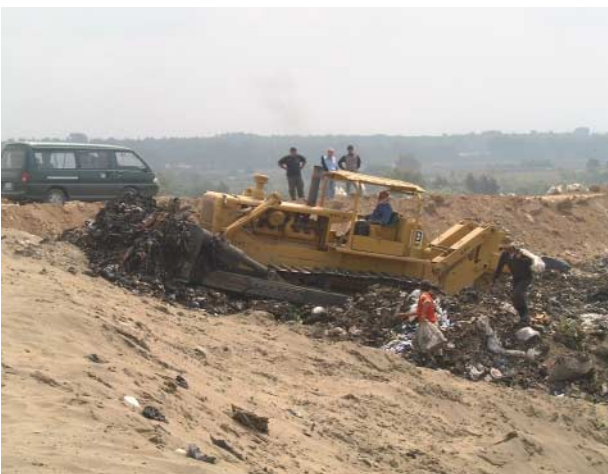
The bulldozer had been instructed by *JICA Study Team* to push the newly discharged waste in the working-phase 1, towards the embankment No.3 (shown on the attached drawing “figure 6.2”) in order to make the compacted waste cell with the slope of about (1:4) from the waste, which may lead the easy operations (figures 6.7 & 6.8).

*(Figure 6.7)* Pushing the new incoming waste by bulldozer towards embankment No.3

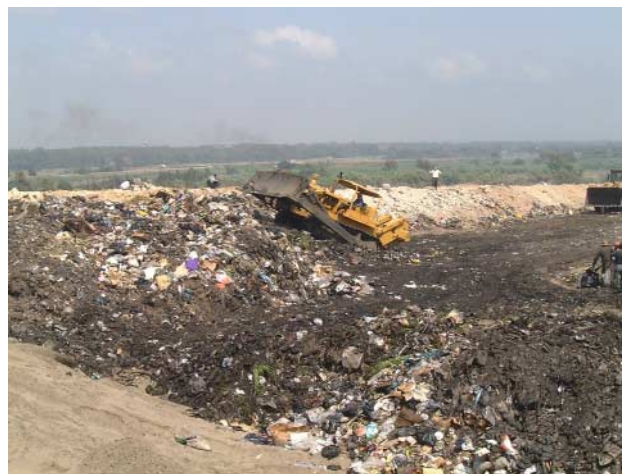
*(Figure 6.8)* The pushed waste after few days...

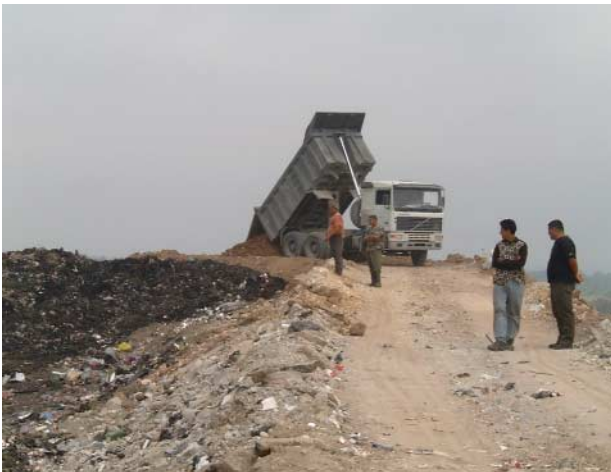
Dump truck is discharging the sand to be used as cover-soil; this sand is being taken – with the cooperation of the excavator) from the hill already existing in the Pilot Study Area (figure 6.2 & 6.9).

*(Figure 6.9)* Dump truck is discharging the soil to be used later as cover soil

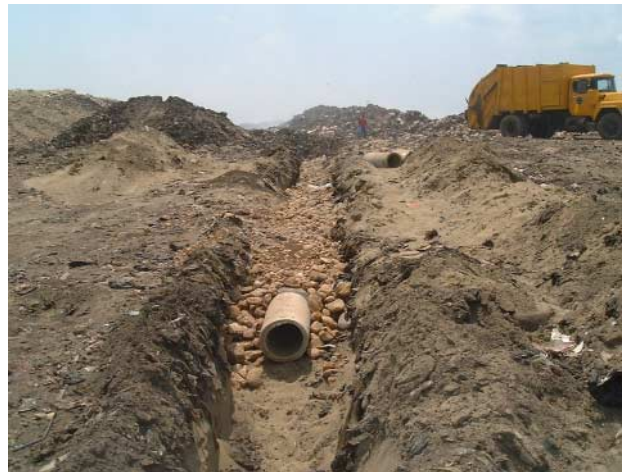
Leachate collection pipes have been installed in two parts (figures 6.2 & 6.10): the first is 35 m long inside working-phase 1 of the Pilot Study Area; the second is 15 m long near the access road.

For this purpose, concrete pipes (1 m long each piece, 5 cm thickness, 30 cm internal diameter & 40 cm external diameter, with holes of 2 cm diameter each 20 cm) is used. Covered with a 10-20 cm layer of gravels (diameters of which are 5-15 cm).

Start level of the first part of the leachate collection pipe is 5.79 m from the sea (-0.5 m from the ground level), end level of which is - 1.5 m from the ground level, and end level of the second part is 4.8 m from the sea (-1.94 m from the ground level).

*(Figure 6.10)* Implementation of Leachate collection pipes (part 1)

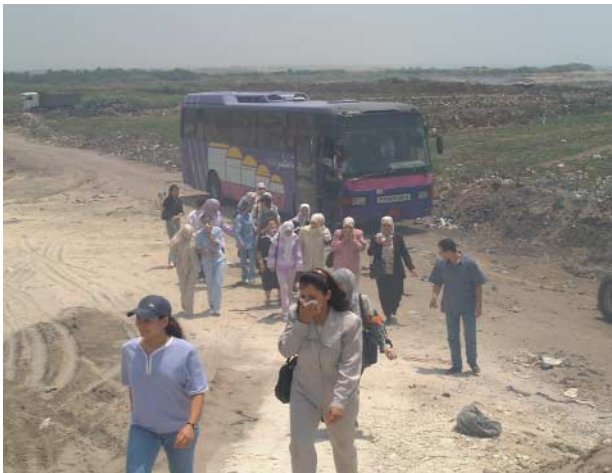
*(Figure 6.11)* Bus tour to Al-Bassa Disposal Site for JICA Study Team & some families

On July 19<sup>th</sup> 2001, *JICA Study Team* in cooperation with the Local Consultant Team, have organized a bus tour to both Compost Plant and the Pilot Project of Al-Bassa Disposal Site in order to increase (or even create) public awareness of what is going on in Al-Bassa...(figures 6.11 & 6.12).

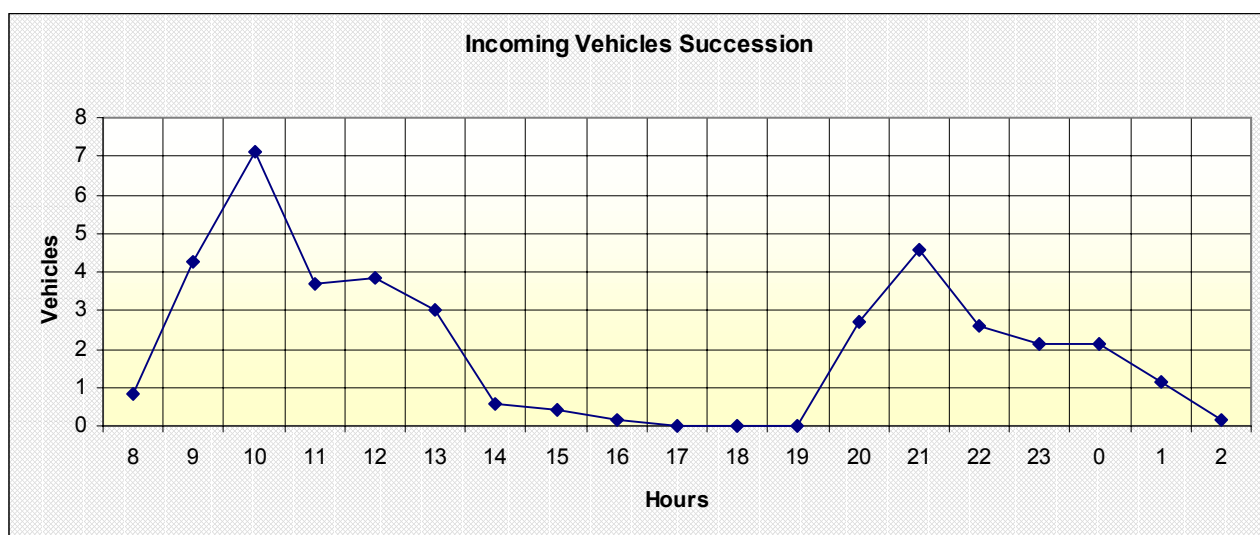
The succession average of the daily incoming vehicles is shown in figure 7.1

*Peak hour for the day-shift this week is 10:00 (it was 11:00 in week 6).*

*Peak hour for the night-shift is 21:00 (same as week 6).*

(Figure 7.1) Average of the daily incoming vehicles during Week 7

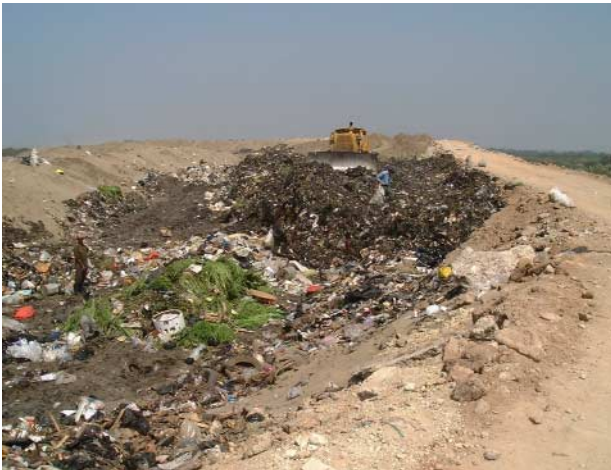
*JICA Study Team* have noticed that the bulldozer is pushing the new waste opposite to the direction of embankment 3 (figure 7.3), and as this would not help in good compaction of the waste, as well as complicating forming the 1:4 slope from the waste. Therefore, the driver has been instructed to push & compact the waste from bottom to up, towards embankment 3 (figure 7.4).

(Figure 7.3) The wrong method in pushing the waste (Working-phase 1)

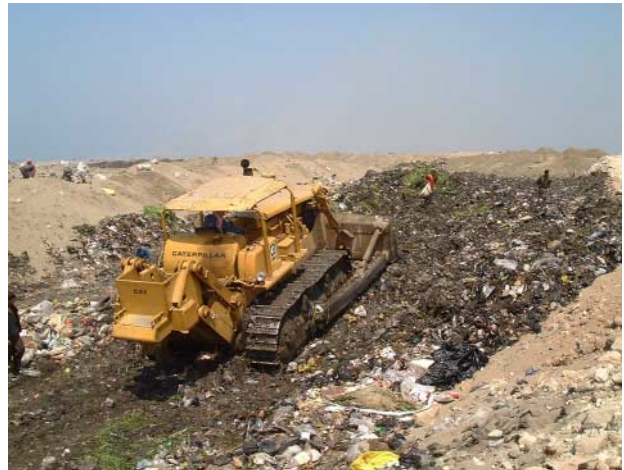
(Figure 7.4) The correct way in pushing & compacting the waste

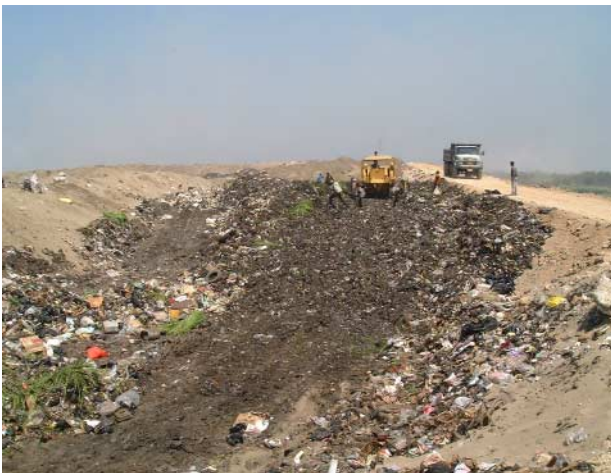
In pushing the waste, the bulldozer had left a clearance between the waste and the existing hill (figure 7.5), so *JICA Study Team* instructed the driver not to leave any clearances anywhere.

(Figure 7.5) The clearance area left to the compacted waste

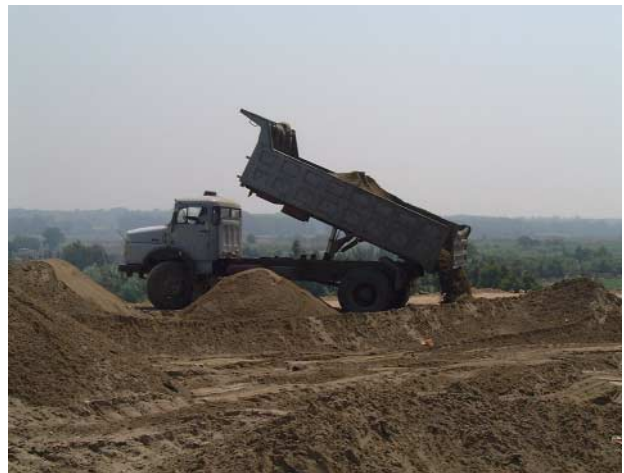
The dump truck is discharging the sand to be used as cover-soil at the corner between embankment 2 and 3 (figure 7.6). While it is driving on the access to the top of embankment 1, some sand is falling due to not closing the back-door firmly (figure 7.7), and that is causing some difficulties to other cars (i.e. inspection vehicles) to go up on the embankments. So *JICA Study Team* instructed the driver to either firmly close the back-door of the dump truck, or drive backwards to the location of discharge, so that way no sand is falling. (It was chosen to drive backwards...).

(Figure 7.6) Discharging the sand to be used later as cover-soil

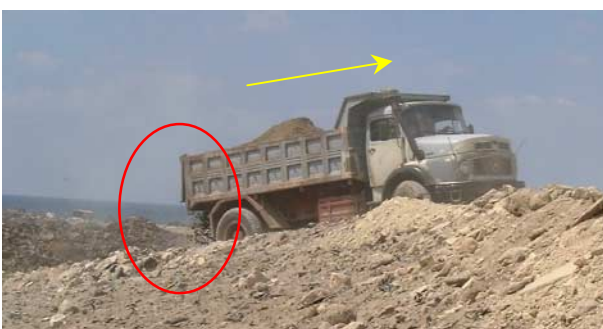
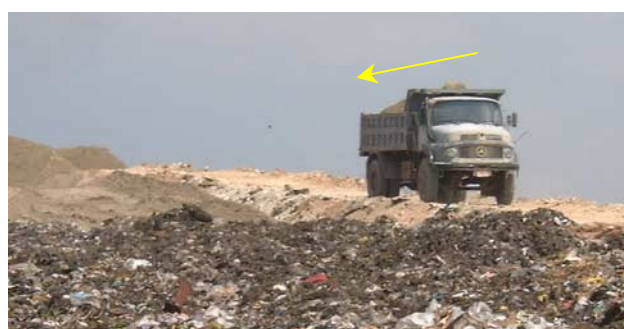
(Figure 7.7) Left: the sand is falling. Right: after instructions by JICA Study Team

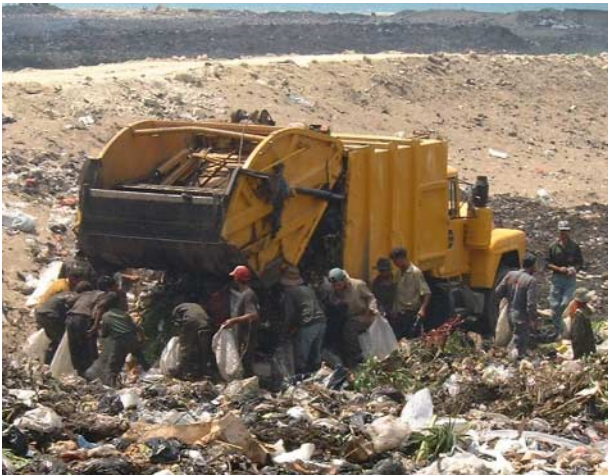
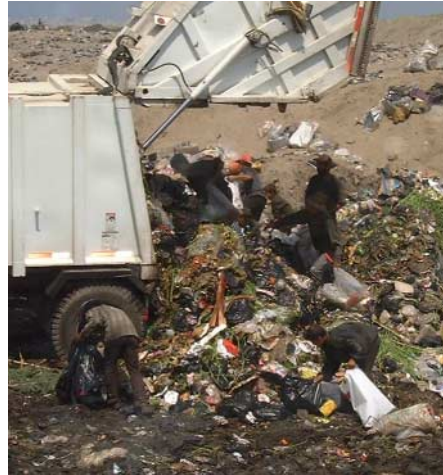
Scavenging activities have increased this week than week 6, the number of waste-pickers became around 50. They are causing delay of landfill work by bulldozer as well as discharging the waste by the collection vehicles. They are so close to the vehicles when the waste discharged as well as the bulldozer to push the waste, i.e. they are picking waste just when being discharged or pushed by the bulldozer, and it may cause a great danger (figure 7.8).

*(Figure 7.8)* Top left & right: Waste-pickers are so close to the vehicles while they discharge.  
Bottom: and also to the bulldozer while pushing the waste
