## **CHAPTER 4 EXISTING ROAD, PAVEMENT AND BRIDGE CONDITIONS AND ITS INVENTORY SURVEY**

### **4.1      Existing Road Conditions**

#### 4.4 Condition of Existing Bridges

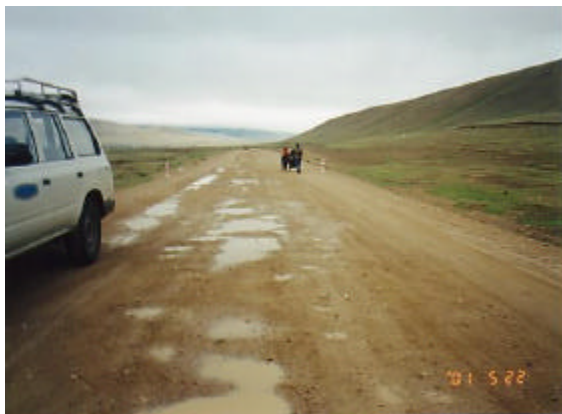
**Photograph 4-8-1 Large amount of potholes on Gravel Road**

A site visit was carried out on May 22, 2001 and photographs shown below taken. Photographs already show potholes and rutting on the surface after one year since construction. In addition, there is loss of fine aggregates on the top of the gravel road and large angular stones were exposed.

These kinds of defects may cause reduced riding comfort and without frequent maintenance, it is very difficult to keep good riding comfort on this kind of gravel road.
