Chapter 6

Traffic Safety Facilities and Devices

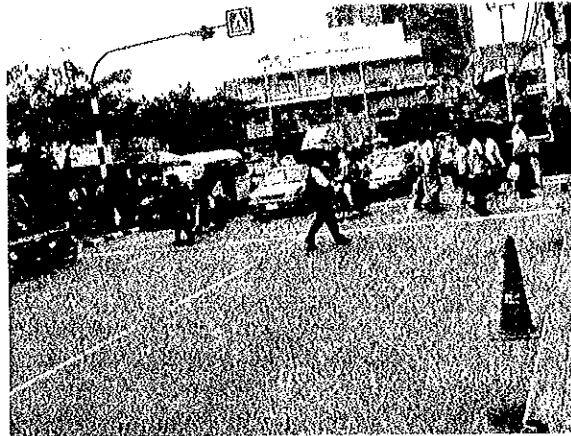
Figure 6-3 Mid-Block Pedestrian Crossing and Illuminated Pedestrian Warning Sign

There are a significant number of non-signalized pedestrian crossings (zebra crossings) around the city. These are often located mid-block and accompanied by wayside pedestrian crossing traffic warning signs. At six special locations (where tourists traffic is high, such as Chang Klan Road, Moonmuang road) internally illuminated pedestrian warning signs on high poles are installed, accompanied by blinking lights (see Figure 6-3)

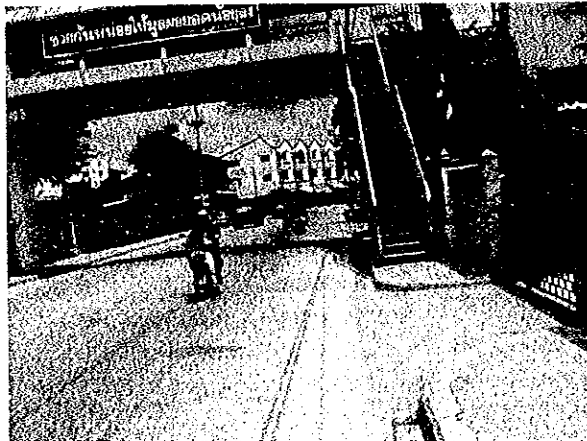
Figure 6-4 Pedestrian Overpass with Steep Steps (Charoen Prathaet Road)

Seven pedestrian overpasses have been installed in the city. Although such overpasses are found mostly near schools for the students to cross streets, on the whole, there are few users. User resistance toward overpasses is high in Chiang Mai most probably due to the height and steep steps when accessing them (see Figure 6-4).

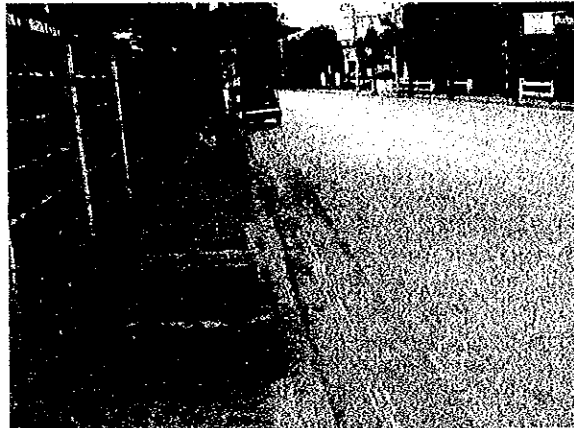
Figure 6-7 Narrow Sidewalk with Obstacles

- There is very little sidewalk space along which people can walk comfortably.
- The difference in elevation between the sidewalk and the roadway is quite substantial at many locations. This may pose a problem to senior citizens and handicapped persons. Due to this big difference, ramps at road corners are steep and therefore unsafe for handicapped persons (see Figure 6-6).
- Many structures and objects are erected in the center of the sidewalks. These include telephone booths, trees, bus stops, lamp poles, telegraph poles, and signal controller boxes (see Figure 6-7).
- Some of the sidewalks are paved with colored concrete blocks. Many are poorly constructed with the result that some blocks are missing or loosen. The surface of the pavement therefore is uneven (see Figure 6-8).

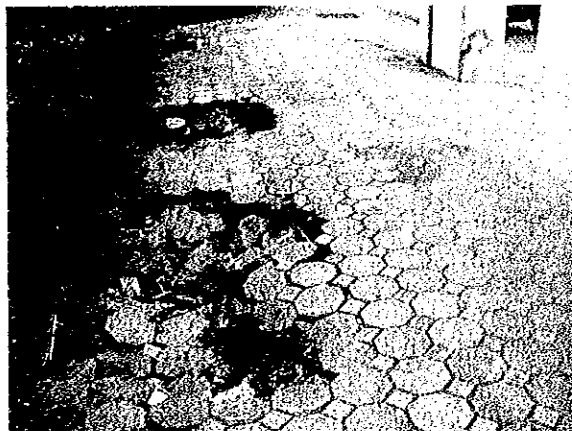
Figure 6-8 Collapsed Block Pavement dues to Poor Sand Compaction

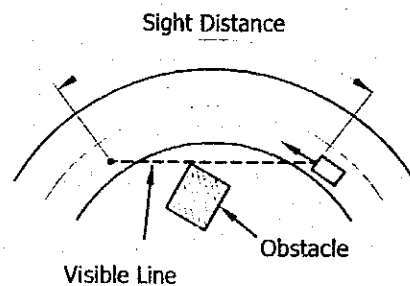
Figure 6-11 Sight Distance of Two-Way Road

Guidelines for providing safe sight distances are given in the table below. Along road sections with sight distances below the recommended distance as shown, the risk of collision is much greater if any obstacles exist ahead.

Type of Road Section	Vehicle Speed	Safe Sight Distance
Two-Way Road (less than two lanes)	30 km/h	More than 60 m
	20 km/h	More than 40 m
Two-Way Road (more than two lanes)	50 km/h	More than 55 m
	40 km/h	More than 40 m
