Location of Phru Phli Khwai Retarding Basin

Profile and Average Grade Line along Khlong Wa

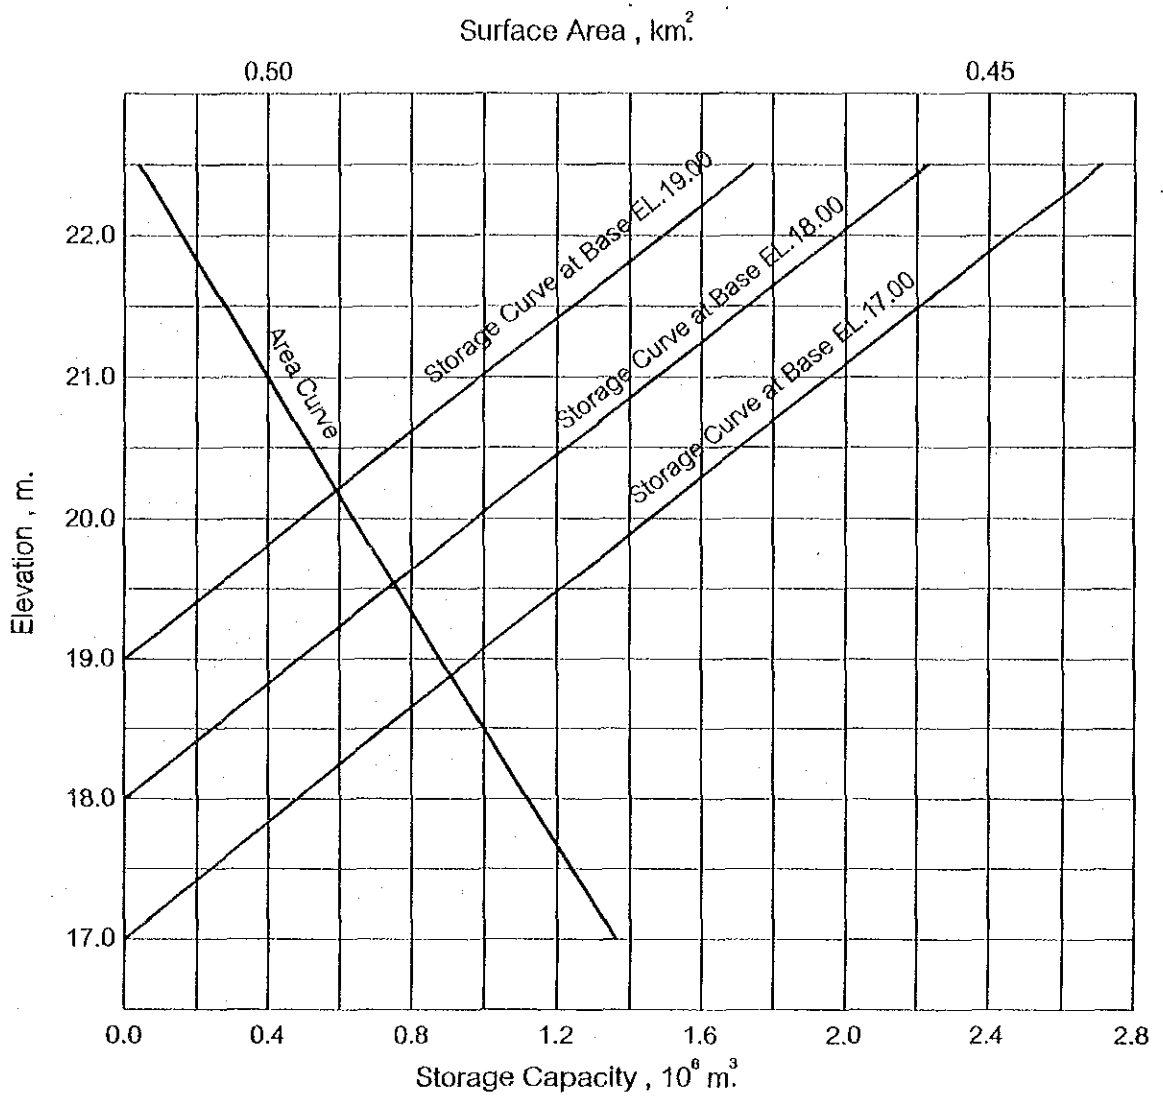
Fig. 4.1-4

Elev. (m.)	Area (km ²)	Capacity at Base Elevation (10 ⁶ m ³)		
		17.00	18.00	19.00
17.00	0.476	0		
18.00	0.482	0.479	0	
19.00	0.488	0.964	0.485	0
20.00	0.494	1.455	0.976	0.491
21.00	0.500	1.952	1.473	0.988
22.00	0.506	2.455	1.976	1.491
22.50	0.509	2.709	2.230	1.745

Area Capacity Curve of Phru Phli Khwai Retarding Basin

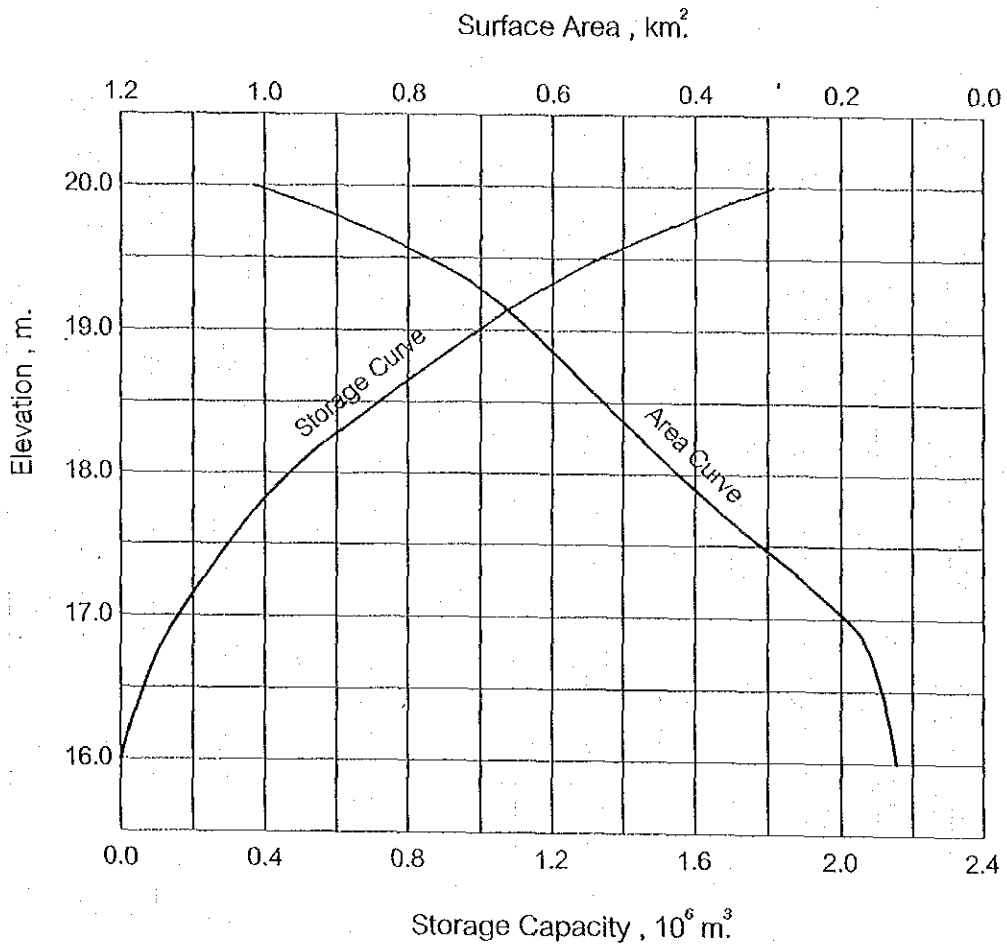
Fig.4.1-5

Elev. (m.)	Area (km ²)	Capacity (10 ⁶ m ³)
16.00	0.123	0
17.00	0.193	0.158
18.00	0.423	0.466
19.00	0.630	0.992
20.00	1.015	1.815

Area Capacity Curve of Phru Mao Retarding Basin
