9.4.2. Sewage Pipeline

9.4.3. Gas Pipeline and Service Box

9.5. Bridge

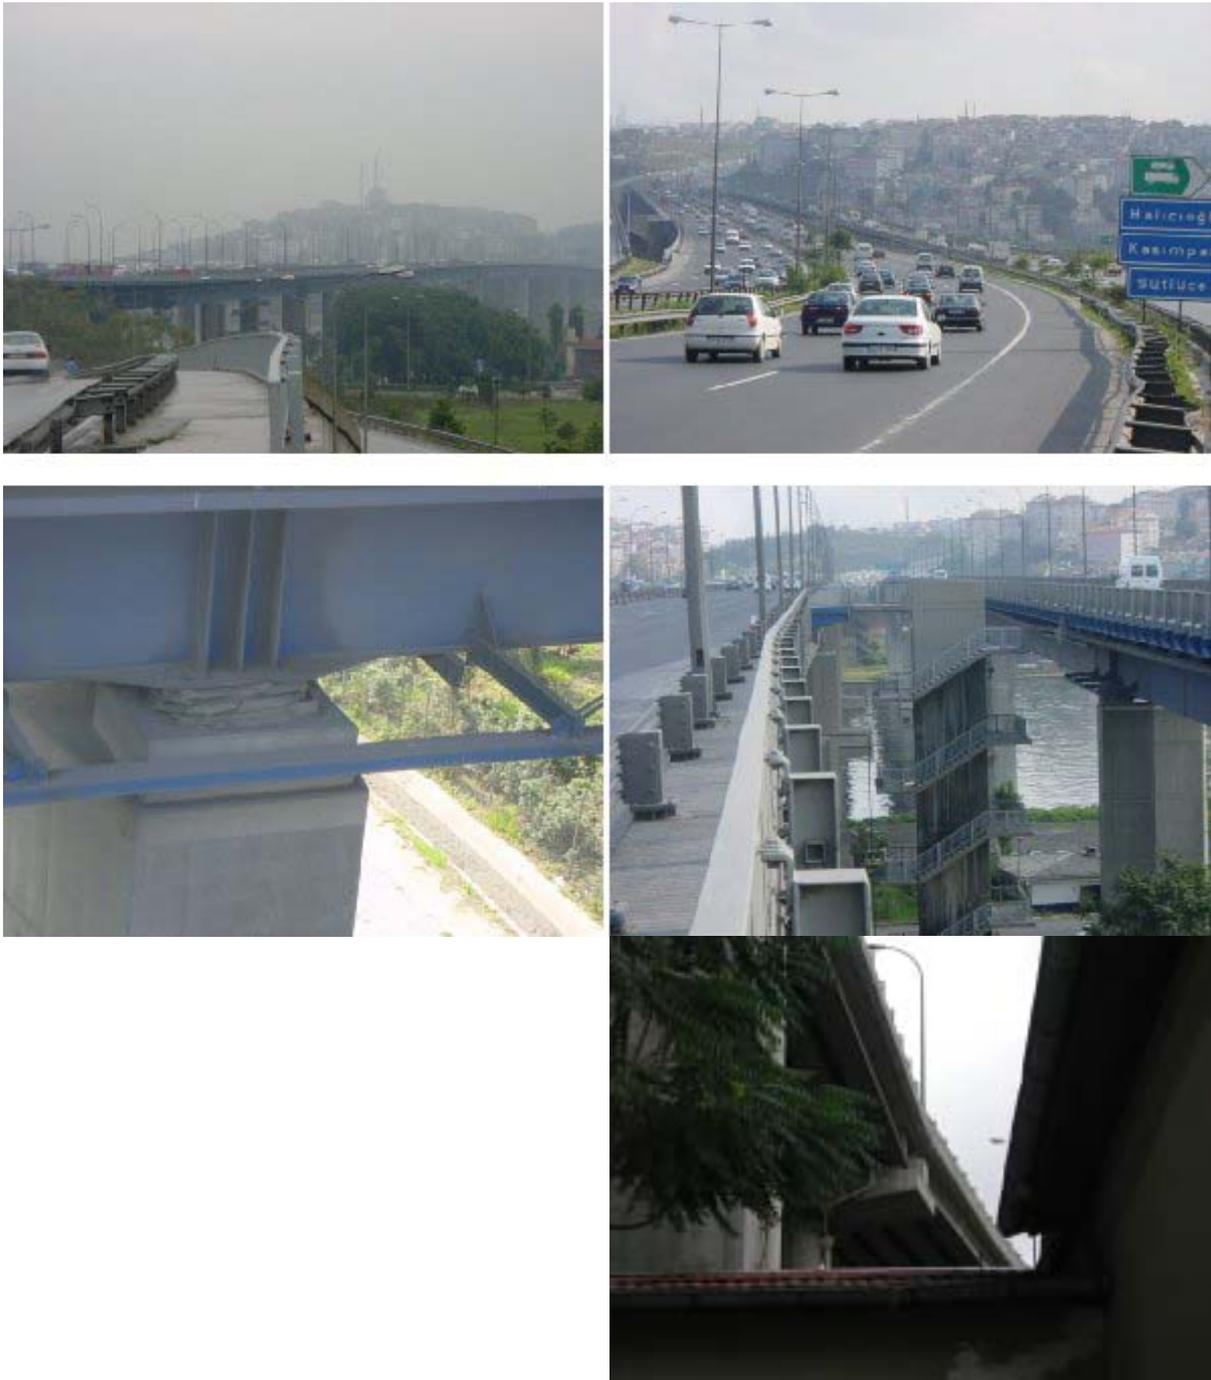
(1) No.52 (Score; 93.7)

The evaluated result of this bridge shows the highest score 93.7, but some explanation is needed for this example. The reason why this bridge possesses the highest value is “there are a combination of single span of the girder and continuous girder” and “the pier is very high”. Some possibility of collision between continuous girder that has very large mass and single span of girder that has comparatively light mass. The girder that has larger mass compared with single span of the girder can give a large impact to the single span of the girder. Therefore careful discussion is needed considering collision. The falling-off prevention device can be effective for this situation as mentioned later.

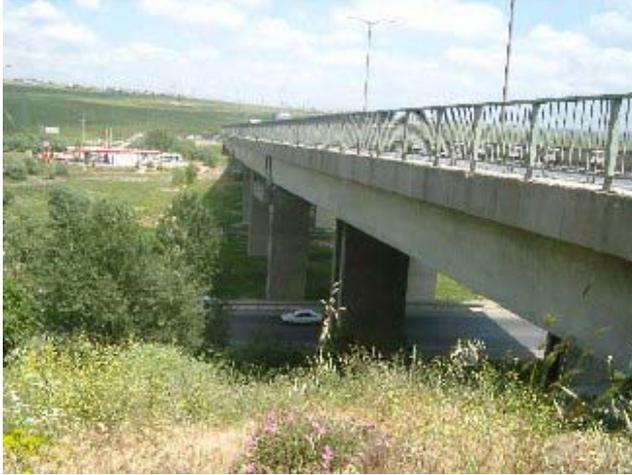
(2) No.188 (Score; 89.8)

The evaluated result of this bridge is 89.8. The reason why this bridge possesses the high value is that this bridge is composed of simple beam of the girder and that pier is comparatively high. The collision between each girder can cause contingent boost of displacement and falling-off of the girder.

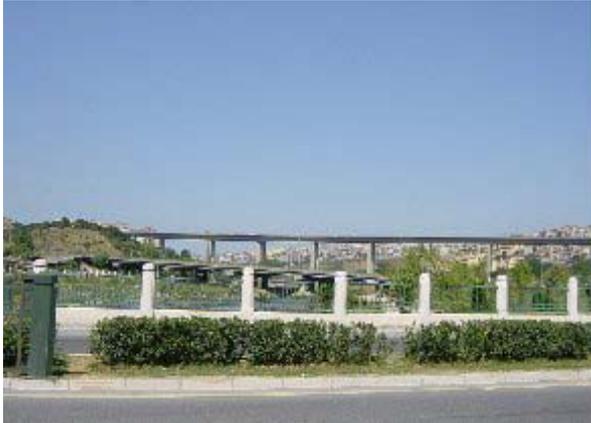
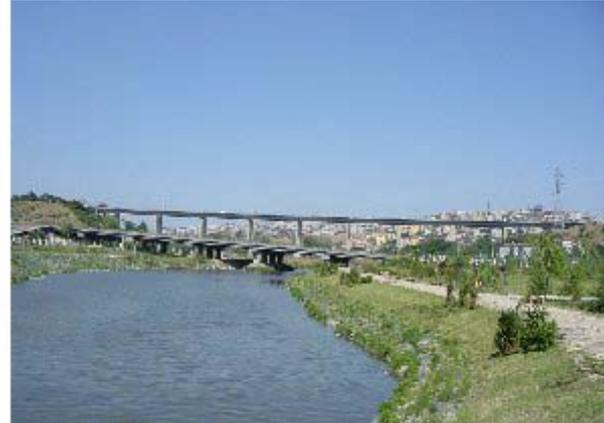
(3) No.89 (Score; 79.2)

The evaluated result of this bridge is 79.2. The reason why this bridge possesses the high value is that this bridge is composed of simple beam of the girder and that pier is comparatively high.

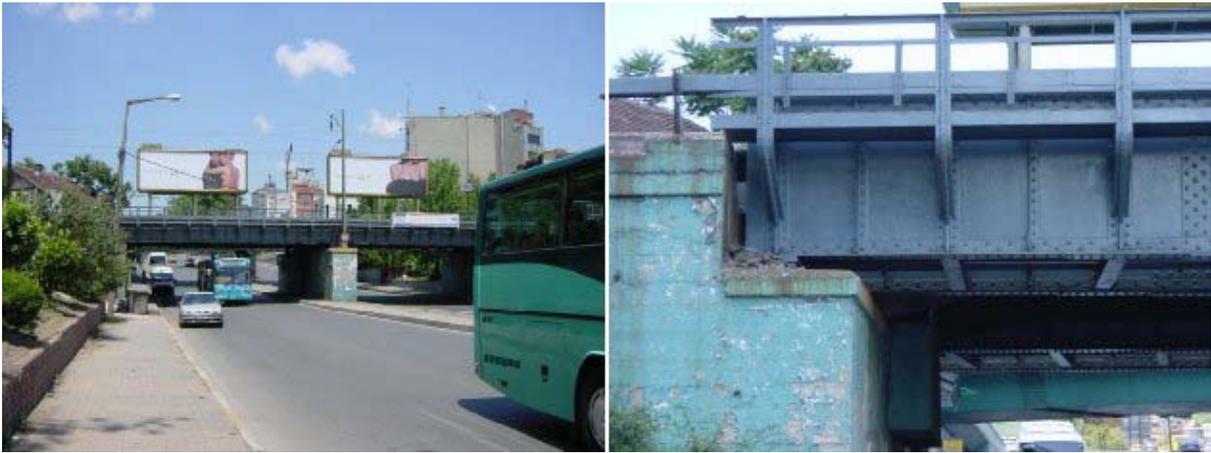
(4) T5 (Score; 62.0)

The evaluated result of this bridge is 62.0. The reason why this bridge possesses the high value is that this bridge is composed of simple beam of the girder. In addition two bearings on the pier allow relative displacement of the girder face to face. This kind of bearing condition can cause very large relative displacement, because neighboring pier may have two bearings, which do not allow relative displacement of the girder face to face. These two kinds of structure parts have very different natural period, so there can be large relative displacement of the girder.

However the neighboring under parts of structure are abutment which is bonded on the earth, so the natural period of the abutment can not be so long. This is a few exception which is assessed excessively severe in Ktayama's method, but this kind of bearing condition must be cautioned.

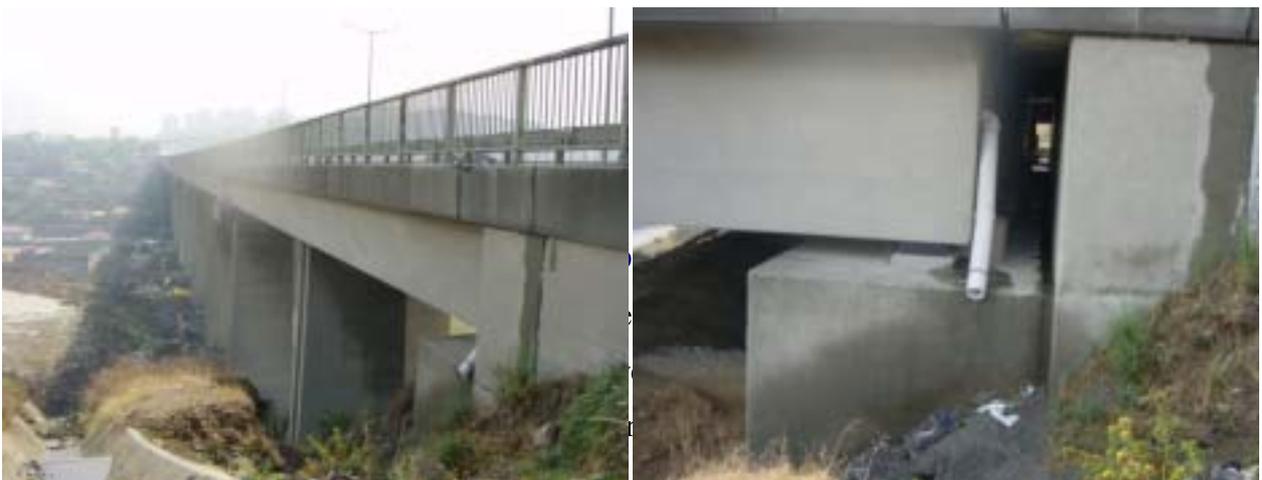
(5) No.57 (Score; 59.9)

However the void between the girder end and the face of abutment is comparatively large, so there may not be a collision in this part.

The void between each girder end on the pier could not be identified in this study. If that void is kept reasonably the problem of collision can be prevented. Regarding the Minimum Seat Width, if the width is kept reasonably the problem of falling-off of the girder can be prevented.
