CHAPTER 5
IMPROVED DEEP WELL

Supporting Report 1

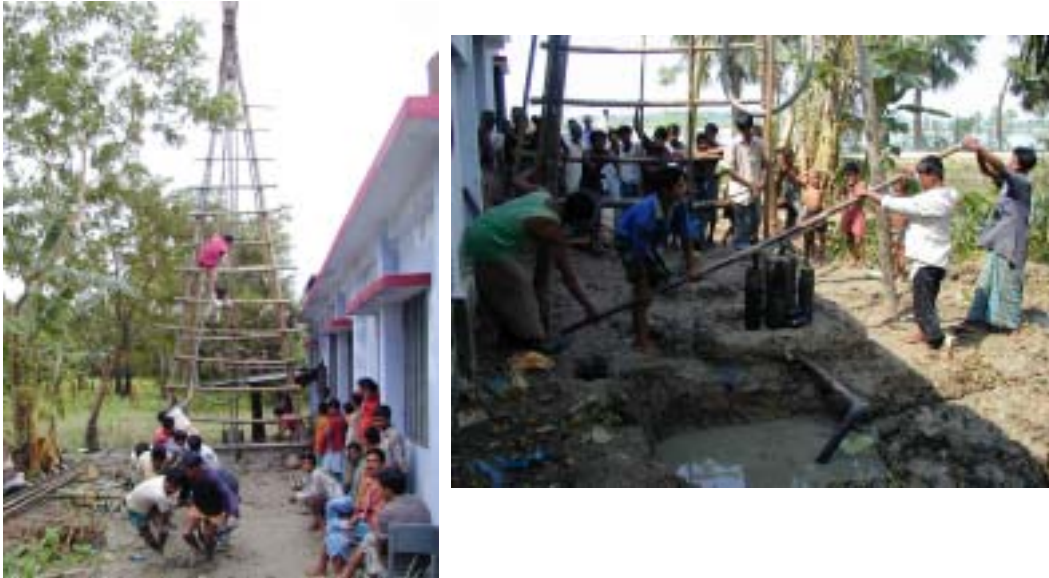
Figure 5.8 Drilling by Donkey method

Because Tremie pipe to fill cement is inserted into the borehole after the placement of the casing, the borehole diameter is increased to 150mm by two steps of drilling. The first step of drilling used the 90mm diameter cutter, and the second step of drilling used the 150mm diameter cutter. Diamond tips are attached to these cutters for drilling stone layers (Fig.5.8).

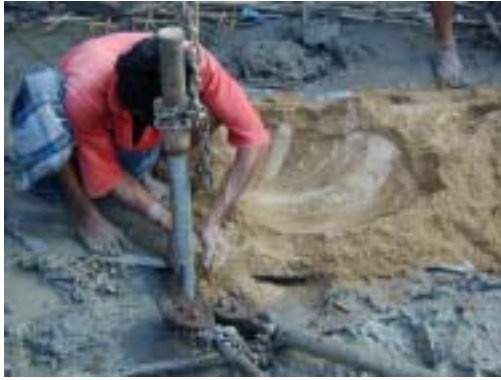
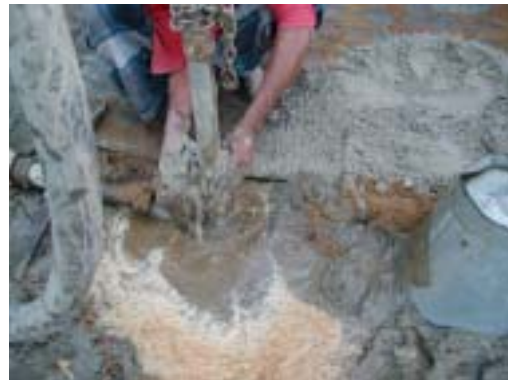
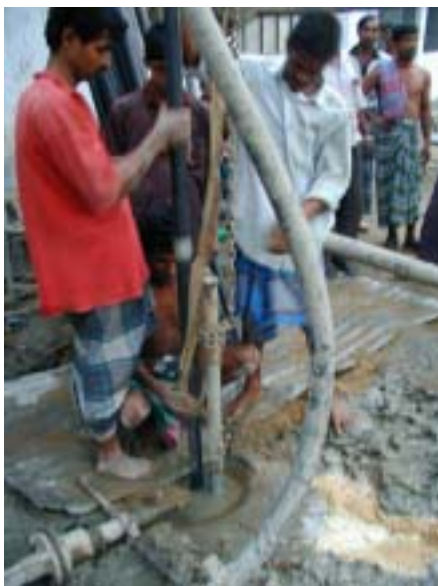
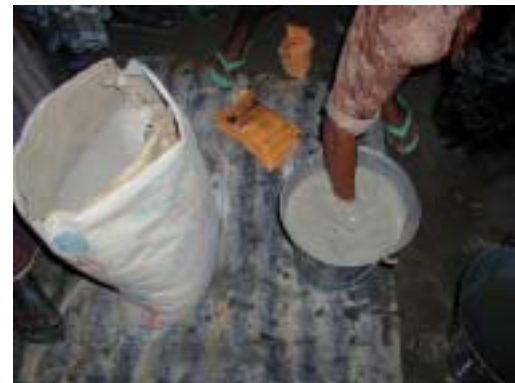
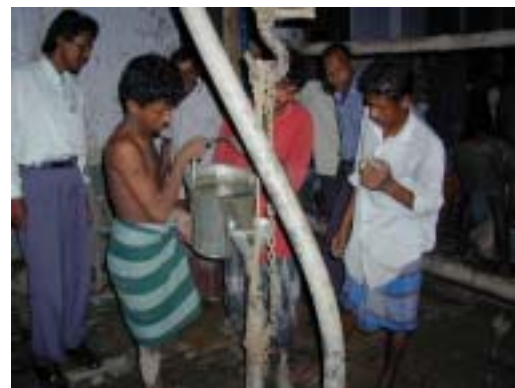
Figure 5.9 Sealing method of Type A

a) Coarse sand filling

b) Fine sand filling

c) Tremie pipe incertion

d) Cement milk making

e) Cement milk injection

Spaces between the wall of the borehole and the screen section of the well casing is filled with coarse sand up to the boundary of the clay layer. Fine sand is filled in the upper part of the coarse sand filter with the depth of 0.5m, and cement is filled with the depth of 5m from the upper part of the fine sand filter. Then, fine sand is filled up to the surface. Portland cement with a water/cement ratio of about 50% is used for cementing. Injection of the cement milk is for the depth of 0.5m on the first day (Fig 5.9).

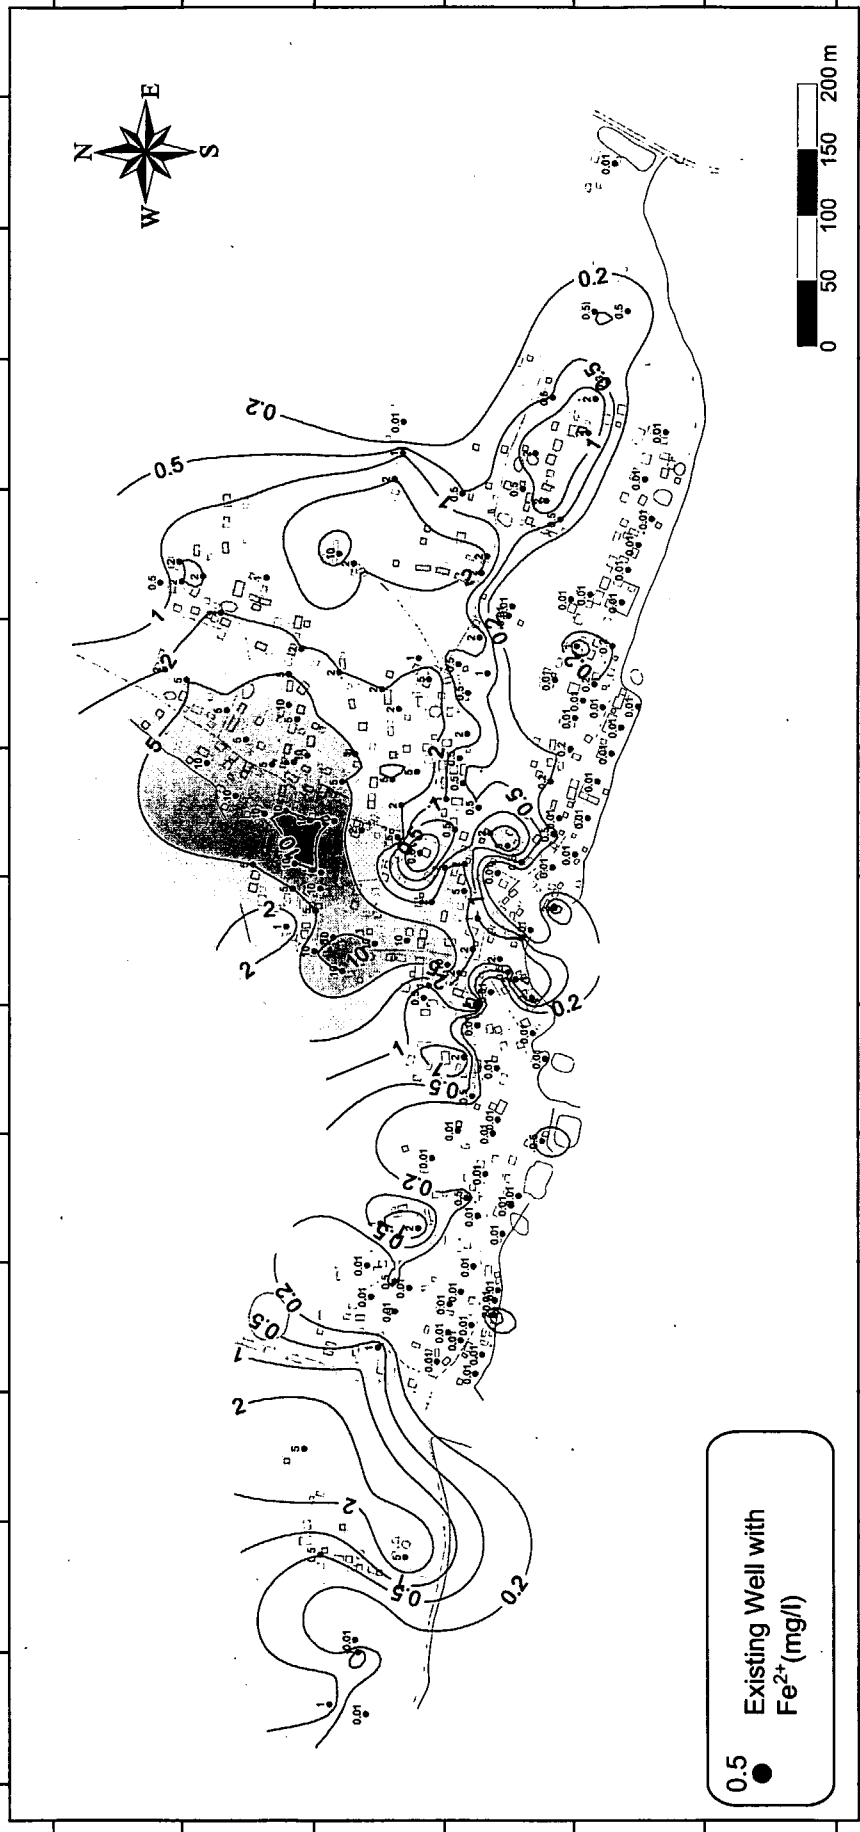
Figure 6.3.32 Fe²⁺ Map of Bara Dudpatila Village (October 2000)

[The groundwater samples were collected from 172 existing wells in October 2000. The Fe²⁺ concentrations were measured at the site by Iron Pack Test Kit.]

Figure 6.3.32 shows the iron concentration map in October 2000. The distribution pattern is similar to that of As concentration. The higher iron concentration was found in the central area. On the other hand, the southwestern part and southeastern part of the village have smaller concentrations less than 0.2 mg/l.
