The Study on Storm Water Drainage Plan
for the Colombo Metropolitan Region
in the Democratic Socialist Republic of Sri Lanka

JAPAN INTERNATIONAL COOPERATION AGENCY

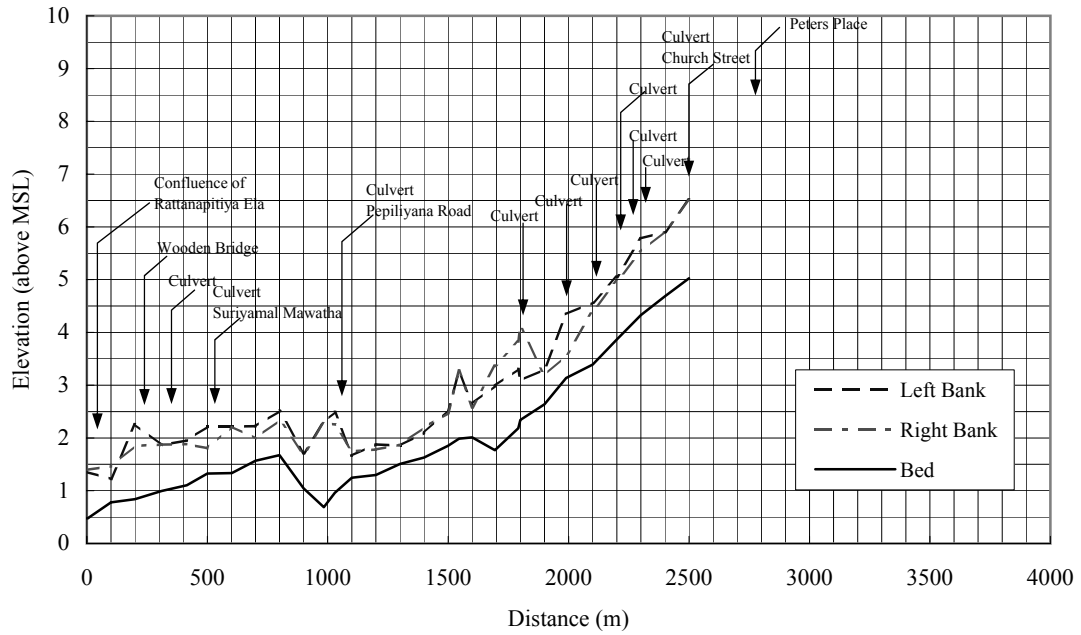
Figure 2.2.3
Present Condition of Rattanaipitiya Ela,
Delkanda Ela and Nugegoda Ela

Nugegoda Ela

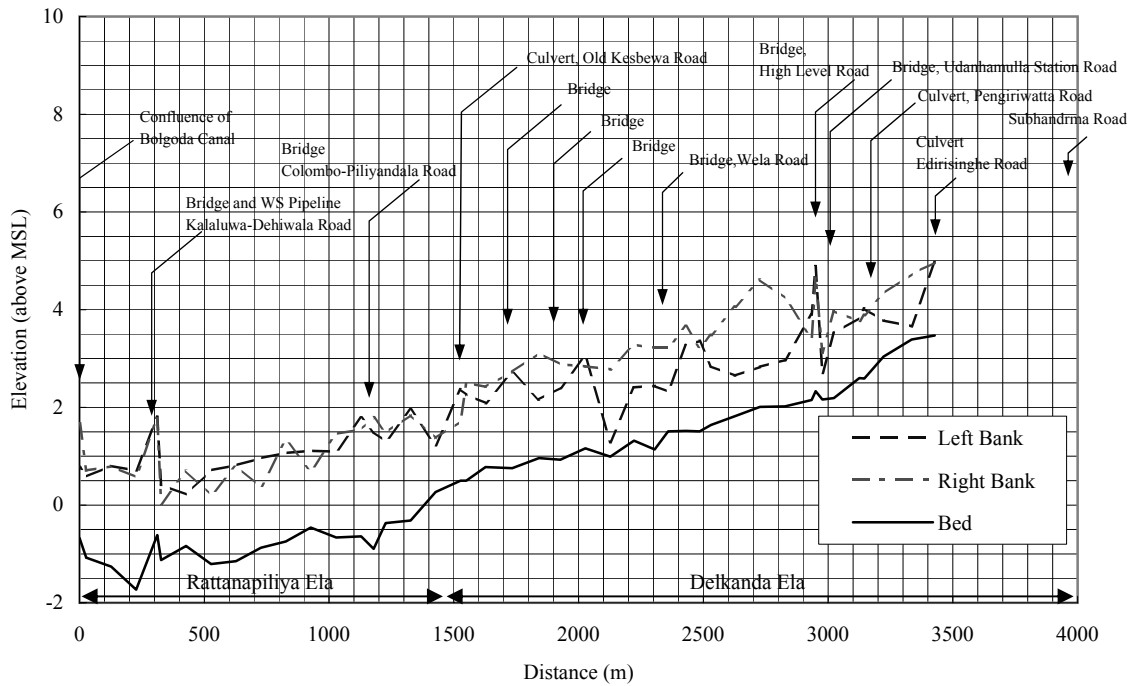
Rattanapiliya Ela and Delkanda Ela

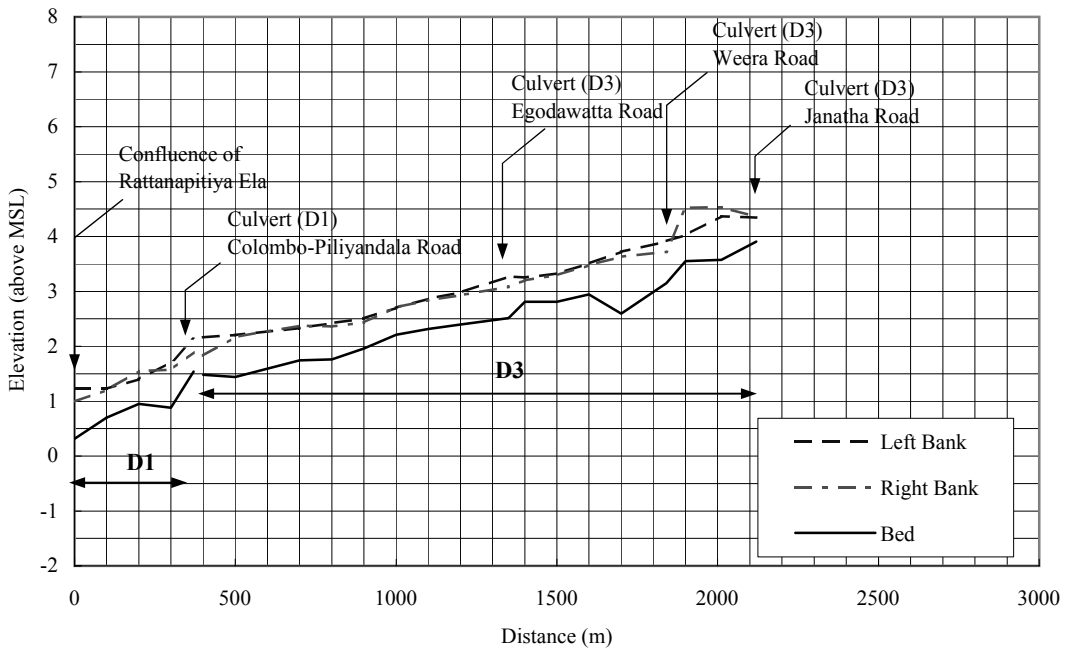
Figure 2.2.7
Present Condition of Boralesgamuwa North Drainage System

Depawa Ela - D1 and D3 channels

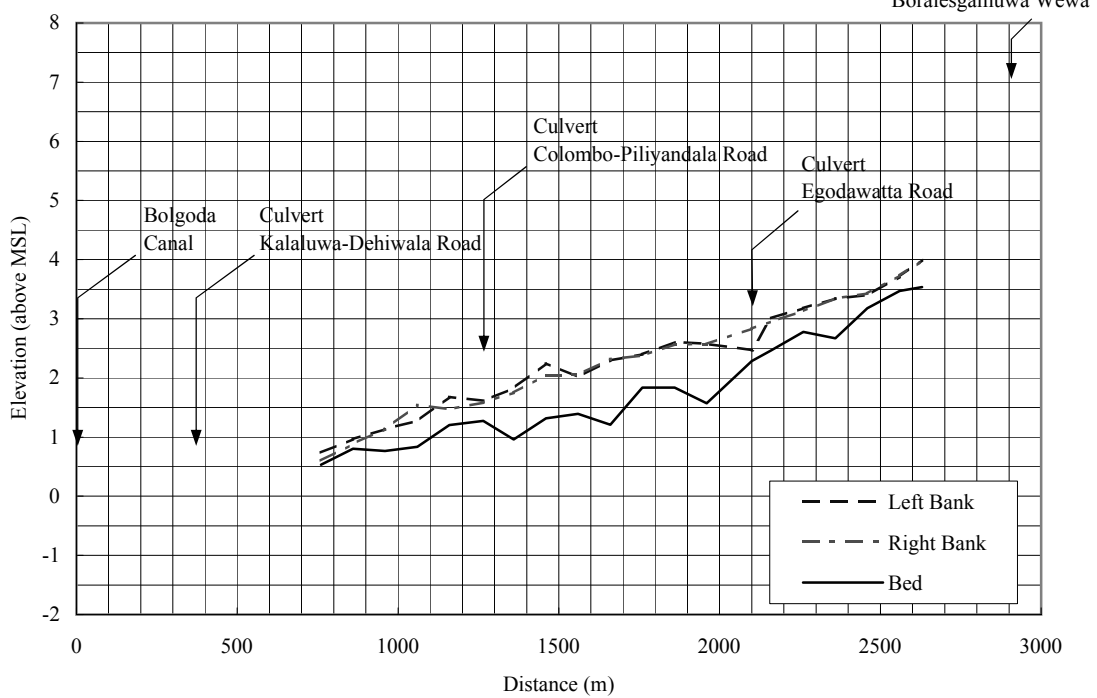
Depawa Ela D2 channel

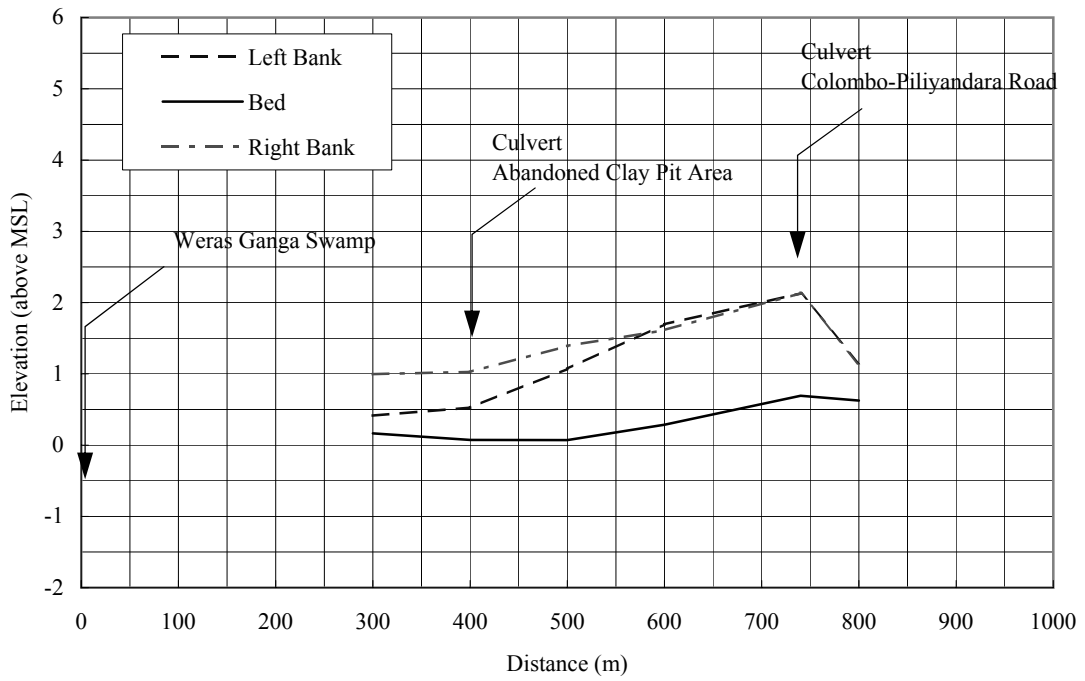
Figure 2.2.9
Present Condition of Boralessgamuwa South Drainage System

Boralesgamuwa South - Werahera Tributary

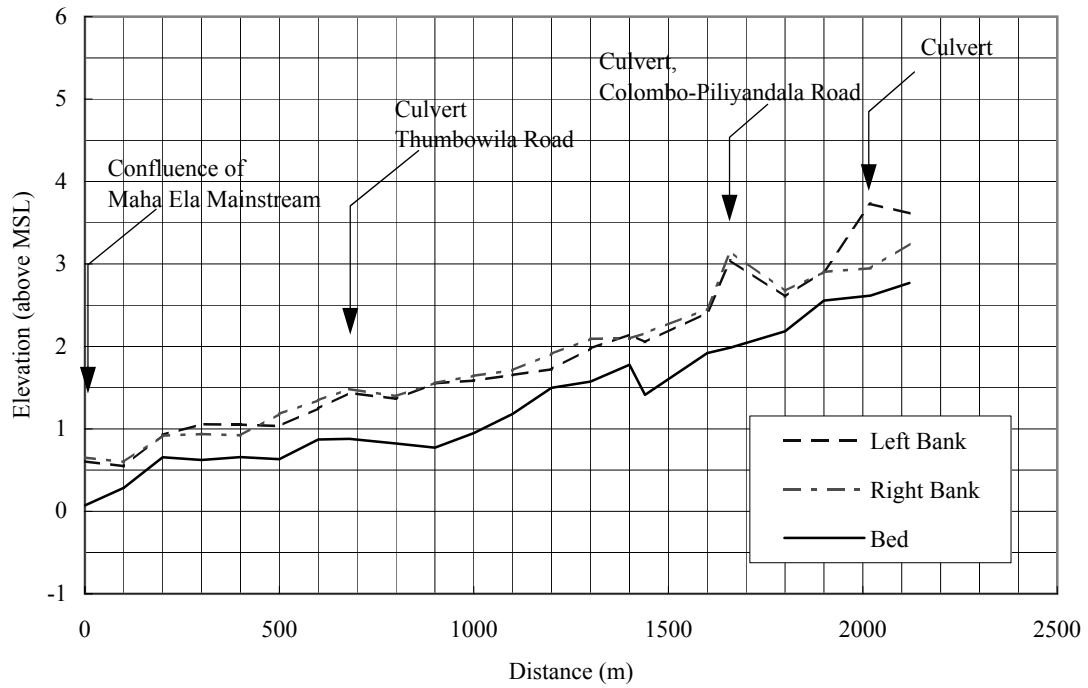
Figure 2.2.11
Present Condition of Maha Ela (3/3)

Maha Ela Tributary
