# THE STUDY ON VULNERABILITY REDUCTION FOR MAJOR ROADS IN THE REPUBLIC OF NICARAGUA

**FINAL REPORT**

*Volume 2 of 5*

**MAIN TEXT**

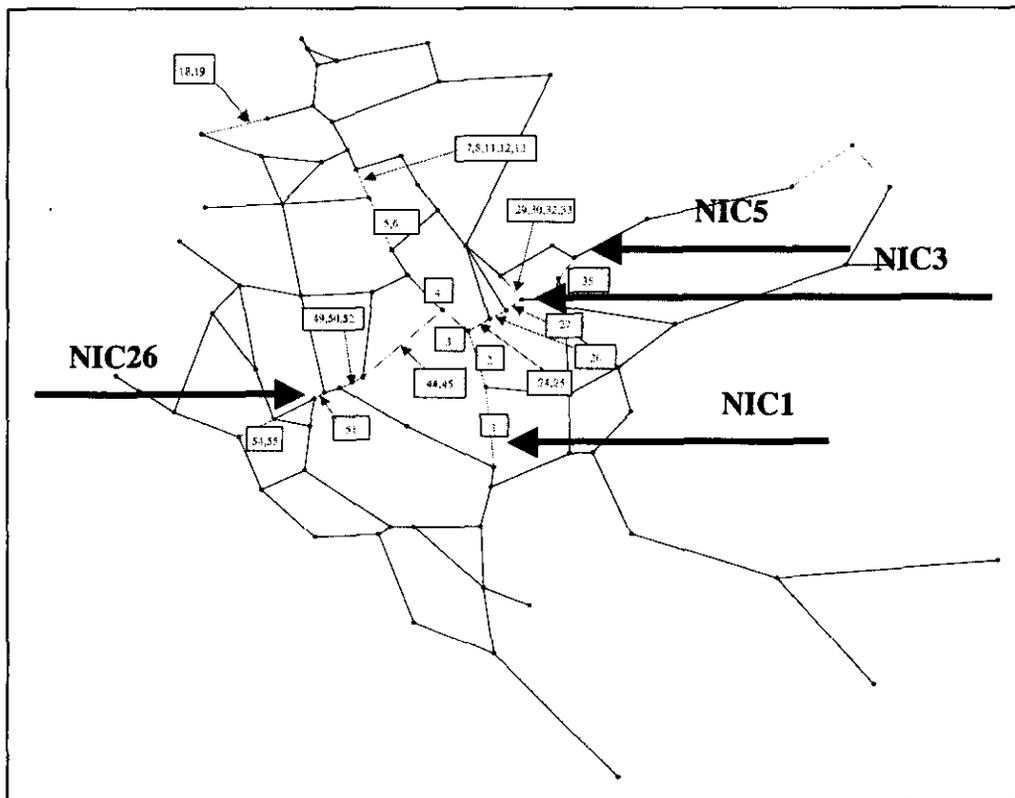
Locations of vulnerable spots are shown in the below figure.

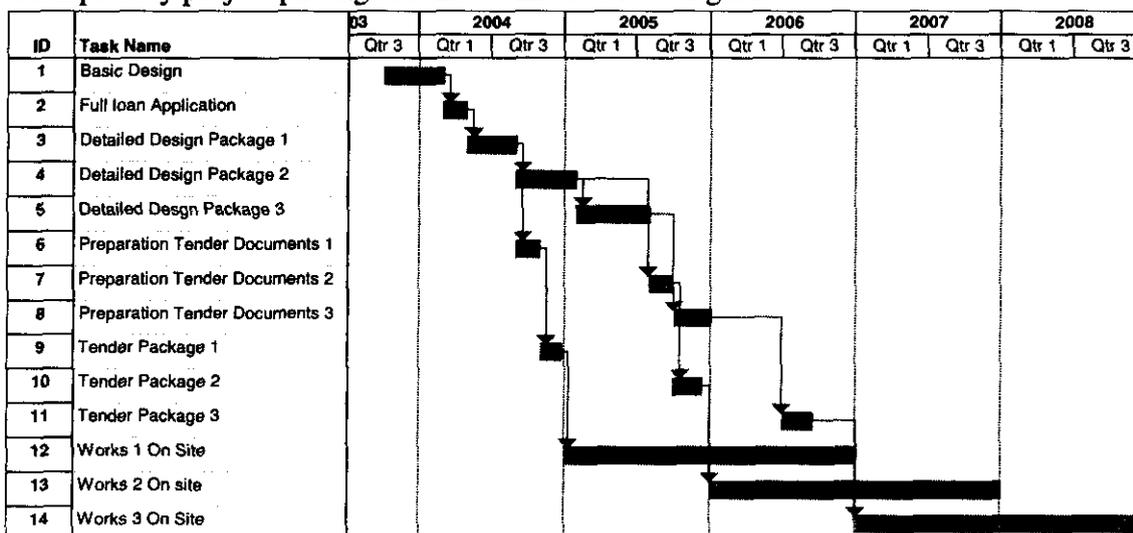
The implementation schedule was set up taking account of the construction period estimated for each priority project package as shown in the below figure.

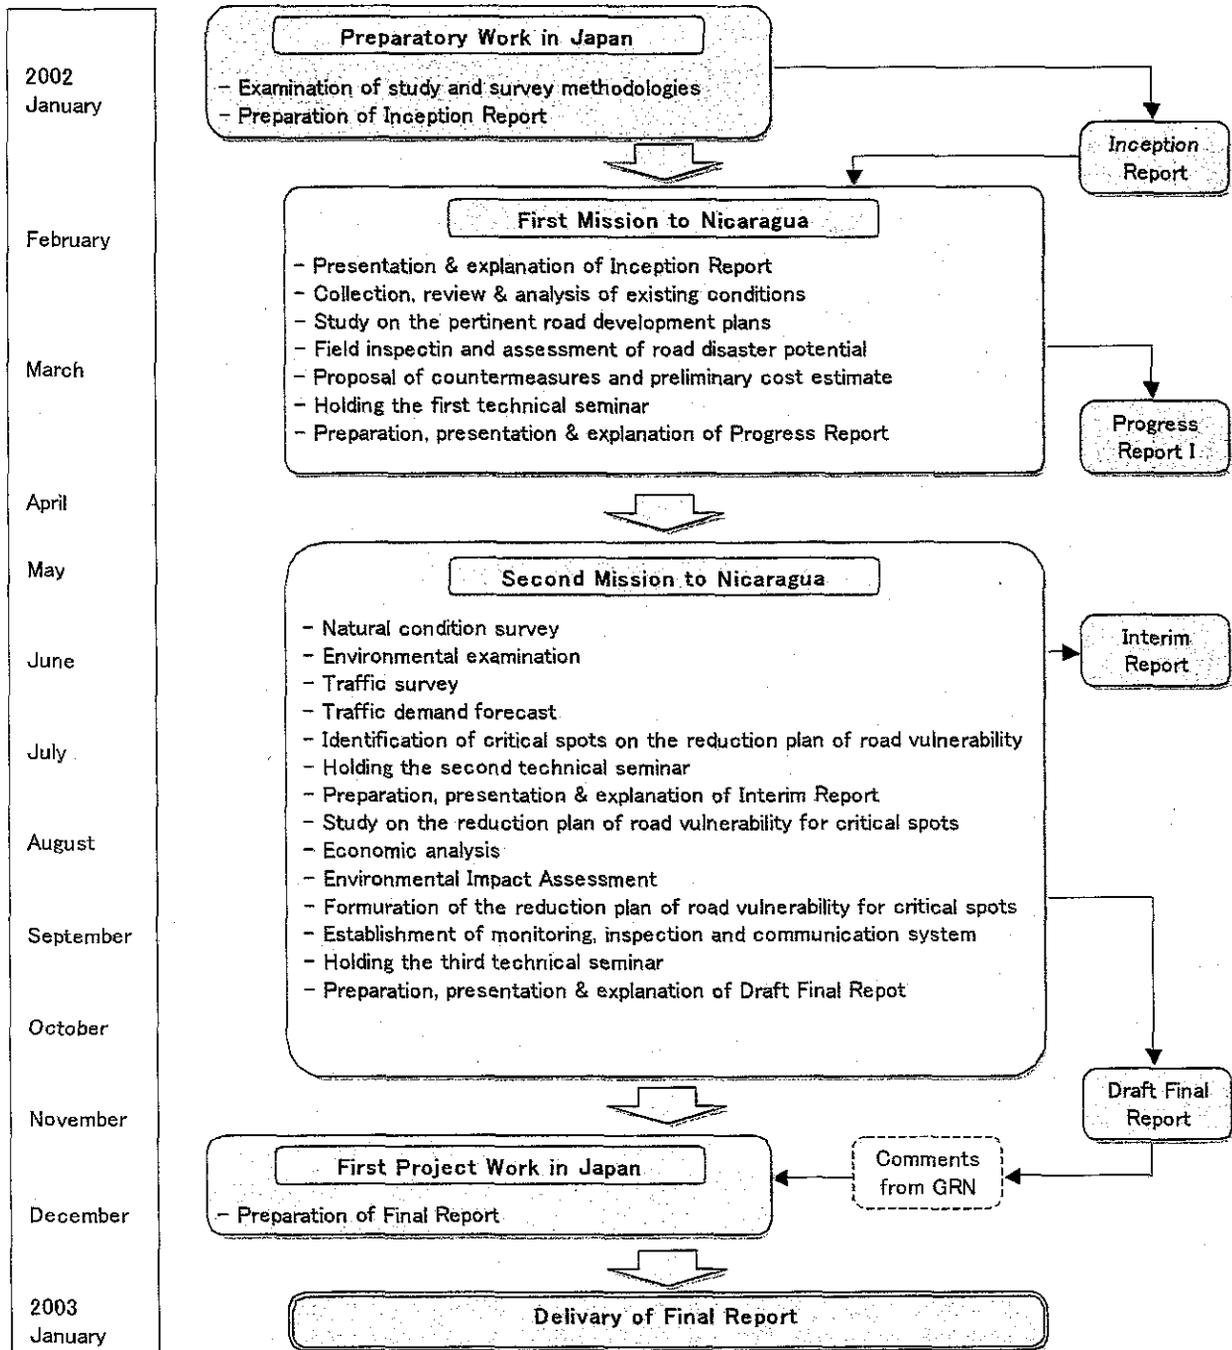
Figure 1.4.1 Study Workflow

The workflow of the Study is shown in Figure 1.4.1.

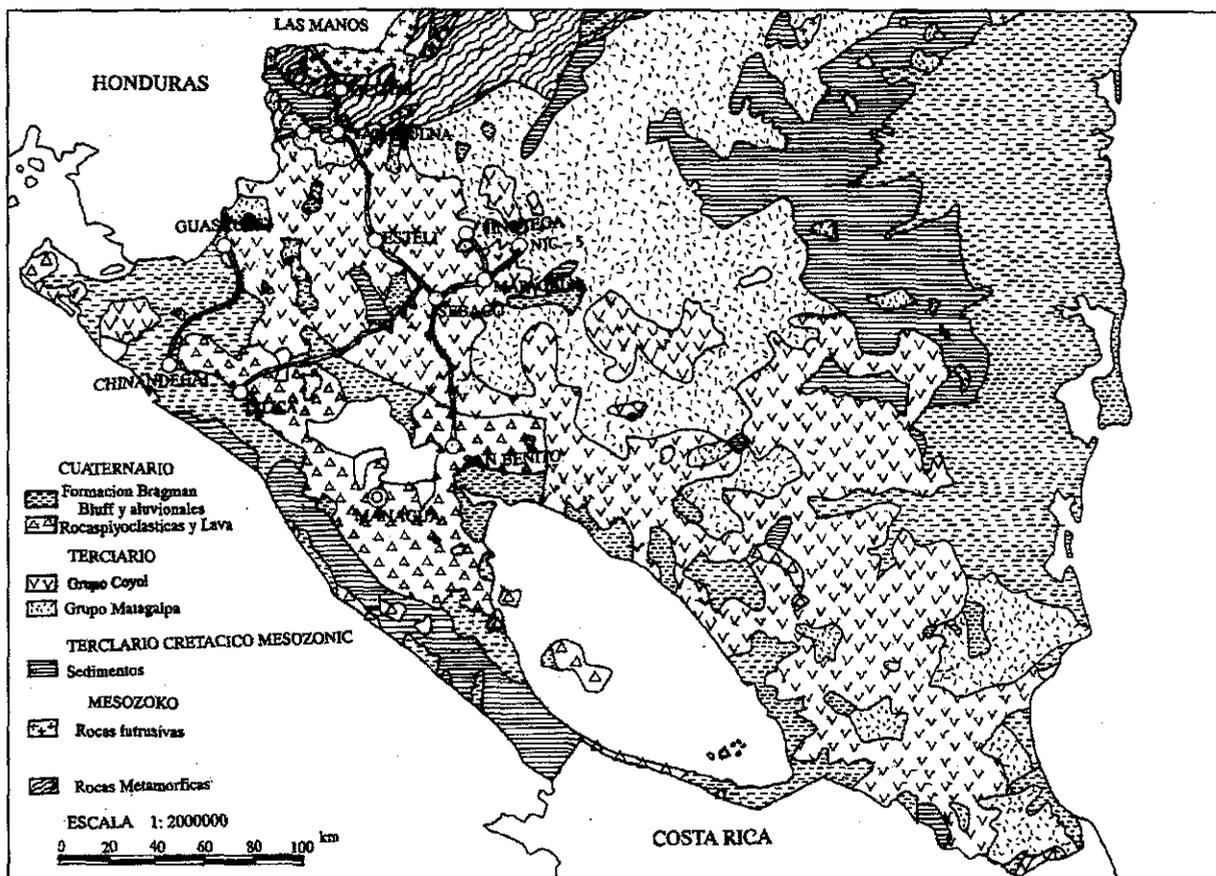
Figure 2.1.1 Geological Map of Nicaragua

Similarly to these old rocks, most of the bed rock in Nicaragua are composed of Mesozoic sedimentary rock, which are divided into Matagarpa Facies and Rivas Facies of Jurassic upper-lower Cretaceous. These rocks are covered widely with volcanic rock of Tertiary Era which gushed out thereafter therefore they are distributed in South-East of Iyas glaben zone of metamorphic rock. It is confirmed through this Study that the black schist of Rivas Facies is distributed in narrow area in NIC.1, NIC.3, NIC.15 and NIC.26. The black schist in this district is fissile which is characteristics to schist but it makes sound slope because it was formulated in older era and is highly sticking and through such coincidence that rocks not

fractured by tectonic movement are distributed on the slope or schistosity shows anti-dip slope. It is not certain if these black schist exist in volcanic rock here because the surface layer was eroded or it was lifted up by dislocation or volcanic activities. It is commonly said that the bedrock as distributed along the project road is under good conditions as the slope by chance but, in many cases, they are fractured or become unstable and collapsed like landslide when they are cut.

More than 50% of the rocks in Nicaragua are volcanic rocks and they are classified as effusive rocks of Palaeogene and, Neogene of Tertiary, and Quaternary. There are some differences petrographic in effusive rock according to the time of activities but they are categorized similar rocks in terms of road engineering. The strength of the lava of andesite as erupted out in a great volume is similar when it is hit with a hammer. However, sufficient observation should be made where the factors for collapse are to be studied because the weathering, joint peculiar to volcanic rock, or bedding plane and structure of lava flow, or crack interval are quite varied depending upon the era of eruption and the place of distribution. In this connection, the main rocks distributed in the Study area and surrounding area are basaltic, andesite-basalt, andesite, rhyolite and other lava and such effusive rocks as tuffbreccia, dacitic agglomerate belonging to Palaeogene, and lava of quartz-andesite, pyroclastic rock, welded tuff belonging to Eocene. They are widely distributed in NIC.1,

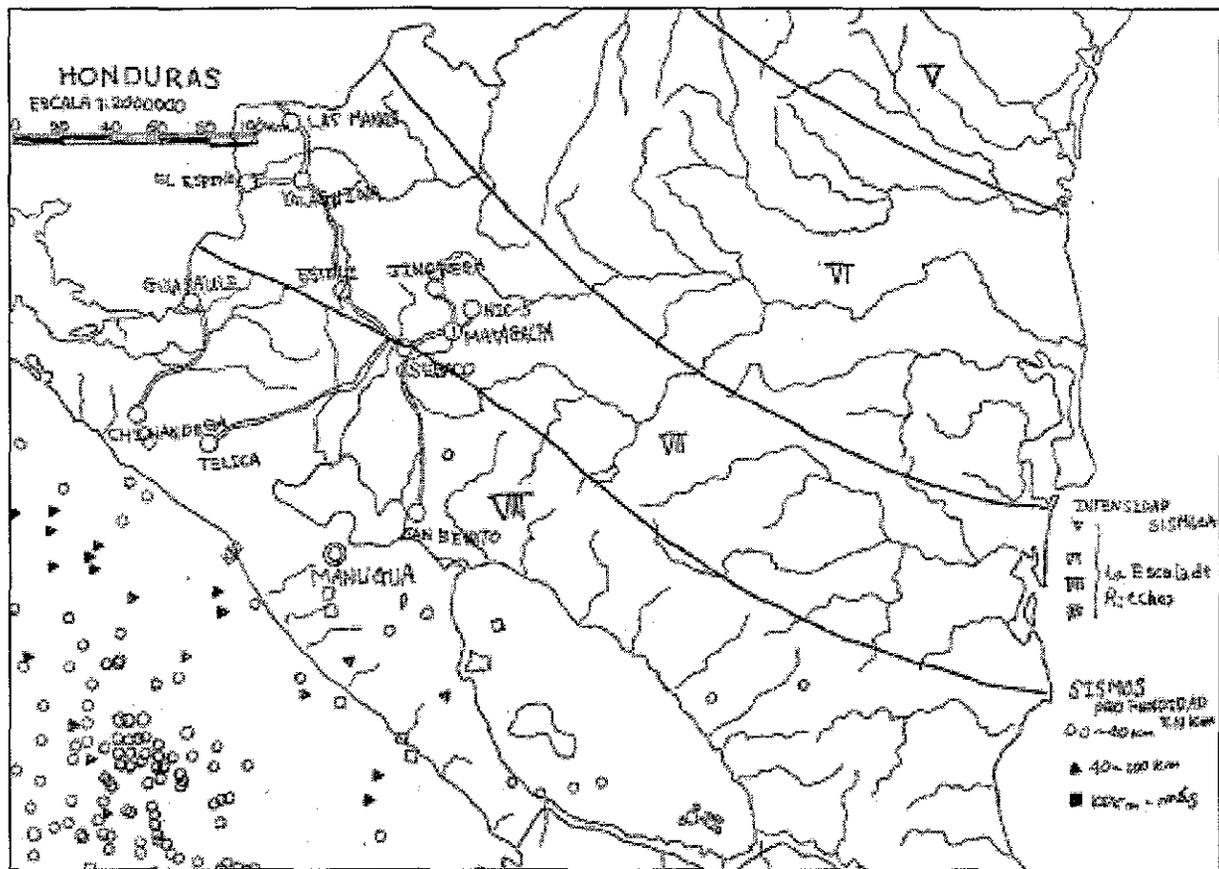
**Legend (Explanation for Seismic Intensity)**

V	Most people perceive and many are awakened. Unstable things fall down.	Acceleration: 10 - 21
VI	All people perceive and many rush outdoor with surprise.	Acceleration: 21 - 44
VII	Most people rush outdoor and poorly made things are damaged.	Acceleration: 44 - 94
VIII	Strong buildings are damaged. Chimneys, monument, and walls fall down, and furniture falls sideways. Sand and mud gushes out and well water will change.	Acceleration: 94 - 202

It is clear through this Figure that NIC.24 and NIC.26 will make large traffic trouble depending upon the size of volcanic activities as related with Western Nicaragua fracture. Records for all the seismic size and seismic center distribution for 1992-1998 are also available but here the distribution of more than magnitude 4.0 is shown in Figure 2.1.-1. There is no special feature showing deep connection with the fracture in this Fig but the results are obtained to forecast the plate subsidence through the distribution map showing the seismic depth. The seismic intensity in Nicaragua is shown hereunder and the distribution is also shown as Figure 2.1.1.

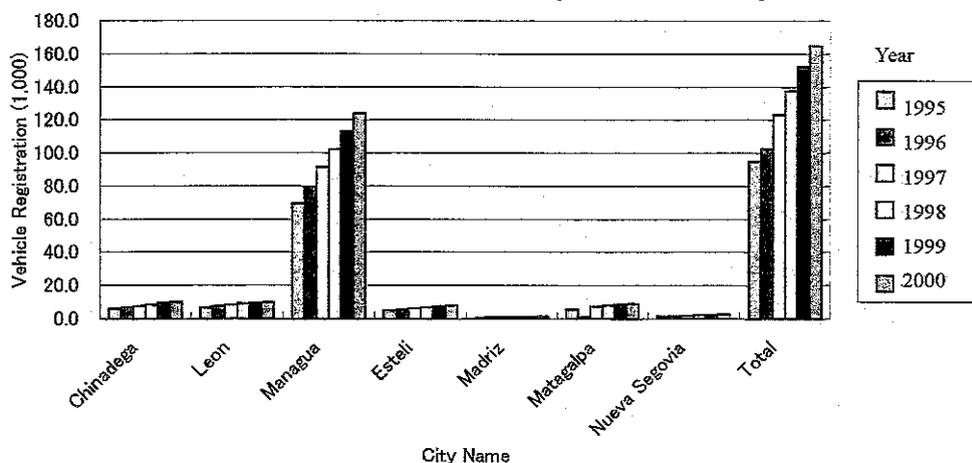
Figure 2.2.4 Vehicle Registration of Main Region

Figure 2.2.4. shows vehicle registrations in selected Departments from 1995 to 2000. Nearly 75% of the country's vehicles are registered in Managua. The growth rate is forecast to be around 74 % between in 1995 and in 2000, with a growth in Managua of 80 %.
