**CHAPTER 12**  
**FUTURE TRAFFIC DEMAND**

### 12.1 General Methodology

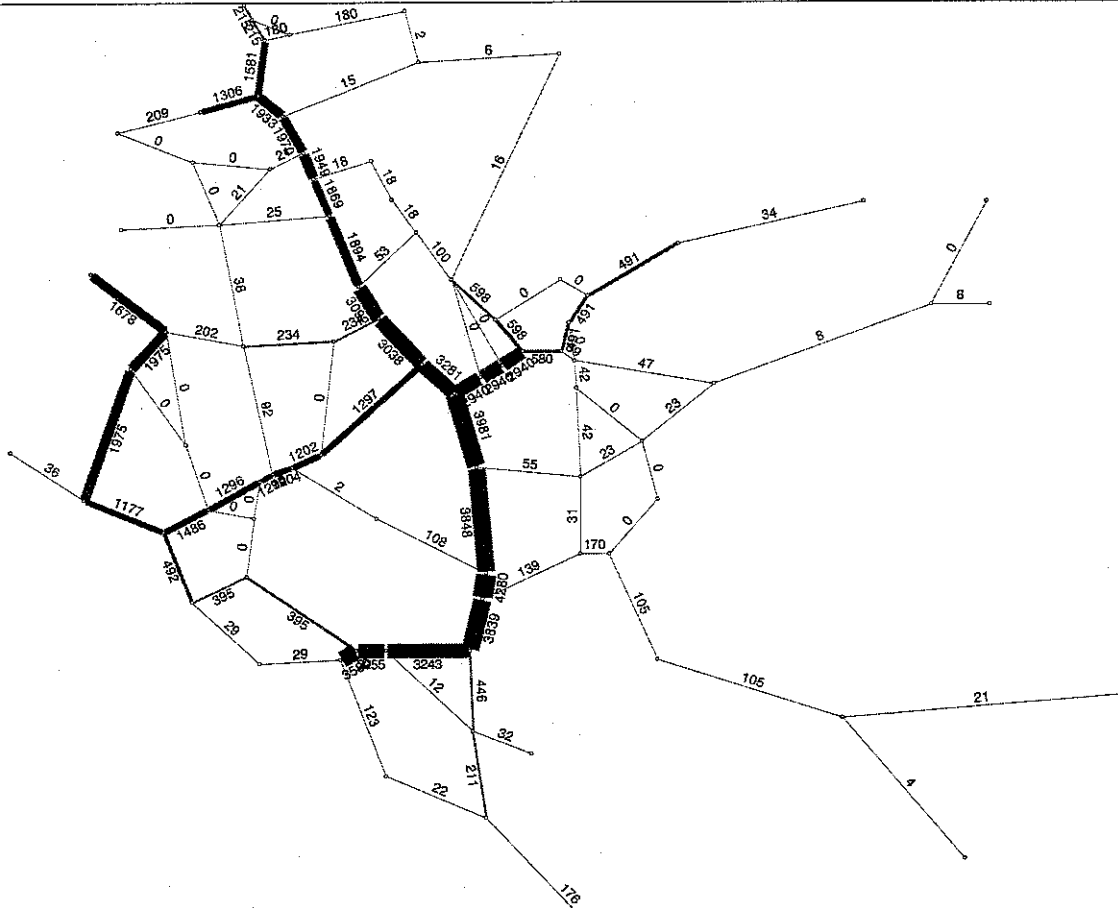
Figure 12.5.1 Traffic Forecast, 2003, AADT

Figures 12.5.1, 12.5.2 and 12.5.3 show traffic assignments for the three forecast years. Network statistics are shown in Table 12.5.2.

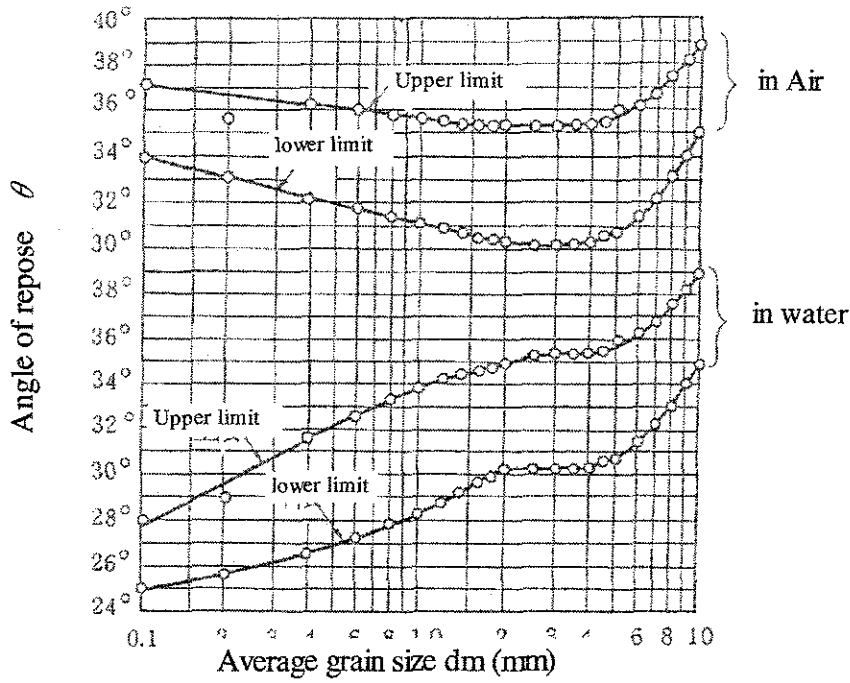
Figure 16.2.7 Relationship between Average Grain Size and Angle of Repose

$\tan \theta = 0.62$

$X = Z/\tan \theta = 1.54$  m
