Table 17.6.6 Selection of Prevention Countermeasure Method

17.6.2 Selection of Countermeasures for Bridge Foundation Scouring

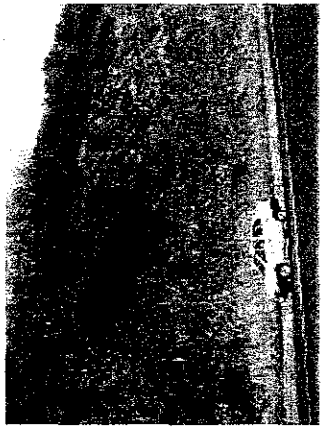
Comments	Because the crack interval of andesite is narrow, subdivided unstable stone is generated a lot. Therefore, many small stones fall. The talus remains thin on the slope, it becomes unstable in the rainy season. Inflow water is confirmed at whole slope.					
Alternative of Countermeasure	Removal + Barrier with gabion wall + Drainage

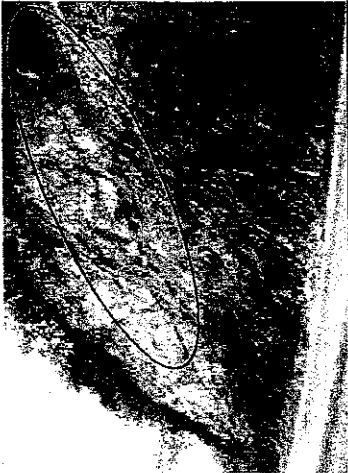
The Rainy Season		
Comments	Left side photograph; The part marked in red is andesite, it is distributed in the upper part of slope. Tuff that weathering is early is distributed in the lower part of slope. The andesite becomes on the overhang and falls. Right side photograph; Upper red mark is loose andesite and lower red mark is tuff. Seepage is oozing from the boundary of the andesite and the tuff					
Alternative of Countermeasure	Removal + Barrier with gabion wall

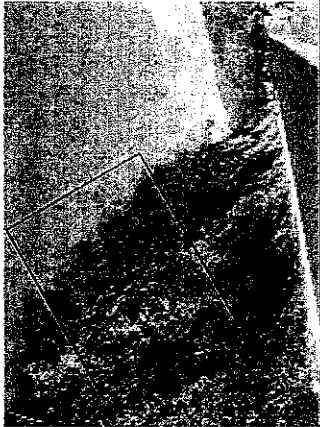
Comments	Left side photograph; Red mark is andesite, its lower side is tuff that weathering is early. Right side photograph; Seepage is oozing from red mark portion in rainy season. There are a lot of skin dropping because weathering is early, therefore andesite becomes unstable and collapses.					
Alternative of Countermeasure	Recutting + Drainage

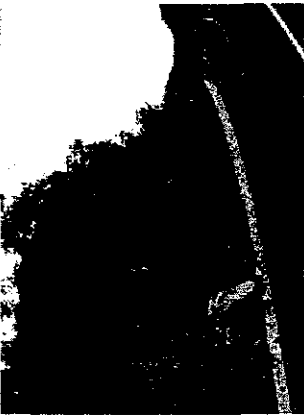
Comments	There are vertical cooling joint. Cracks are open by weathering advance. There are comparatively large falling rocks. Prevention of weathering is necessary after cutting tuff. As a result, the andsite can be prevented from collapse.					
Alternative of Countermeasure	<p>Recutting + Drainage</p>

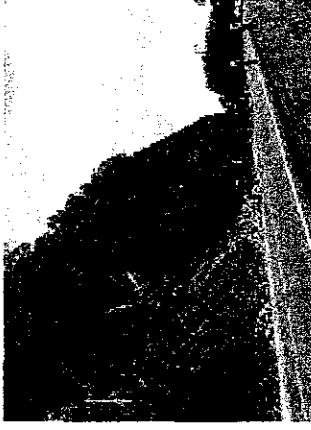
Comments	<p>There is a collapse history. The part where the slope height is large is an intrusive rock and a hard rock. It is intrusive along the fault(white mark), therefore the rock is extremely weak at its both sides. The condition of a peripheral rock by influence of the fault is bad, and there is a possibility to be going to repeat a big collapse in the future. Drastic counter measurements are necessary</p>			
Alternative of Countermeasure	<p>Recutting + Drainage</p>

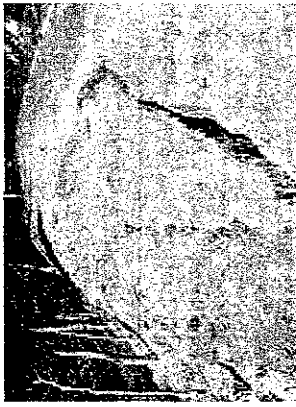
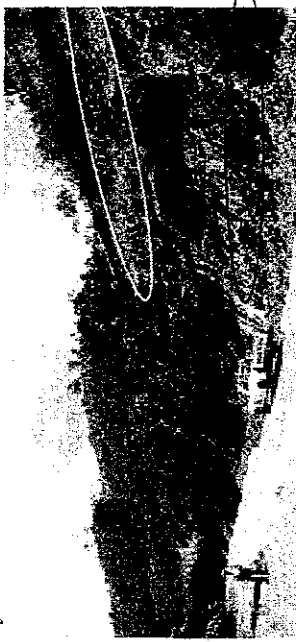
Comments	The weathering of tuff is advancing, its geological features collapse easily and are weak to rain. The transformation was not seen at fill. Water collected in leg of slide scarp (white mark). The seepage and small collapsing was confirmed.					
Alternative of Countermeasure

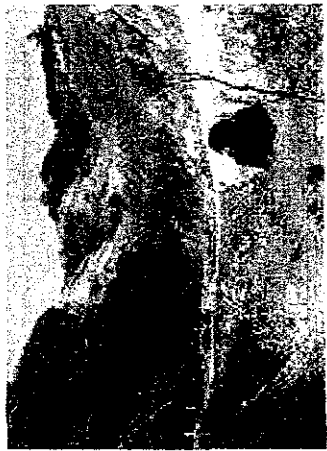
Comments	The quality of rock is changed. The difference of hard and soft is violent because of the place. The weathering belt in the hillside has surface collapse due to shallow seepage. The main disaster is flash flood than debris flow. The main disaster is flash flood than debris flow.					
Alternative of Countermeasure

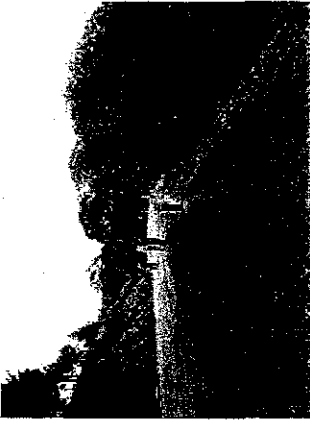
Comments	Weathering of tuff is advancing. There is a watercourse in the rock and it was confirmed by the oozing from embankment. It is necessary to examine the installation of the horizontal drainage to control the water level. The cut gradient will be determined according to the boring result and the position of the church. T-shaped retaining wall will be necessary because it minimizes width of land use of coffee plantation.					
Alternative of Countermeasure

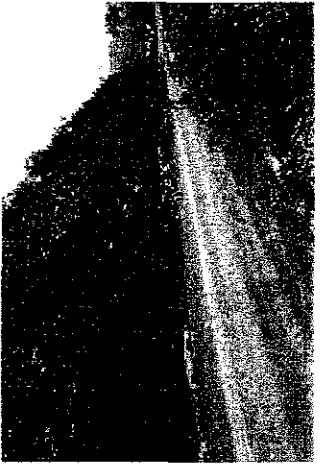
The Rainy Season		
Comments	The slope consists mainly of talus of diluvial age over tuff. The existing road became unstable by the leg of talus was cut. The crest ditches were installed after collapse, but the infiltrating water is oozing. Falling rock continues because the gradient of cut is too steep.					
Alternative of Countermeasure

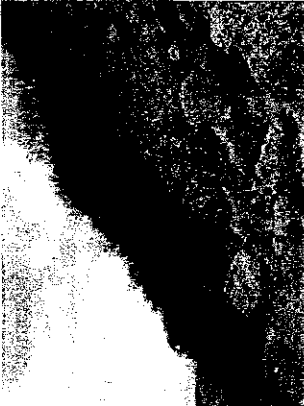
Comments	The width of crashed zone of tuff is about 50m. The angle of slide scarp is 60°, and it is instability. Falling rock was confirmed in dry season, it enters the rainy season and has increased further. 40° is recommended as the angle of cutting. The slope has the small collapsing in the vicinity of the crashed zone. The inflow water was confirmed from the cracks.					
Alternative of Countermeasure	<p>Recutting + Horizontal drainage + Drainage Crest ditch</p>

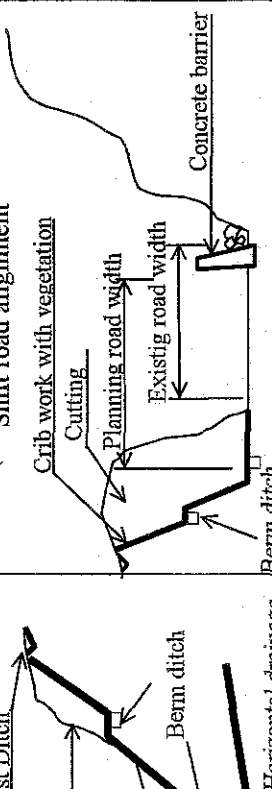
<p>Crib work with vegetation Cutting Planning road width Existing road width Concrete barrier Berm ditch</p>

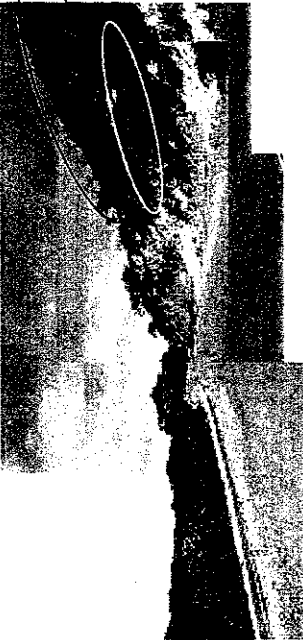
The Rainy Season		
Comments	The whole of slope is a changing in quality action and a fragile rock. Marked in red is slide scarp, it is a supply source of the falling rock and the collapse, and it piles up in the place which slope was marked in white. The slope on the road side collapses easily, too and minute gravel diffuse to the road. The inflow water was confirmed at four positions in rainy season.					
Alternative of Countermeasure	<p>Retcutting + Drainage</p> <p>Retaining wall + Embankment +Vegetation + Drainage</p>

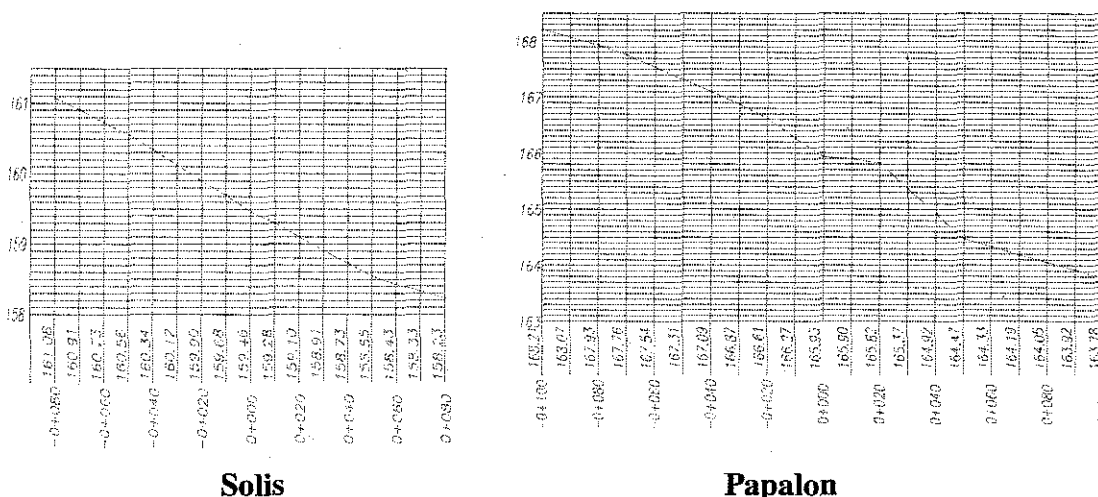
Figure 17.6.13 The Vertical Alignment of Riverbed at Solis Bridge and Papalon Bridge

The year of construction of both Solis bridge and Papalon bridge is relatively young (built in 1963). Nonetheless, due to the highly advanced scouring, the level of riverbed has been lowered below the subgrade of abutment by more than 60cm at Solis bridge, and up to almost same as subgrade of abutment at Papalon bridge, making the site condition very dangerous. It is estimated that the weathering of surface stratum of riverbed is highly advanced, and that the scouring of foundation was gradually promoted through the outflow of powdered fine granular by the water flow. According to the geological survey result, although the subgrade of abutment is weathered tuff, due to the small volume of river flow in this area, the weathering of riverbed surface is seemingly being speeded by the repetition of dry condition and wet condition. In addition, as shown in Figure 17.6.13, because the vertical alignment of whole river channel is uniform with gradient about 2%, not only the level of riverbed around the bridge but also the level of whole river channel descends uniformly.

Further more, the vertical alignment falls into disorder to some extent at the Papalon bridge, showing the influence of the bridge on the scouring. The sectional area at the Papalon bridge, which is smaller than that of the upstream and downstream of the river channel, is considered as the cause of this disorder

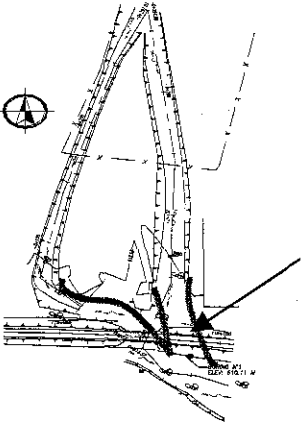
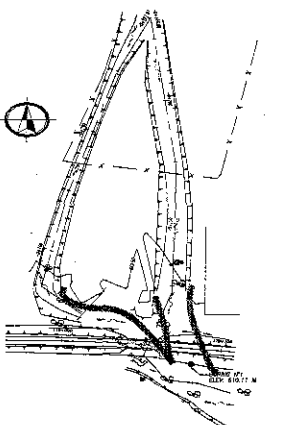
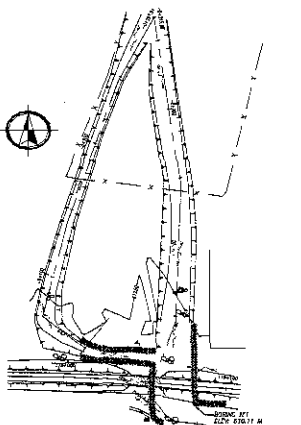
Plans	Plan 1	Plan 2	Plan 3
Abstractive layout

Abstract of structure	To construct box culvert in the side of Matagarupa. Then let the small stream flow through the existing bridge, and let the larger river flows through the new culvert.	To construct a new bridge in the side of Matagarupa. Then to let the small stream flow through the existing bridge, and let the larger river flow through the new bridge (L=20m).	To replace the existing bridge with a new bridge(L=30m)
River	The river joins at the downstream of bridge, and the impacts on the scouring will be small.	The river joins in the downstream side of bridge, so the impact on the scouring will be small.	The river joins in the upstream side of the bridge, so the protection measure for the scouring of bridge foundation will be necessary.
Road	It is possible to maintain the existing alignment. It is necessary to make diversion of the traffic on the construction	It is necessary to raise the vertical alignment of road by 2 meter higher than the existing alignment. It is necessary detour the traffic on the construction	It is necessary to raise the vertical alignment of road by 2 meter higher than the existing alignment.

Advantages and disadvantages	When the driftwoods stick at the bridge, they block the sectional area and become a cause of scouring. Therefore there remain problems including obstruction ratio, span length, and so on.	The obstruction ratio and span length will be improved. The arrangement of the existing bridge and a new bridge is complicated.	All problems will be solved.
Structure	The initial cost is cheapest. But because the existing bridge is old, it will be necessary to replace the existing one in the near future. As a result, this plan will be relatively expensive.	The initial cost is cheapest next to the Plan 1. But because the existing bridge is old, it will be necessary to replace the existing one in the near future. As a result, this plan will be relatively expensive.	The initial cost is expensive, but the maintenance work in the future is unnecessary.
Economy	The initial cost is cheapest. But because the existing bridge is old, it will be necessary to replace the existing one in the near future. As a result, this plan will be relatively expensive.	The initial cost is cheapest next to the Plan 1. But because the existing bridge is old, it will be necessary to replace the existing one in the near future. As a result, this plan will be relatively expensive.	The initial cost is expensive, but the maintenance work in the future is unnecessary.
