Appendix 5
AHP Data

Appendix 6

Countermeasures Selection of Slope

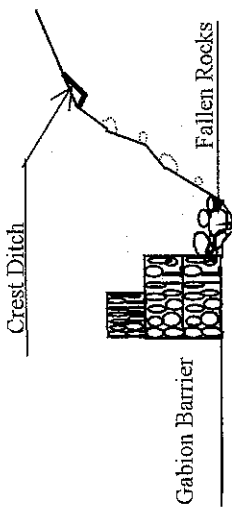
Removal + Prevention net + Drainage

Workability	-Wire of gabion cannot resist against energy of the assumed falling rock. Δ	-The construction results are not in Nicaragua. -This type is almost permanent structure. ○	-The concrete barrier will be too big size for resistance against energy of the assumed falling rock. Δ

Environment Impact	-Deterioration of environment will be forecast by damage of gabion. Δ	-It is necessary to cut trees. Δ	-Installing the concrete barrier lacks harmony with the surrounding. Δ			
Influence on Road	-It is difficult to stop completely jumping over rock by barrier. Width for construction of barrier is enough. Δ	-There is no problem. ⊙	-It is difficult to stop completely jumping over rock by barrier. Width for construction of barrier is enough. Δ			
Maintenance	-It is necessary to remove collected rock. Δ	-Durability depends on the life of the wire. Δ	-Because the structure is too large, the space for the removal of fallen rocks is necessary. Δ			
Economy	-This alternative is cheapest of all. Because maintenance cost is high, costs of three alternatives is almost even. ○	-Net materials are expensive, but maintenance cost isn't high. ○	-Maintenance cost is high. Δ			
Evaluation	-The gabion isn't steady by the collision of assumed falling rock. 3	-This type prevents completely dispersion of rock collapse. 1	-The concrete barrier isn't steady by the collision of assumed falling rock. 2

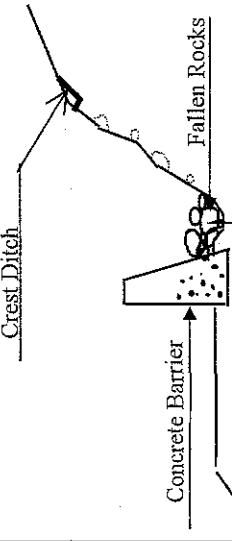
Removal + Barrier with concrete wall + Drainage

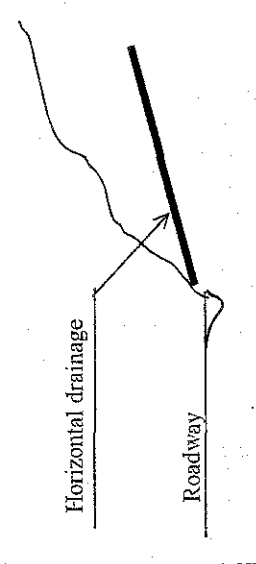
<p>Horizontal drainage</p>

Workability	<p>-The slope become unstable by raise of underground water, but this alternative cannot suppress the rise of underground water level. Δ</p>

Economy	<p>-The cost of cribwork is expensive. Δ</p>					
Evaluation	<p>The purpose of cribwork is for the vegetation and it does not take part in stability. 3</p>					
Workability	<p>-Underground water level is suppressed by horizontal drainage, therefore the slope become stable. ○</p>					
Environment Impact	<p>-The present condition of slope surface will be maintained because it will be not touched. ◎</p>					
Influence on Road	<p>-One lane is restricted by the boring. Δ</p>					
Maintenance	<p>-The inspection is necessary water volume from the horizontal drainage. ○</p>					
Economy	<p>-The horizontal drainage is expensive, but other costs are unnecessary ○</p>					
Evaluation	<p>-This alternative is economical and effective. 1</p>

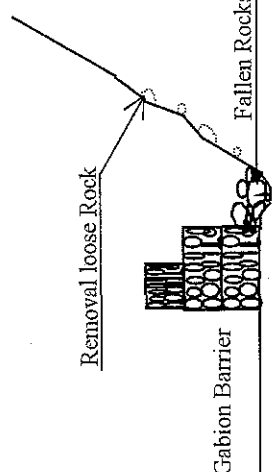
<p>Removal + Prevention net</p>

Workability	-Wire of gabion cannot resist against energy of the assumed falling rock. Δ	-The construction results are not in Nicaragua. -This type is almost permanent structure. ○	-The concrete barrier will be too big size for resistance against energy of the assumed falling rock. Δ

-The gabion isn't steady by the collision of assumed falling rock. Width for barrier is not enough. 3	-This type prevents completely dispersion of rock collapse. 1	-The gabion isn't steady by the collision of assumed falling rock. Width for barrier is not enough. 2

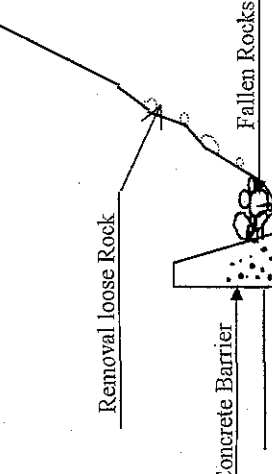
<p>Removal + Barrier with concrete wall</p>

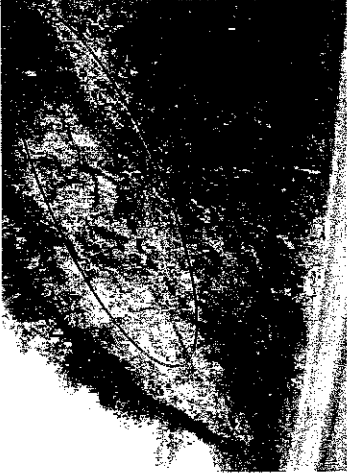
Table A6-4 Selection of Prevention Countermeasure Method

ID : N001B230	Topography	The Foot of The Ridge	Height and Incline	H =13 ~ 33 m , θ =40~65 deg.	The kind of The Rock	Almost Tuff and Andesite is a part.
Situation of Slope	Impact of Rain (Inflow water)	After rain	Stability Analysis	Unnecessary	Purpose of Countermeasure	Rock Collapse
Situation of Slope	The Dry Season

The Rainy Season		
Comments	Left side photograph, The part marked in red is andesite, it is distributed in the upper part of slope. Tuff that weathering is early is distributed in the lower part of slope. The andesite becomes on the overhang and falls. Right side photograph; Upper red mark is loose andesite and lower red mark is tuff. Seepage is oozing from the boundary of the andesite and the tuff					
Alternative of Countermeasure	Removal + Barrier with gabion wall

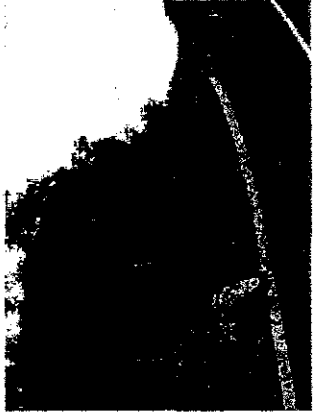
Table A6-6 Selection of Prevention Countermeasure Method

ID : N001B150	Topography	The Point of The Ridge	Height and Incline	H = 7 ~ 13 m , θ = 50 ~ 70 deg.	The kind of The Rock	Almost Tuff but Upper part are Andsite.
	Impact of Rain (Inflow water) The Dry Season	After rain	Stability Analysis	Unnecessary	Purpose of Countermeasure The Rainy Season	Rock Collapse
Situation of Slope

Comments	There are vertical cooling joint. Cracks are open by weathering advance. There are comparatively large falling rocks. Prevention of weathering is necessary after cutting tuff. As a result, the andsite can be prevented from collapse.					
Alternative of Countermeasure

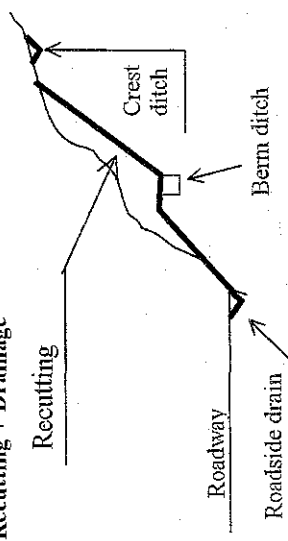
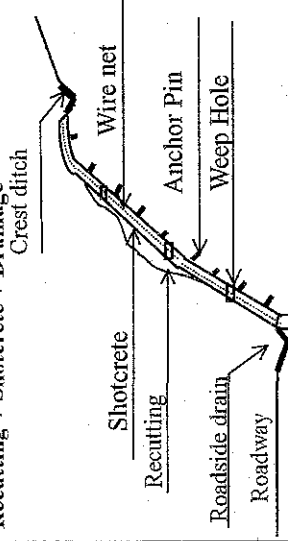
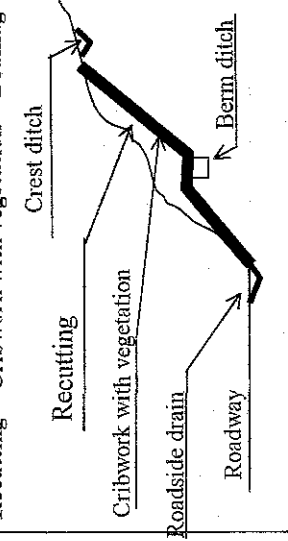
Workability	- The weathering is measured by installation of drainage facilities. ○	- It is necessary special equipment. - It is excels for countermeasure of weathering. ◎	- The purpose of cribwork are for the vegetation and increase stability. ○			
Environment Impact	- Slope is expected of natural vegetation. △	- It is difficult to harmonize with surroundings. △	- The environment is prevented from deteriorating by vegetation among the cribwork. ○

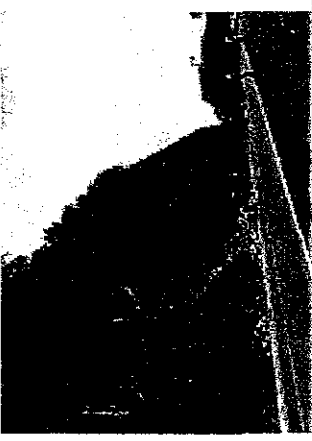
Table A6-7 Selection of Prevention Countermeasure Method

Comments	There is a collapse history. The part where the slope height is large is an intrusive rock and a hard rock. It is intrusive along the fault (white mark), therefore the rock is extremely weak at its both sides. The condition of a peripheral rock by influence of the fault is bad, and there is a possibility to be going to repeat a big collapse in the future. Drastic counter measurements are necessary				
Alternative of Countermeasure	<p>Recutting + Drainage</p>

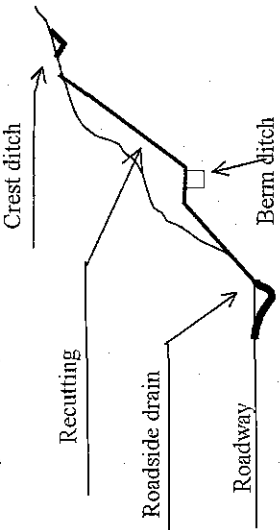
<p>Recutting + Horizontal drainage + Drainage</p>

Workability Structural feature	-Large-scale collapse is prevented by cut of 55° Stability will increase by drainage facilities. ○	-Horizontal drainage is added to left side alternative as the increase stability. △	-The purpose of cribwork are for the vegetation and increase stability ○		
Environment Impact	-Slope is expected of natural vegetation. △	-Slope is expected of natural vegetation. △	-The environment is prevented from deteriorating by vegetation among the cribwork. ○		
Influence on Road	-Traffic control is necessary during construction, but here is no influence after construction. ○	-Traffic control is necessary during construction, but here is no influence after construction. ○	-Traffic control is necessary during construction, but here is no influence after construction. ○		
Maintenance	-It is necessary to maintain slope surface. △	-The inspection is necessary water volume from the horizontal drainage. △	-The maintenance is necessary until the vegetation takes root. It is important to maintain anchor of cribwork. △

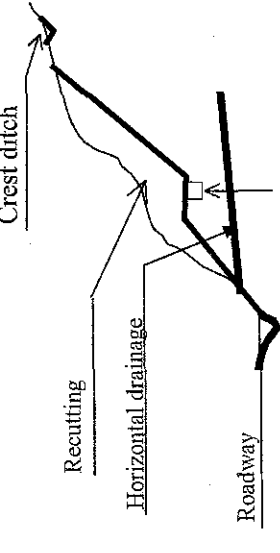
<p>Recutting + Cribwork with vegetation + Drainage</p>

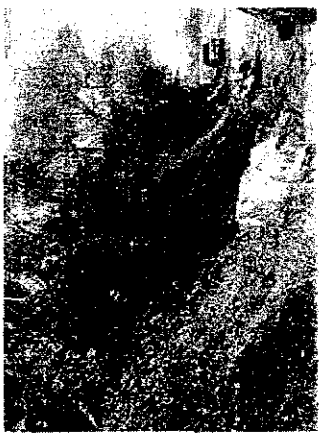
Table A6-8 Selection of Prevention Countermeasure Method

ID : N003B400	Topography	The Point of The Small Ridge	Height and Incline	HI = 8 ~ 18 m , θ = 33 ~ 48 deg.	The kind of The Rock	Tuff and a part of Agglomerate
	Impact of Rain (Inflow water) The Dry Season	After rain	Stability Analysis	Unnecessary	Purpose of Countermeasure The Rainy Season	Rock Collapse and Topping
Situation of Slope

Comments	The surface water flow along the crack, and it ooze from the vicinity of the toe of the slope (red mark). The width of crack of tuff increases, the toppling phenomenon is caused.					
Alternative of Countermeasure	<p>Recutting + Drainage</p>

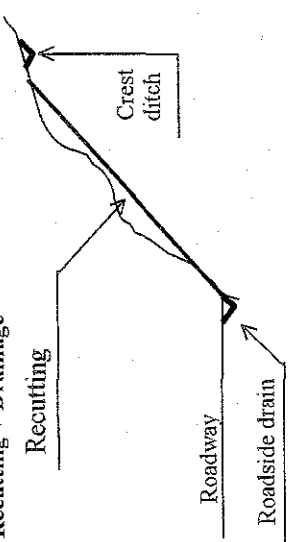
<p>Recutting + Shotcrete + Drainage</p>

Workability	- The weathering is measured by installation of drainage facilities. ○	- Cutting is no need for stability. - It is excels for countermeasure of weathering. ◎	- The purpose of cribwork are for the vegetation and increase stability ○

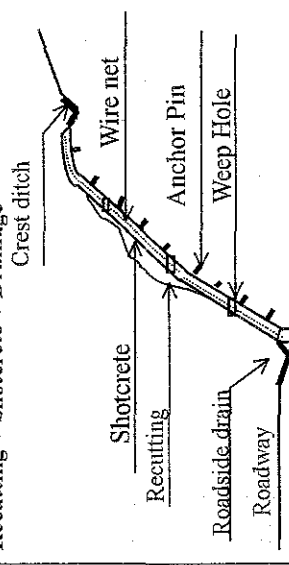
<p>Recutting + Cribwork + Vegetation + Drainage</p>

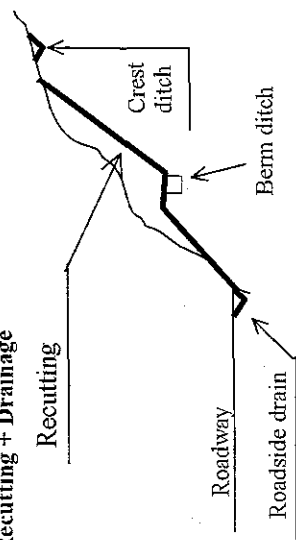
Recutting + Shotcrete + Drainage

Workability Structural feature	-There is not problem of construction. - The weathering is measured by installation of drainage facilities	-Special equipment is necessary. -It is excels for countermeasure of weathering.	-The purpose of cribwork are for the vegetation and increase stability	○

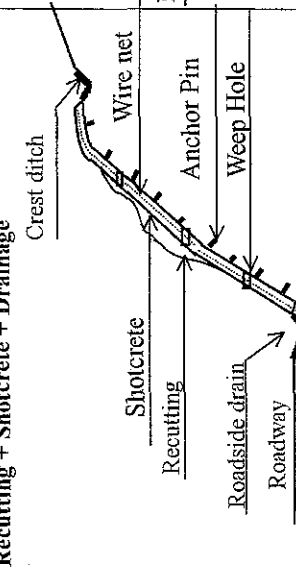
Recutting + Vegetation + Drainage

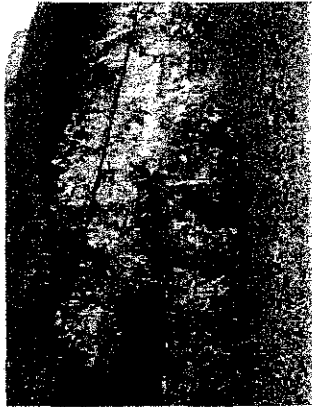
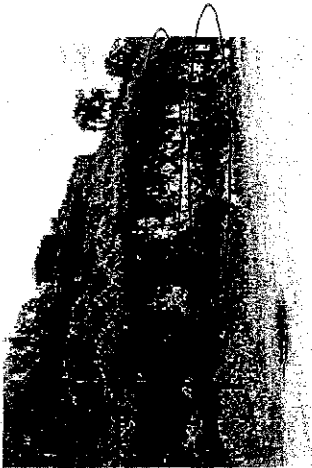
Table A6-10 Selection of Prevention Countermeasure Method			
ID : N003B320	Topography	The Point of The Small Ridge	Height and Incline
	Impact of Rain (Inflow water) The Dry Season	After rain	Stability Analysis
			Unnecessary
			Purpose of Countermeasure
			The Rainy Season
Situation of Slope

Rock Collapse
Comments	The weathering of tuff is advancing, the distributed layer of scoria at leg of slope is weak to rain, and collapse is early. The inflow water was confirmed from the part marked in red in rainy season.		
Alternative of Countermeasure

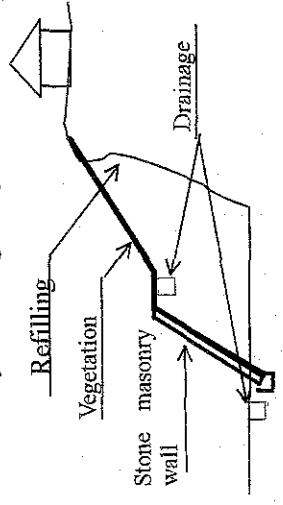
<p>Stone masonry + Refilling + Vegetation + Drainage</p>
Workability Structural feature	-Behavior of existing slope and constructed embankment is problem. Δ	-There is no problem of loosening of the backfill by the retaining wall. Construction is no problem. \odot	-There is no problem of loosening of the backfill by the retaining wall. Construction is no problem. \circ

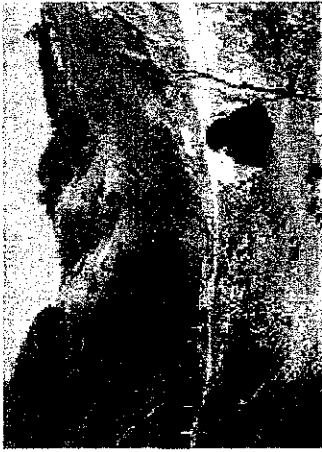
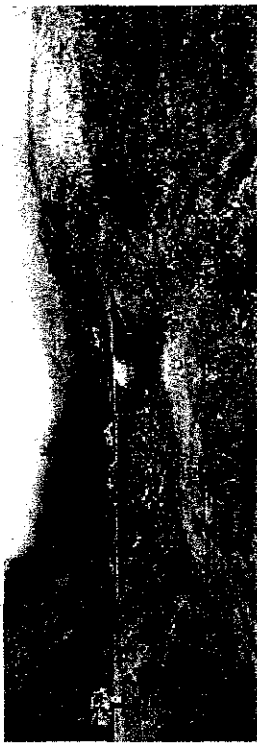
ID : N003E170	Topography	The Mountainside	Height and Incline	H = 10 ~ 22 m, θ = 45 ~ 62 deg.	The kind of The Rock	Alteration of Tuff and Andesite (Alteration zone)
	Impact of Rain (Inflow water)	Debris Flow Inflow water	Stability Analysis	Unnecessary	Purpose of Countermeasure	Debris Flow and Rockfalls
Situation of Slope

Comments	The quality of rock is changed. The difference of hard and soft is violent because of the place. The weathering belt in the hillside has surface collapse due to shallow seepage. The main disaster is flash flood than debris flow. The main disaster is flash flood than debris flow.					
Alternative of Countermeasure

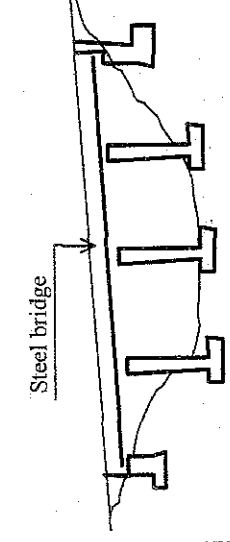
<p>Recutting + Cribwork with vegetation+ Drainage Steel bridge</p>	The Rainy Season		
Workability Structural feature	Construction is not so difficult. ○	Construction is not so difficult. ○	Construction is not so difficult. The purpose of cribwork are for the vegetation and increase stability ○	-The bridge of the length of about 100m is necessary. -Countermeasure of the approach road slope is necessary. △

Environment Impact	Slope is expected of natural vegetation. -It is difficult to harmonize with surroundings until taking root. △	The environment is prevented from deteriorating by vegetation among the cribwork. ○	The environment is prevented from deteriorating by vegetation among the cribwork. ○	-The environment is prevented from deteriorating by vegetation among the cribwork. ○		
Influence on Road	Detour of traffic is necessary during construction. △	Detour of traffic is necessary during construction. △	Detour of traffic is necessary during construction. △	-Detour of traffic is necessary during construction. △		
Maintenance	Maintenance is not for stability. ○	Maintenance is necessary until the vegetation takes root. ○	Maintenance is necessary until the vegetation takes root. ○	-The maintenance is necessary until the vegetation takes root. Maintenance of bridge is unnecessary. ○		
Economy	This alternative is cheapest of all. Maintenance cost is higher than other alternatives ◎	The cost is middle of all. ○	The cost is middle of all. ○	-Cost of new bridge construction is very expensive. △

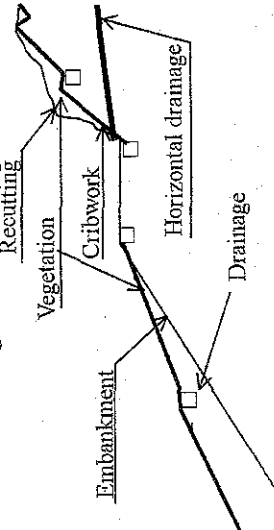
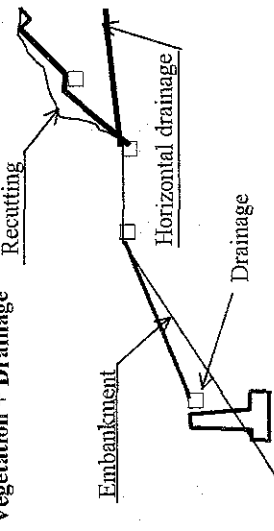
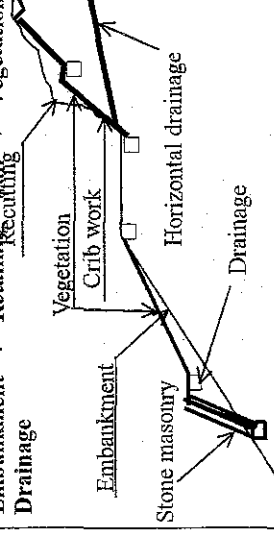
Situation of Slope						
Comments	Weathering of tuff is advancing. There is a watercourse in the rock and it was confirmed by the oozing from embankment. It is necessary to examine the installation of the horizontal drainage to control the water level. The cut gradient will be determined according to the boring result and the position of the church. T-shaped retaining wall will be necessary because it minimizes width of land use of coffee plantation.					
Alternative of Countermeasure

Recutting + Horizontal Drain + Drainage Embankment + T-shaped retaining wall + Vegetation + Drainage	Recutting + Cribwork with vegetation + Drainage + Horizontal drainage Embankment + Retaining Wall + Vegetation + Drainage	Recutting + Cribwork with vegetation + Drainage + Horizontal drainage Embankment + Retaining Wall + Vegetation + Drainage

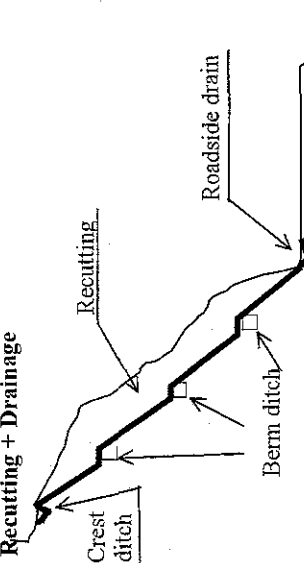
<p>Recutting + Drainage</p>

<p>Recutting + Cribwork with Vegetation + Drainage</p>		
Workability	-Large-scale collapse is prevented by cut of 35°. Stability will increase by drainage facilities. ○	-Vegetation is added to left side alternative as the increase stability. ○	-The purpose of cribwork is for the vegetation and increase stability. But it does not contribute almost in stability. ○

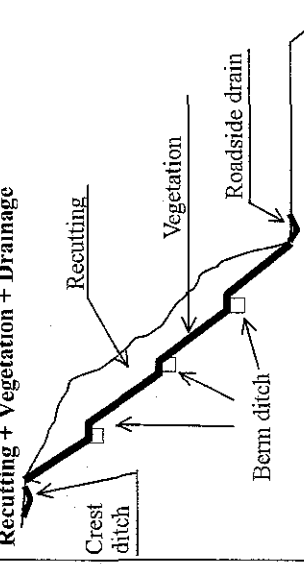
<p>Recutting + Vegetation + Drainage</p>

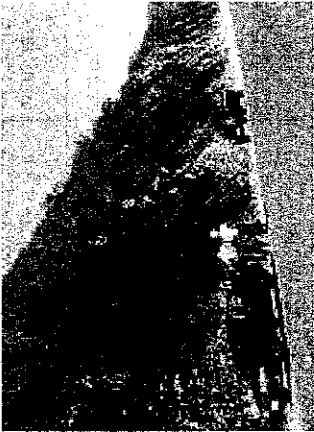
ID : N0026A060	Topography	The Mountain side	Height and Incline	H = 9 ~ 14 m , θ = 53 ~ 63 deg.	The kind of The Rock	Tuff
	Impact of Rain (Inflow water) The Dry Season	After water	Stability Analysis	Unnecessary	Purpose of Countermeasure The Rainy Season	Rockfalls
Situation of Slope

Comments	The surface dropping and falling rock stand out in rainy season. The layer of weathering tuff collapses, therefore andesite near shoulder become overhanging and collapses. Tuff becomes collapse along the cracks because it is subdivided by repeating dry and wet.					
Alternative of Countermeasure	<p>Recutting + Vegetation + Drainage</p>

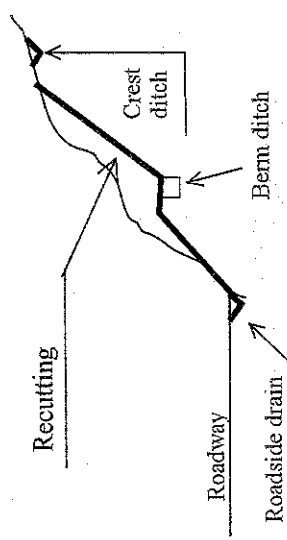
<p>Recutting + Shotcrete + Drainage</p>

Workability	-Construction is not difficult. Cutting is inferior in respect of the weathering measures	△	-It is necessary special equipment. -It is excels for countermeasure of weathering.	◎		-Construction is not difficult. -Some technologies are necessary.

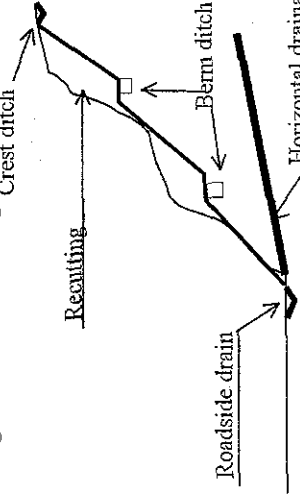
<p>Recutting + Horizontal drainage + Drainage Crest ditch</p>

Workability	-Large-scale collapse is prevented by cut of 40° at fracture zone, 55° at the other zone. Stability will increase by horizontal drainage facilities. ○	-Cribwork is added to left side alternative as the increase stability and vegetation. ○	-The road alignment is shifted, and then concrete barrier is installed. Cribwork is installed after slope is cut at the opposite side. △			
Environment Impact	-Slope is expected of natural vegetation. △	-The environment is prevented from deteriorating by vegetation among the cribwork. ○	-Vegetation is done among the cribwork, but opposite side remain slope of existing condition. △			
Influence on Road	-One lane is operated while constructing ○	-One lane is operated while constructing ○	-One lane is operated while constructing ○			
Maintenance	-The maintenance is necessary until the vegetation takes root. Inspection of slope surface is necessary. △	-The maintenance is necessary until the vegetation takes root. ○	-Maintenance of cribwork side is unnecessary, but maintenance of existing slope side is necessary. ○

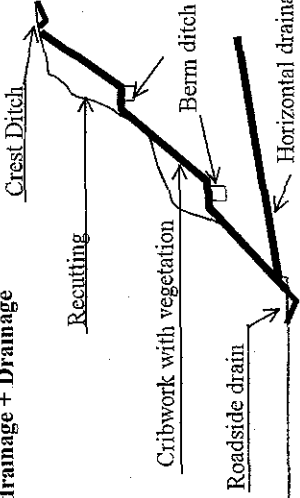
<p>Recutting + Cribwork with vegetation + drainage Crest Ditch</p>

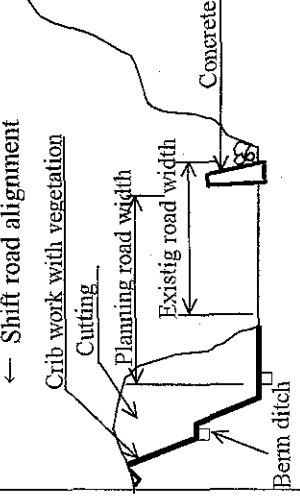
<p>Shift road alignment ← Shift road alignment Crib work with vegetation Cutting Planning road width Existing road width Concrete barrier Berm ditch</p>

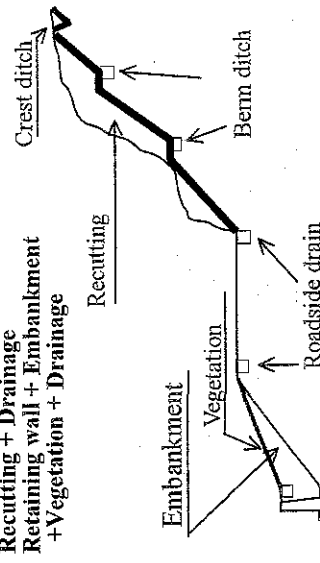
Retcutting + cribwork with vegetation + Drainage +Embankment +Vegetation

Workability	-Large-scale collapse is prevented and stability increase by cut of 55°. Retaining wall is installed at embankment side.		-Cribwork and vegetation are added to left side alternative as the increase stability. Embankment increase stability by bench cutting of existing slope.		-Large-scale collapse is prevented and stability increase by cut of 55°. Roadside ditch is installed at shoulder of slope at embankment side.	
Environment Impact	-Slope is expected of natural vegetation at cut slope side		-The environment is prevented from deteriorating by vegetation among the cribwork.		-Slope is expected of natural vegetation at cut slope side.	
Influence on Road	-One lane is operated while constructing		-One lane is operated while constructing		-One lane is operated while constructing	
Maintenance	-The maintenance is necessary until the vegetation takes root.		-The maintenance is necessary until the vegetation takes root.		-Inspection of slope surface is necessary.

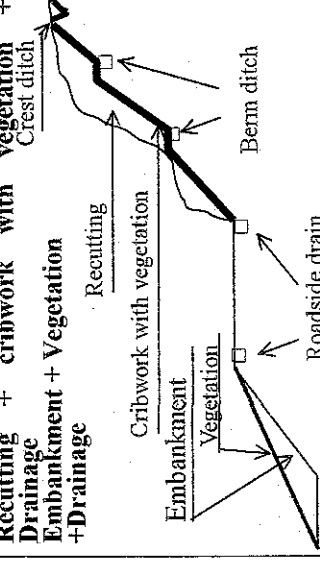
Retcutting + Drainage

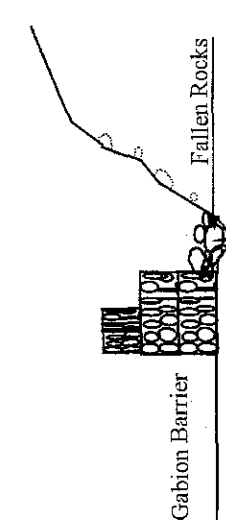
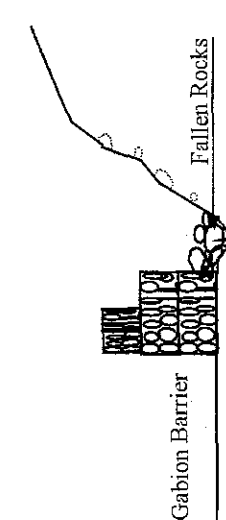
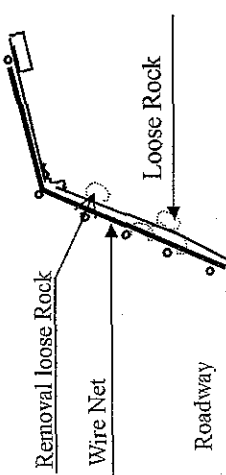
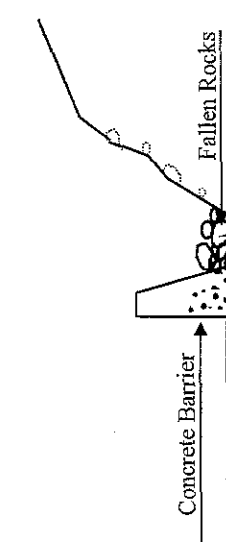
Workability	-Wire of gabion cannot resist against energy of the assumed falling rock. Δ	-The construction results are not in Nicaragua. -This type is almost permanent structure. ○	-The concrete barrier will be too big size for resistance against energy of the assumed falling rock. Δ			
Environment Impact	-Deterioration of environment will be forecast by damage of gabion. Δ	-It is necessary to cut trees. Δ	-Installing the concrete barrier lacks harmony with the surrounding. Δ

Influence on Road	-It is difficult to stop completely jumping over rock by barrier. Width for barrier is not enough. Δ	-There is no problem. ◎	-It is difficult to stop completely jumping over rock by barrier. Width for barrier is not enough. Δ			
Maintenance	-It is necessary to remove collected rock. Δ	-The environment deterioration is eased by partially constructing the net. Δ	-It is necessary to remove fallen rocks. ○			
Economy	-Durability depends on the life of the wire. Δ	-Net materials are expensive, but maintenance cost isn't high. ○	-The maintenance of the structure is unnecessary. ○			
Evaluation	-Because maintenance cost is high, costs of three alternatives are almost even. ○	-This type prevents completely dispersion of rock collapse. 1	-The cost is middle of all. But the costs of three alternatives are almost even. ○			
	-The gabion isn't steady by the collision of assumed falling rock. Width for barrier is not enough. 3		-The gabion isn't steady by the collision of assumed falling rock. Width for barrier is not enough. 2
