## Appendix-7 Photographs of Existing Bridges Selected for Phase1

## Appendix-8 Draft Cost Estimation

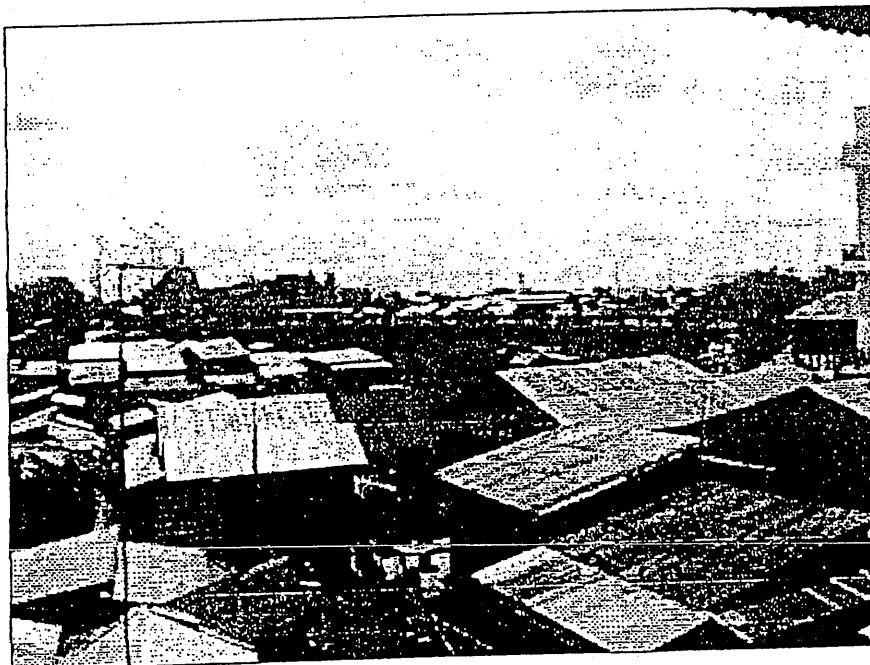
Photo2 -1 Stung Meancheay in Phnom Penh City

This Bridge is locating southwest of Phnom Penh Arterial Road that is leading to Inner Ring and Industrial Zone.

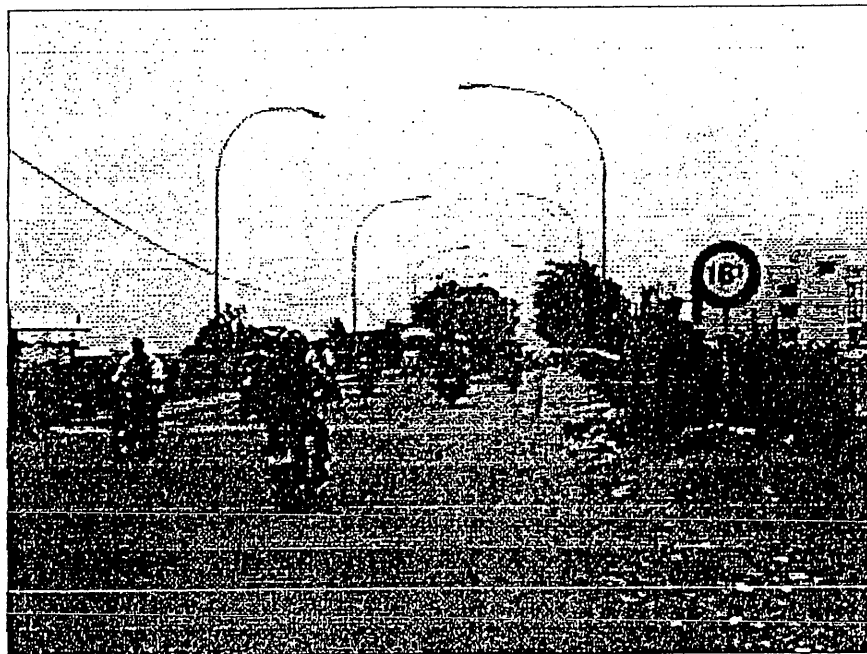
Photo 2-2 Stung Meancheay

Recently traffic jam often happens due to short of traffic capacity at this bridge  
And Truck Weight is limited as 16t that cannot be satisfied for ideal vehicle design load.

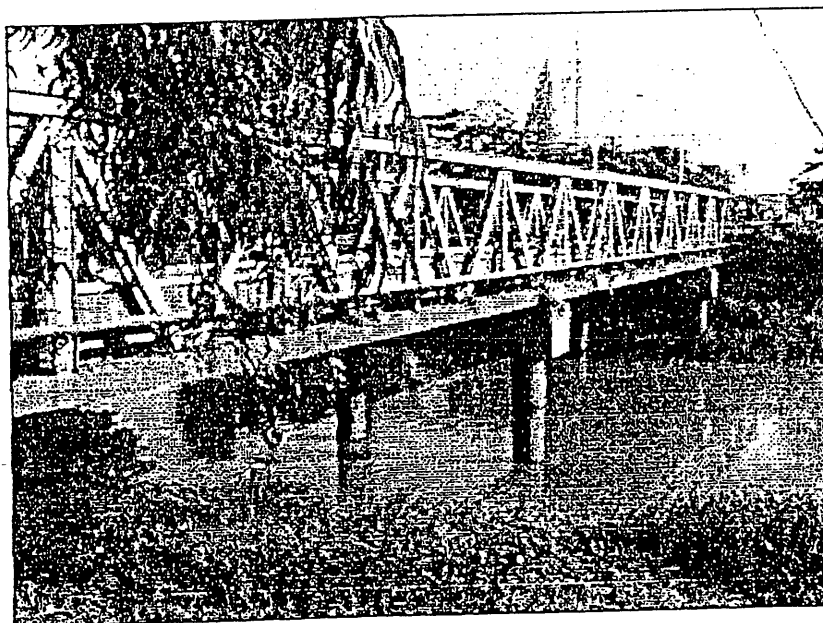
Photo-5 View of Ta Khamu Steel Truss

This bridge was temporary repaired by MPWT due to the serious rusting of steel truss and the inclination of substructure

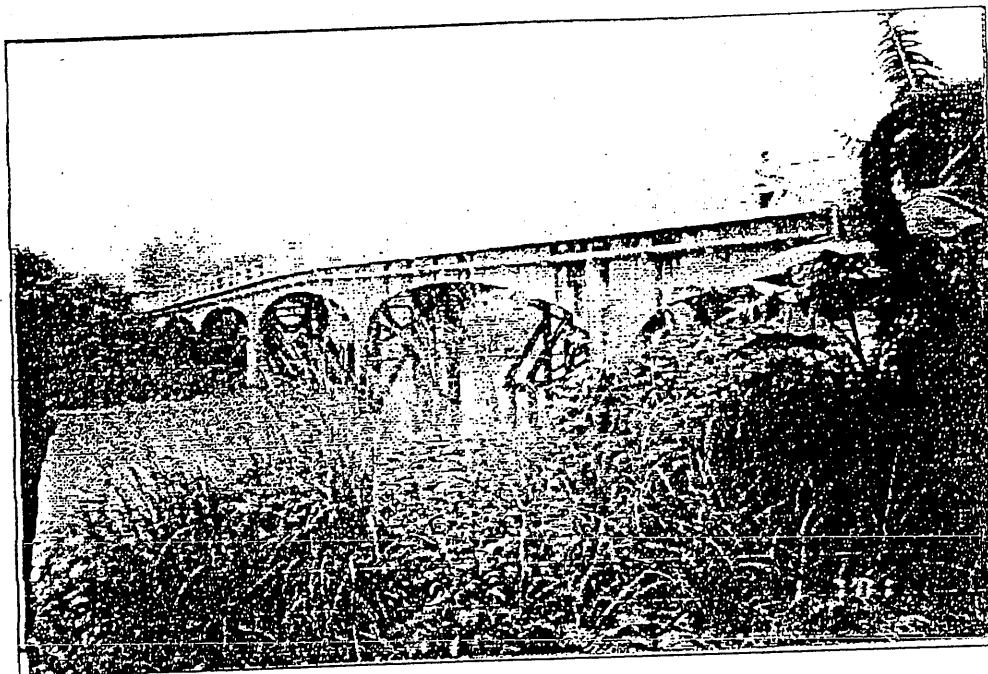
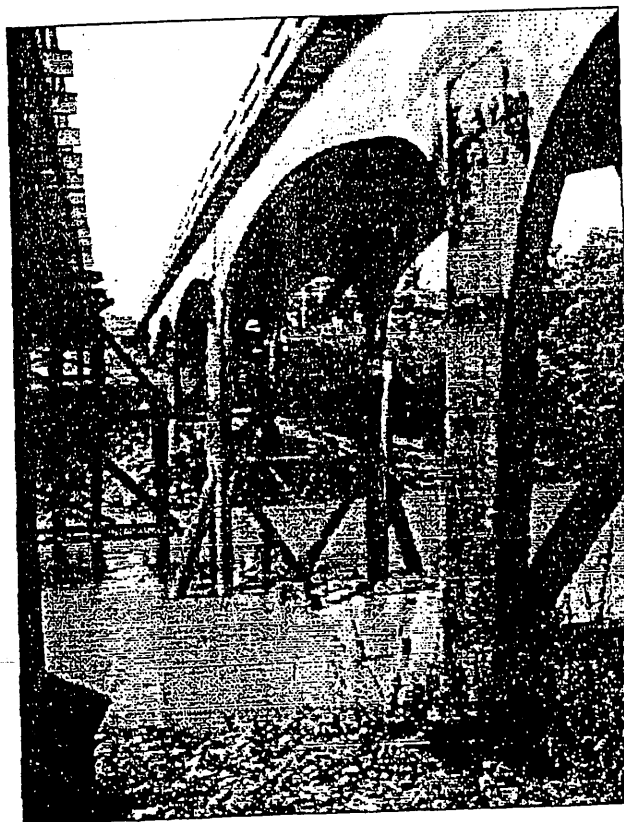
Photo-7 Preak Ho Bridge on NR2 was constructed in 1922.

Several Piers have been suffered due to ageing and heavy loaded truck

MPWT has fixed damaged members in these days and constructed one temporary bridge to solve a traffic jam at this point

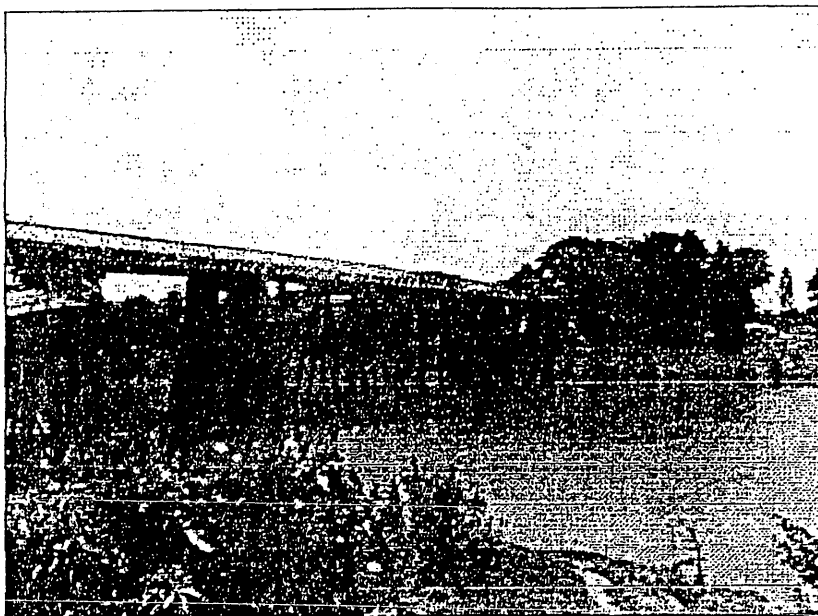
Photo-12 Peam Ror Bridge on NR11

Peam Ror was repaired at northern abutment, which was destroyed by 2000 Flood.  
Now RGC repaired this abutment and installed temporary bailey bridge again.

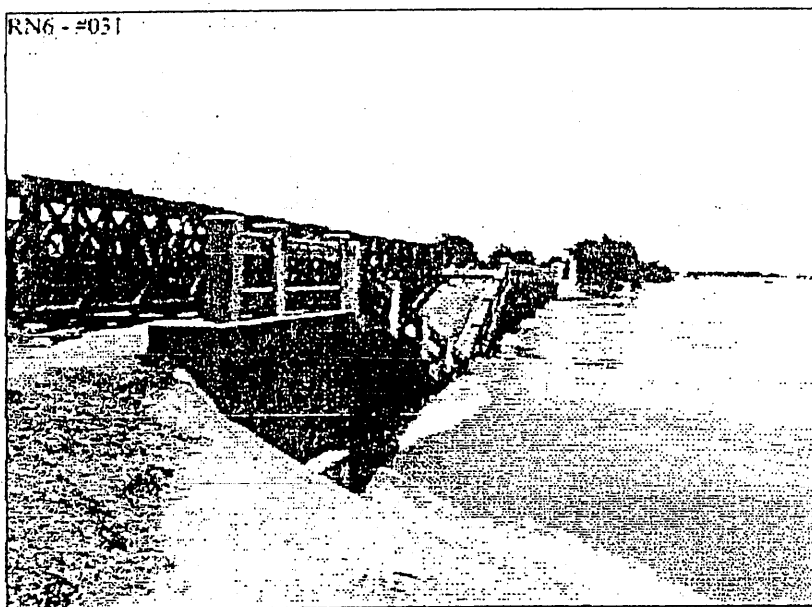
Photo-13 No.24 Bridge Collapsed in Aug 2001

This bridge was constructed in 1960's same as other bridges along 6a.  
Causes of collapse are mainly due to deteriorations on steel pipe substructures,  
and other influences of overloaded vehicles and flood are not negligible

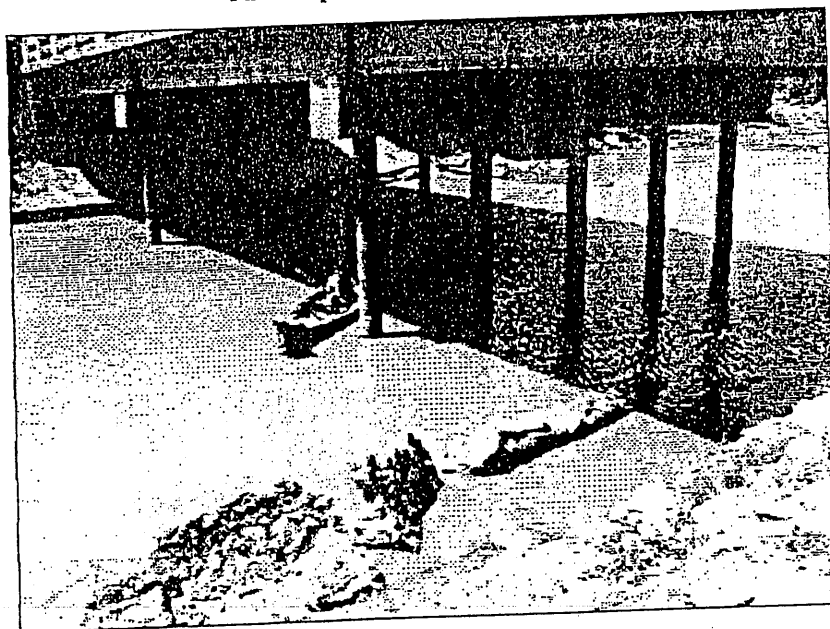
Photo-14 Serious Scoring at No.15 Bridge on NR6a

Those types of deteriorations can be seen easily at neighbor bridges  
Due to riverbed scoring, the substructures may be unstable condition.  
Masonry broken by floodwater can be seen on front side.

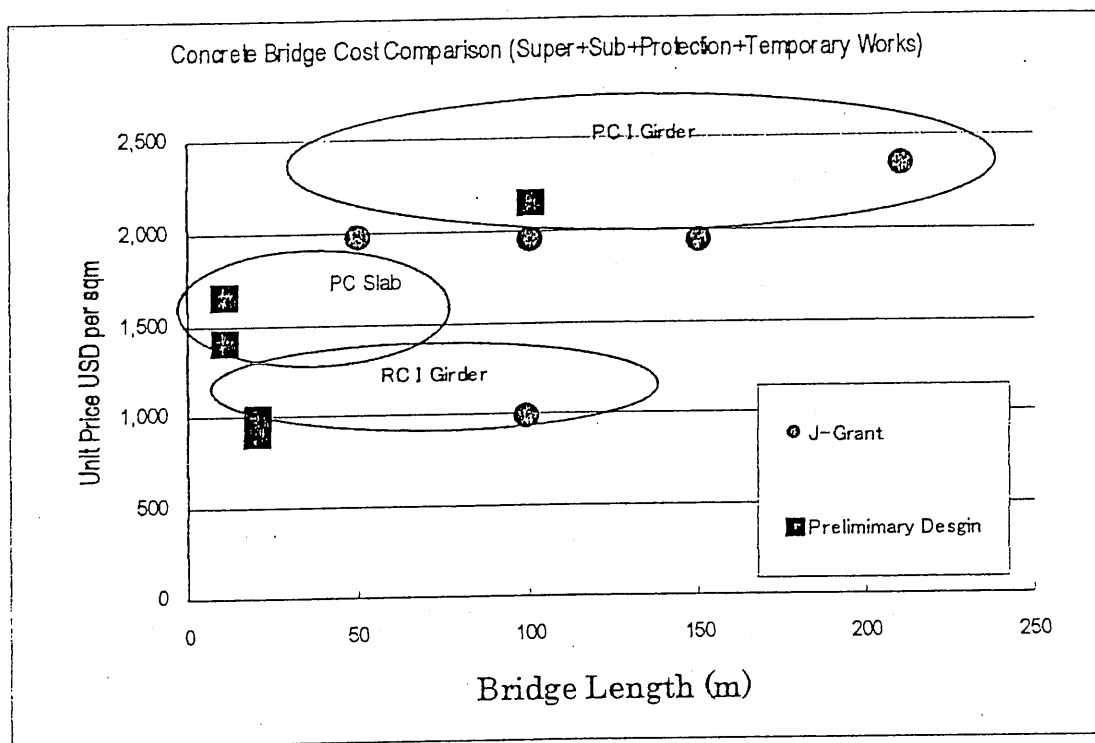
Figure-1 Unit Price of Bridges

Figure-1 shows Bridge Construction Direct Cost that is collected from Japan Grant Project and the Cambodia Standard Bridge Preliminary Design.
