5.5. PRESENT TRAFFIC SAFETY SITUATION

5.7. SAFETY MEASURES FOR PASSENGERS OF BUSWAY SYSTEM IN CURITIBA

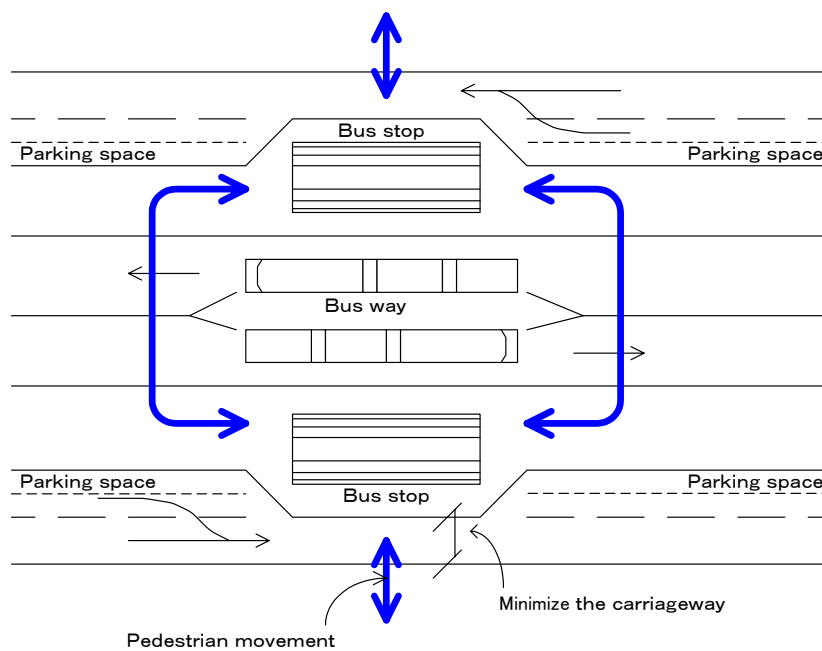
Figure 5.7-2 Pedestrian Facilities at Bus Stop with Low Traffic Volume

- c. At bus stops where there is relatively low traffic volume, the lane width of the carriageway is narrow for safe crossing of bus passengers. However, there is no marking of pedestrian crossings at the bus stops (See Figure 5.7-2.).

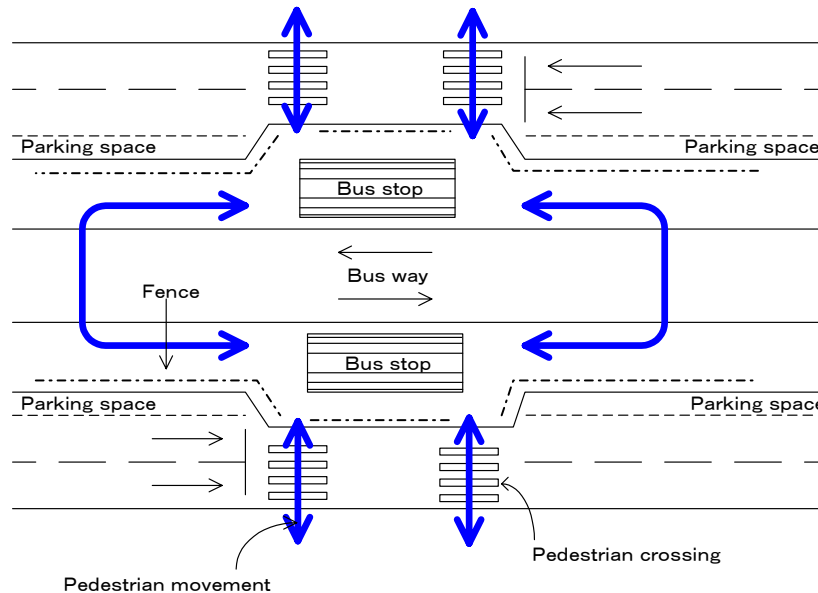
Figure 5.7-3 Pedestrian Facilities at Bus Stop with Relatively Heavy Traffic Volume

- d. At busway stops where there is a relatively heavy traffic volume, zebra markings and a safety guard fence for pedestrian crossing are prepared, but there is no traffic signal at this point. The traffic safety education for drivers is conducted at the bus stops where drivers slow down at the pedestrian crossings and stop when they see pedestrians, spontaneously (See Figure 5.7-3.).

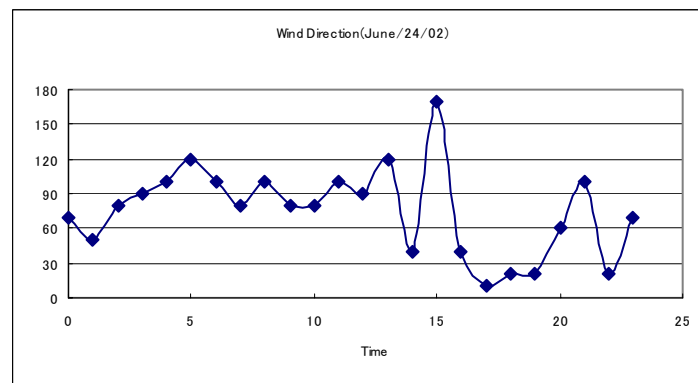
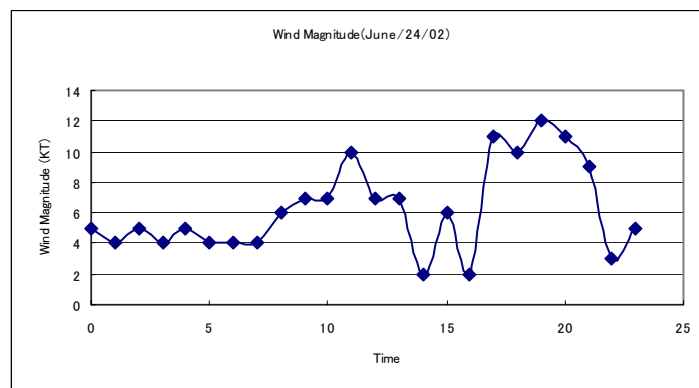
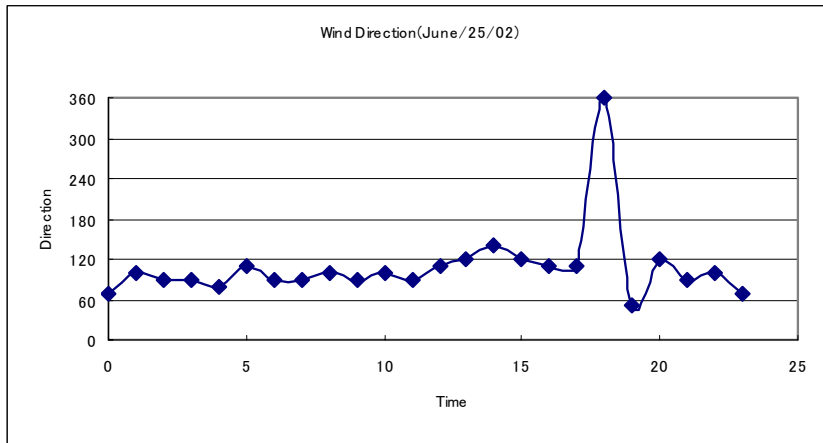
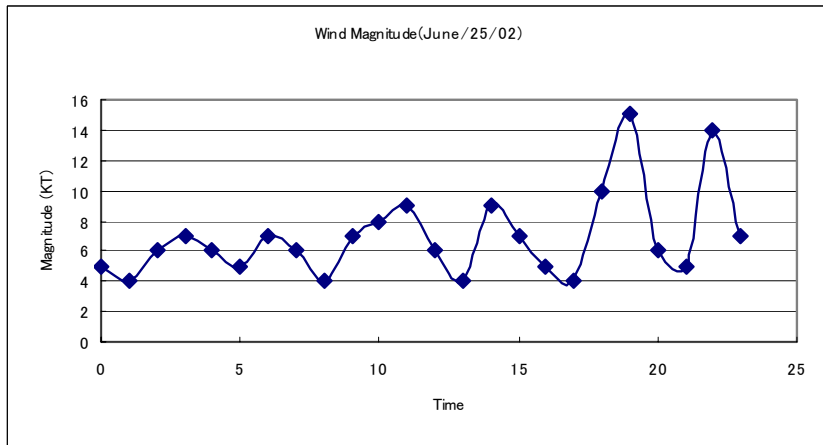
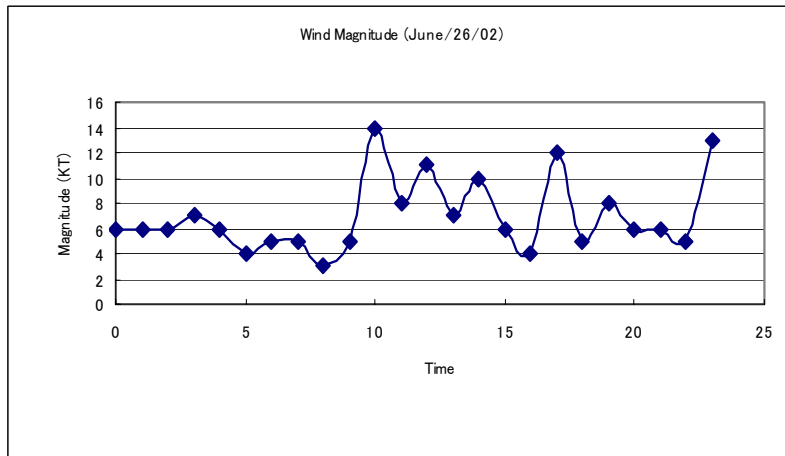
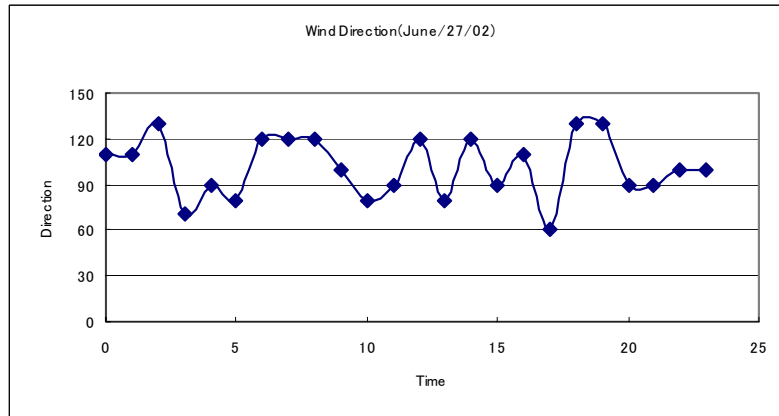
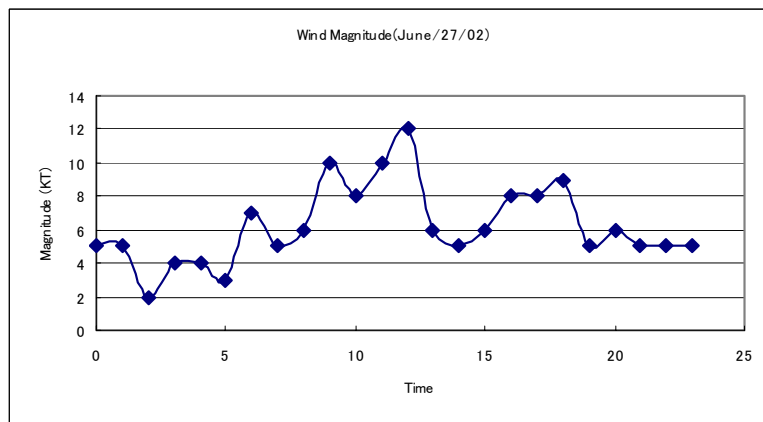
As shown in these figures, the prevailing wind direction is easterly (i.e., 90 degrees) and the maximum wind speed reaches around 10.0 - 14.0 KT (approximately 5.0 – 7.0 m/sec) throughout this period. This tendency is also observed in current reports (e.g., Cabral C, 1993).

Basically, there is no strong wind in the early morning and it can be said that regional atmospheric conditions seem to be stable. Then, after 8:00 or 9:00 a.m., the wind starts blowing gradually and ceases at evening. Usually, this wind blows for 12 – 14 hours every day. This is the typical wind pattern observed in Belem during this dry season although there are several exceptional cases of exceptional winds. Also, several short-term wavelength fluctuation patterns ($T = 3 - 4$ hours) are recognized within each daily wind pattern, and these might be caused by meso-scale climatological conditions such as the occurrence of torrential rain. It is recommended to collect more regional meteorological data sets for more detailed meteorological study such as a correlation study between wind and rainfall patterns.
